Above the Flood: Elevating Your Floodprone House

FEMA 347 / May 2000

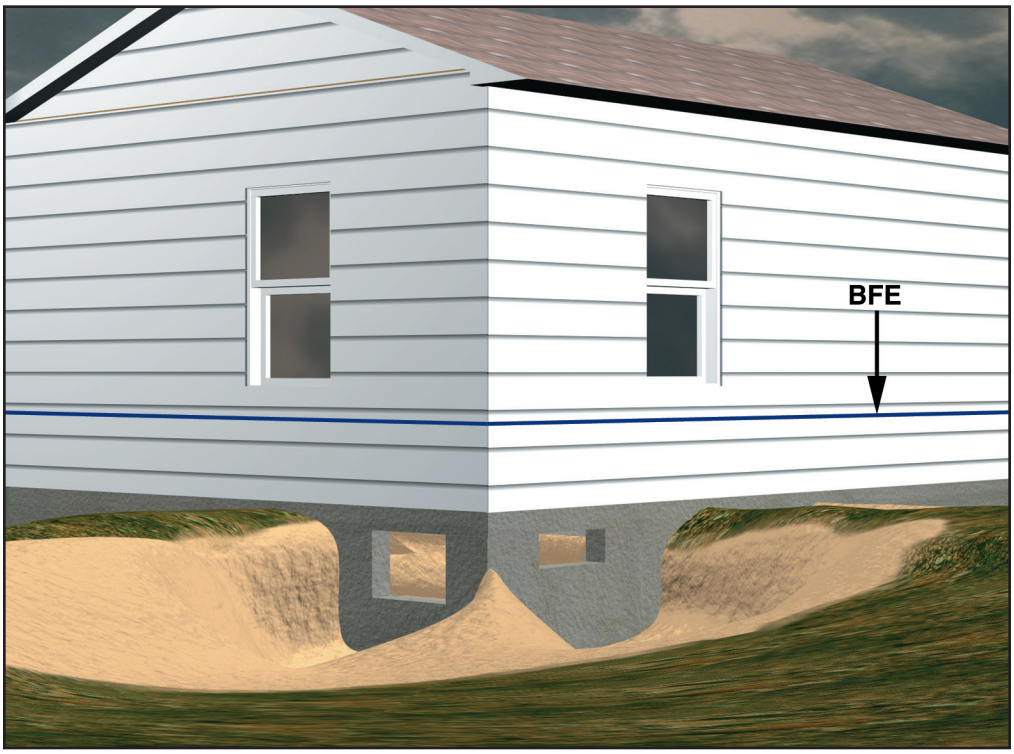
Figure 17
Trenches and tunnels under the slab provide access for the jacks and I-beams that will lift the house.

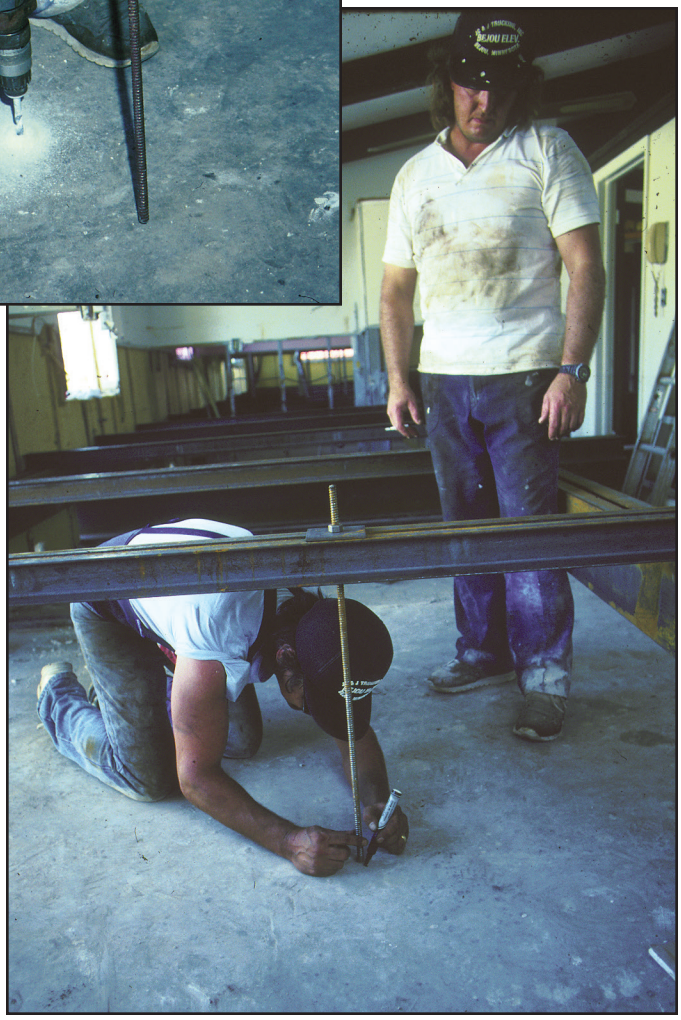
Figure 77
... install anchors ...
