CONDOMINIUM RESERVE STUDY

Denholm Building

**484 Main Street
Worcester, Massachusetts**

**Subject: Condominium Reserve Study & MEP/LS Report
Denholm Building
484 Main Street, Worcester, Massachusetts
EBI Project #1319000663**

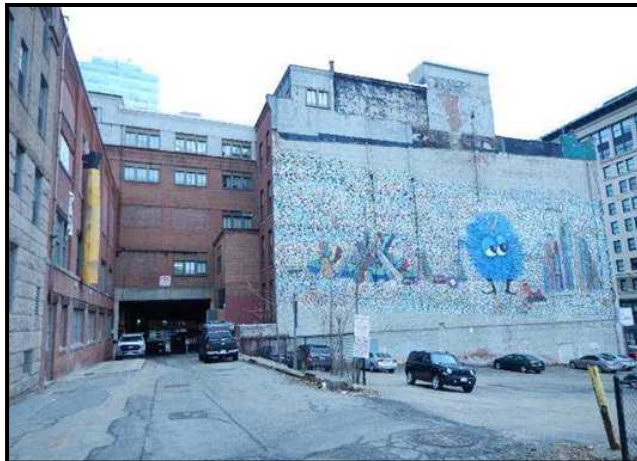
View of southern side of service alley

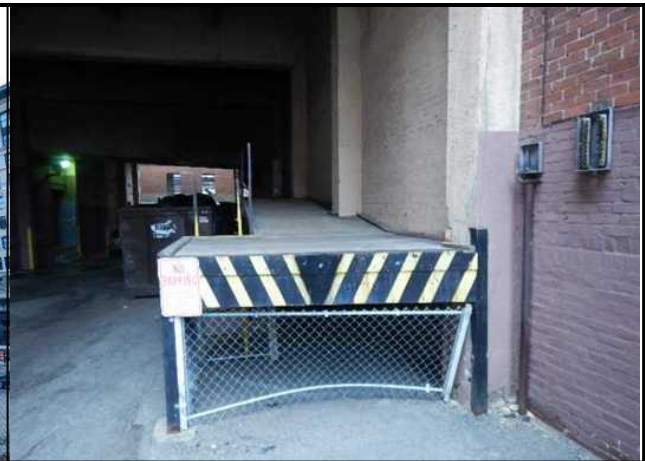
View of loading dock within service alley

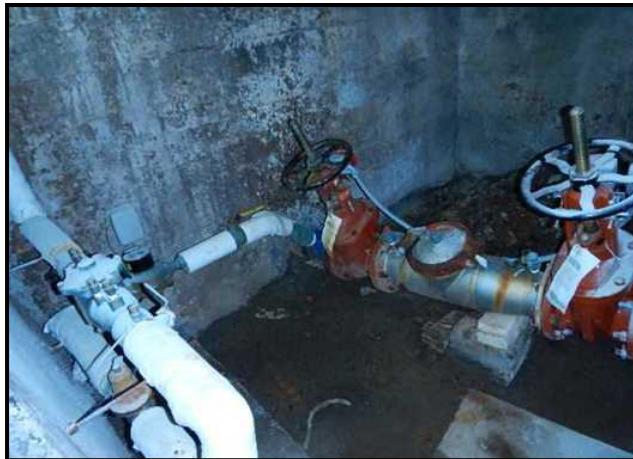
Rear domestic and sprinkler water service line

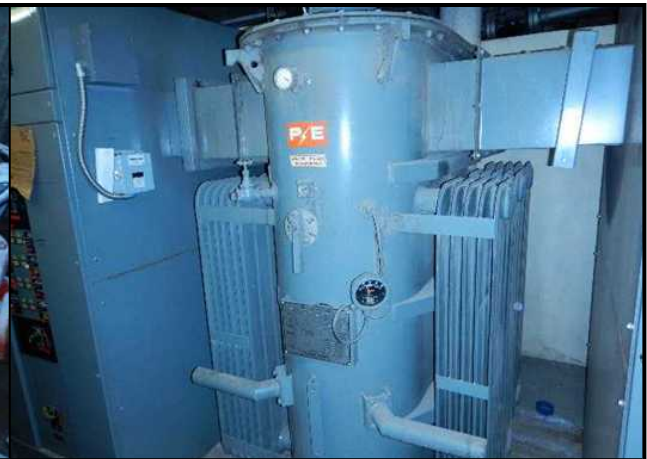
One of two main transformers

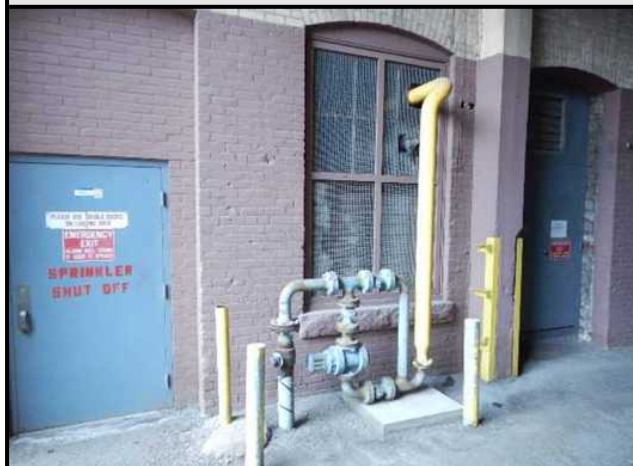
Main gas meter within service alley

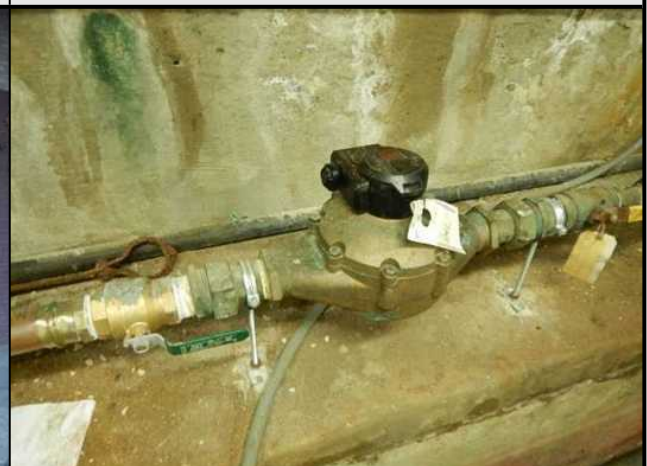
Front of building domestic water meter

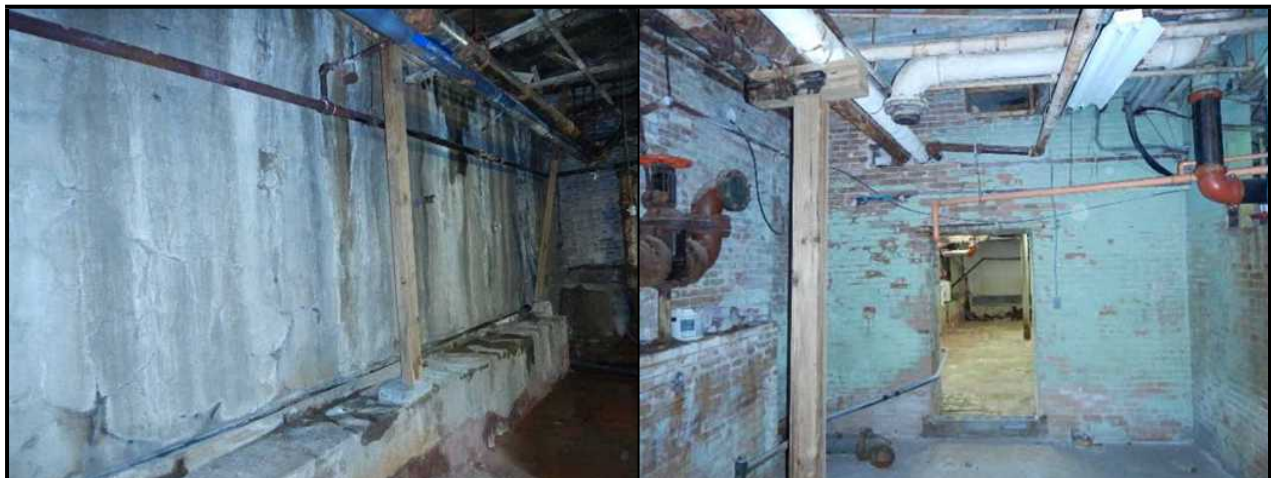
Stucco covered stone basement foundation wall at front of building

Basement brick foundation walls

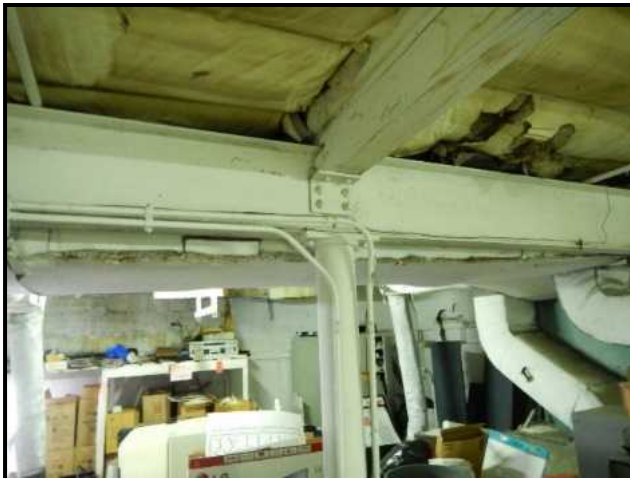
Steel and wood roof framing at 7th floor storage space

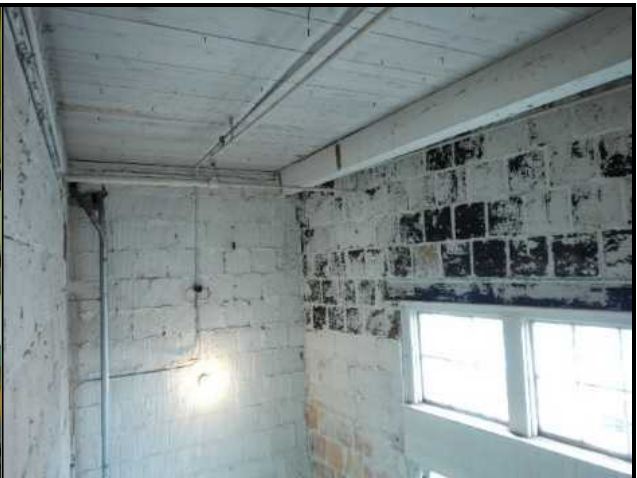
Stairwell structure showing wood roof sheathing

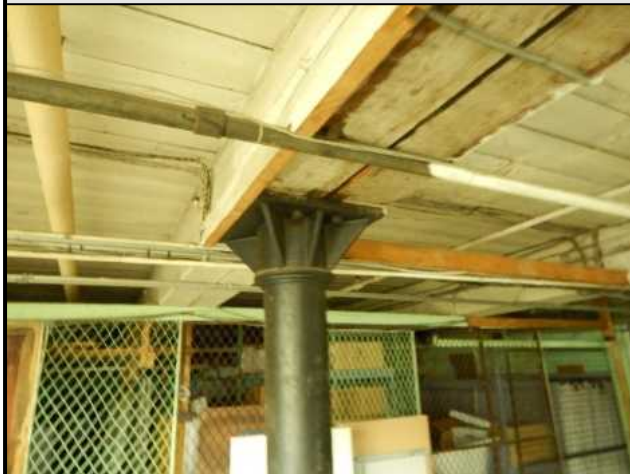
Cast iron column supporting wood framing

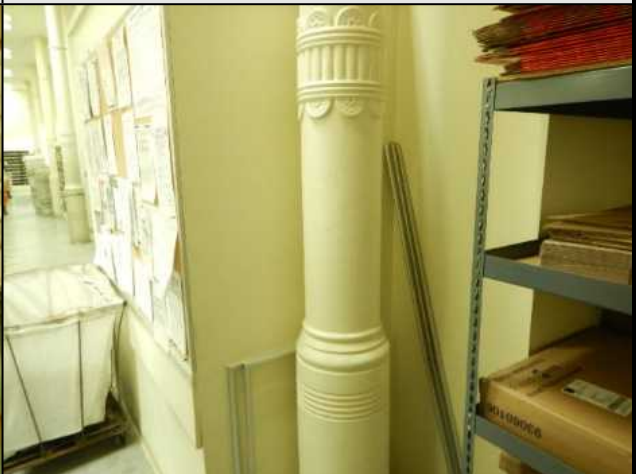
Ornamental cast iron building column visible in Post Office space

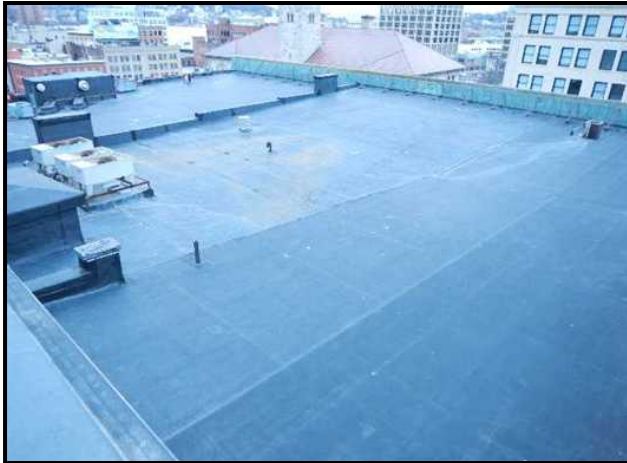
Front EPDM membrane roofing designated section A and B

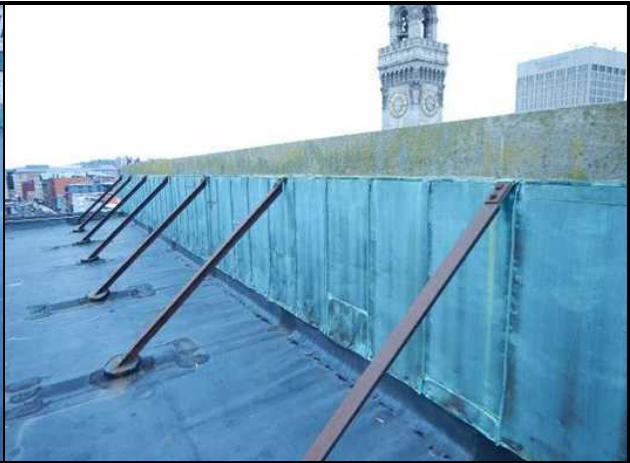
Front roof parapet wall with copper facing and steel struts

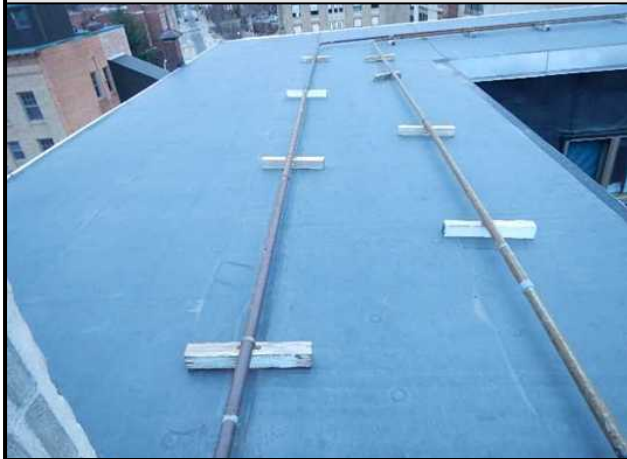
New EPDM roofing over 7th floor entrance corridor

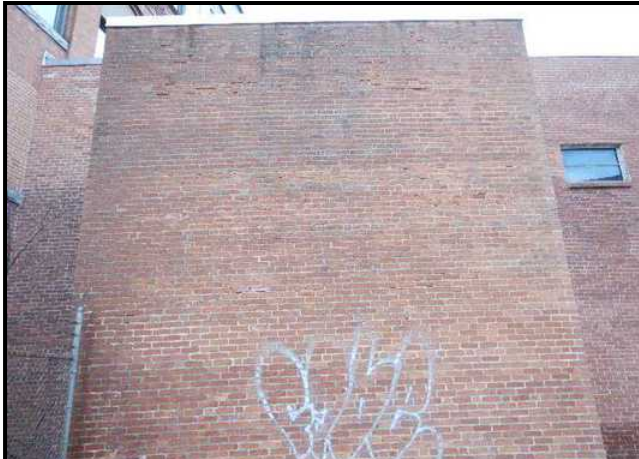
Northern façade brick mortar joint deterioration

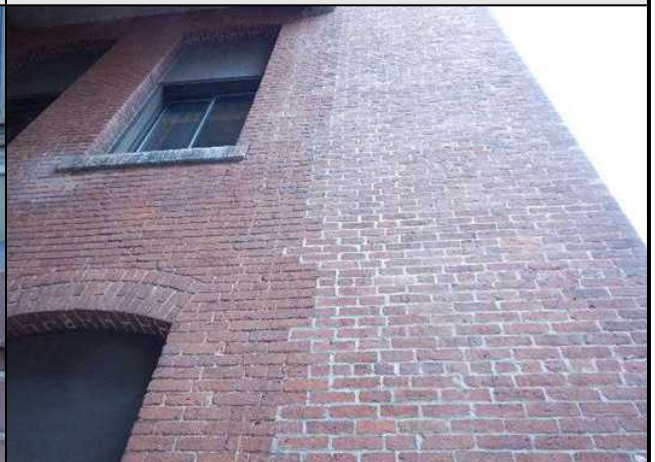
Previous mortar repointing along northern side of building

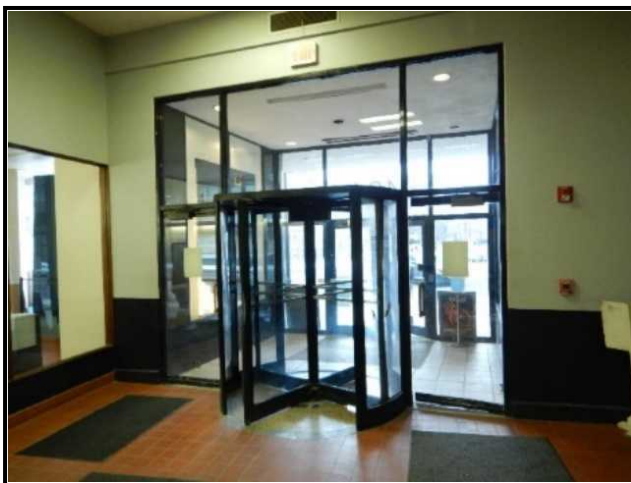
Revolving door vestibule entrance

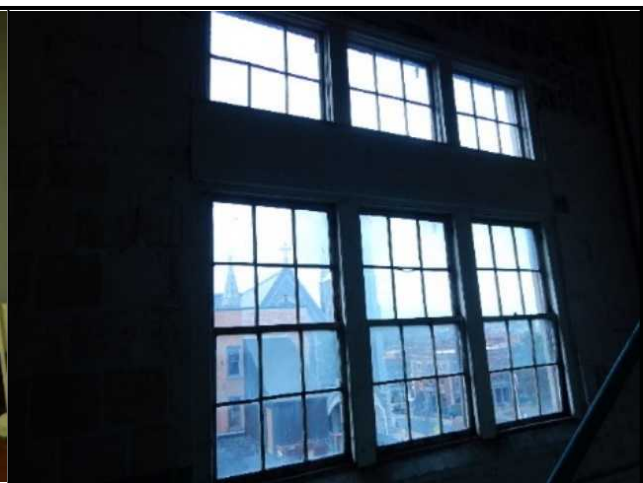
Single-pane stairwell original windows

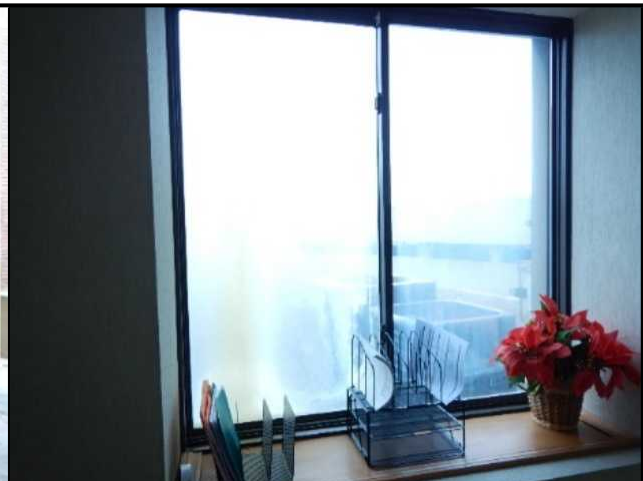
Fogged window pane in office space

- **Replace broken pane and/or fogged window panes**

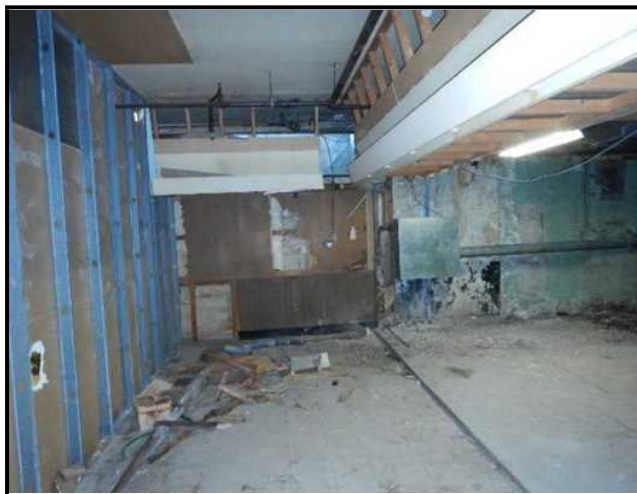
Stripped basement finishes

The basement was reportedly utilized during the time when the building was a department store and furniture was sold at the basement level. Currently, the basement is in generally poor condition with recent flooding damage observed due to a malfunctioning sump pump. Moisture infiltration appears to be a common issue along several perimeter walls where ground water is constantly seeping in and needs to be pumped out. Based on the observed condition, Non-Critical Repairs are recommended for a general cleanup of the basement so that worn and water damaged finishes are removed and the basement is in an easier to maintain condition.

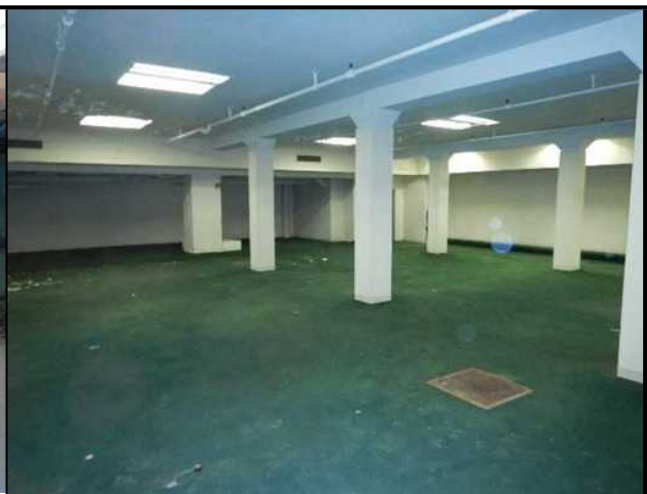
Remaining basement finishes

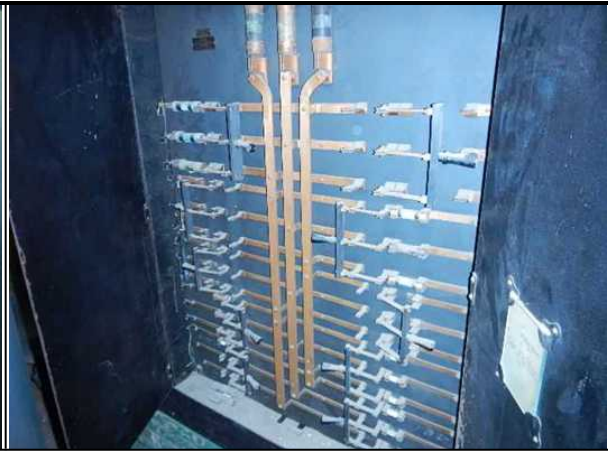
Vintage electrical knife switch panel

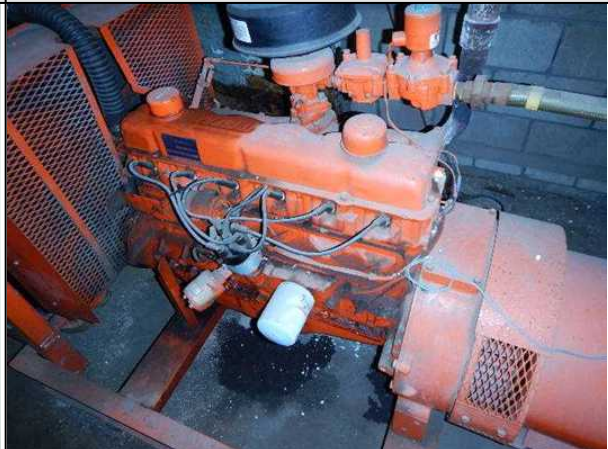
Basement mounted backup generator

- **Replace Gas-Fired Emergency Generator (60 kW)**

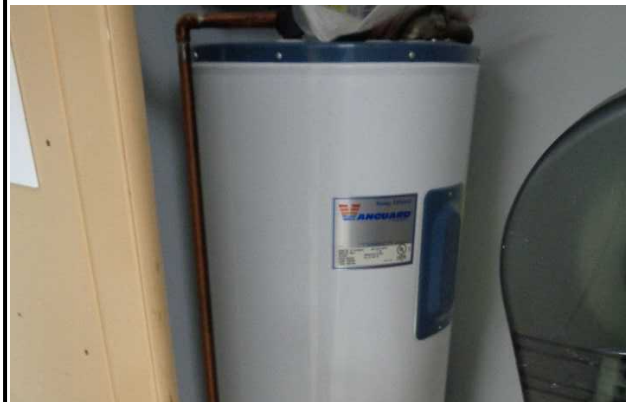
Common Bathroom Water Heater

- **Replace electric water heaters**

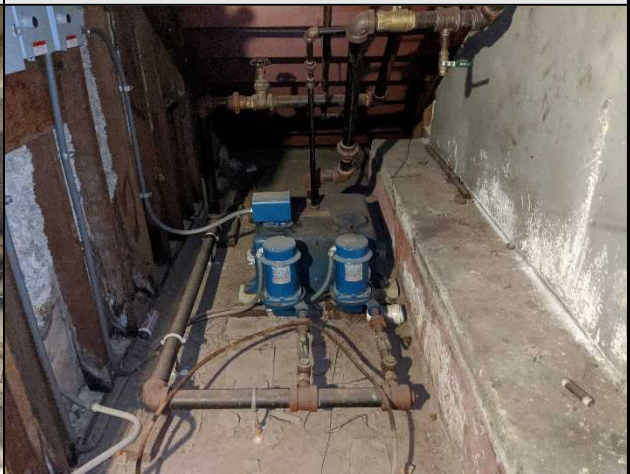
The steam piping where able to be observed, appear to be in fair to poor condition. The Subject Property is over 45 years old and the sewer pipes are starting to corrode. It is recommended that the steam piping be evaluated by a qualified professional to assess its current condition, identify repair needs, and provide an estimate of its remaining useful life as an Immediate Repair. Any modifications/repairs recommended by the evaluation should be completed as part of Short Term Repairs.

Steam System Piping

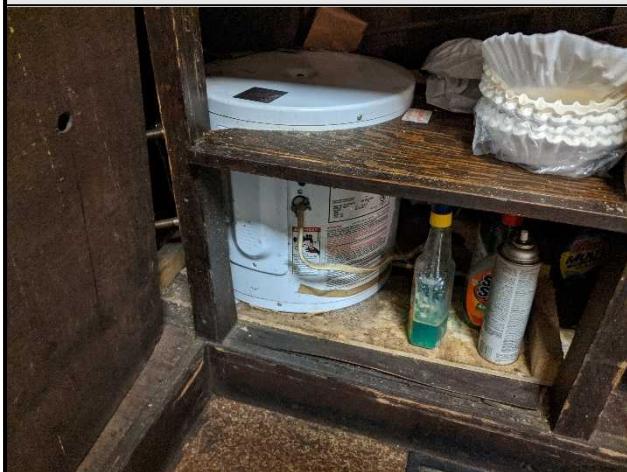
Water Heater Lacking Catch Pan

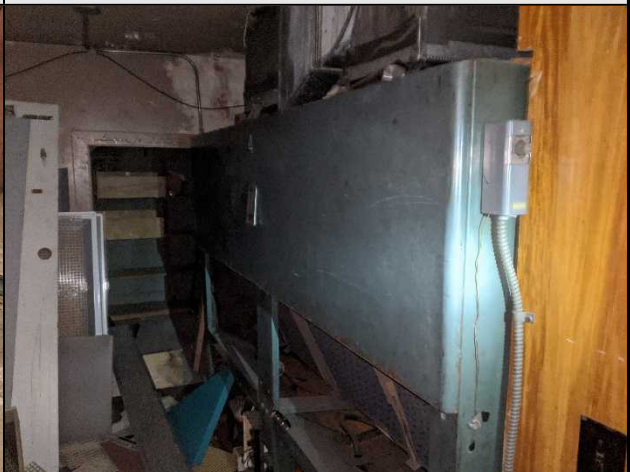
Inoperable Air Handler Unit

- **Replace Gas-Fired Steam Boiler (3770 MBH)**
- **Licensed Engineering firm to evaluate the replacement and natural gas conversion of oil-fired steam boiler (3770 MBH) and provide cost**
- **Replace six (6) DX condensers**
- **Replace eight (8) SCAHU's**
- **Replace two (2) DX AHU**
- **Replace two (2) RTU's**

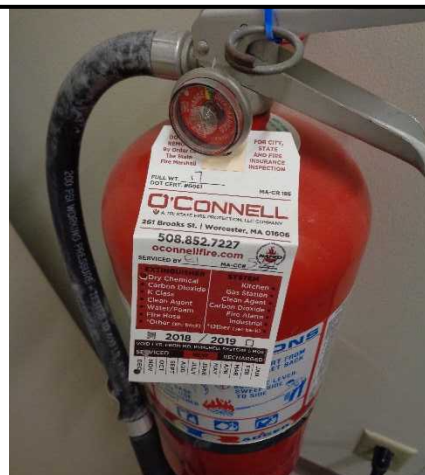
The fire extinguishers are reportedly inspected annually, a few of the fire extinguishers have expired inspection tags, but appear to be in serviceable condition. The inspection dates on the fire extinguisher are December, 2018, and April, 2019. Based on the expired inspection tags, repairs are recommended for updating the expired fire extinguisher inspection tags. Subsequent to our site visit, the client

Expired Fire Extinguisher Inspection

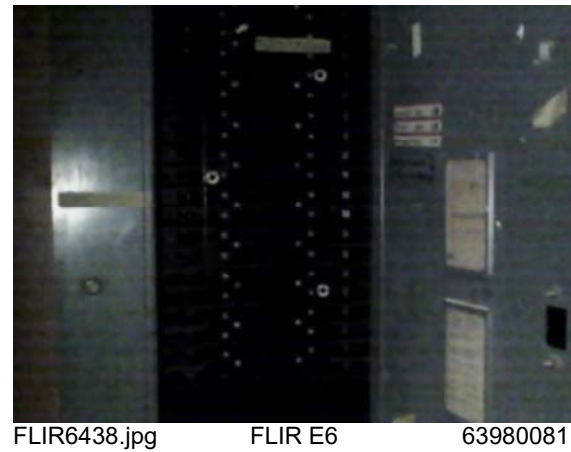
Distribution Panel - 3rd Fl. Annex North. section 2

Bx1	Max	80.9 °F
	Min	78.3 °F
	Average	79.3 °F

The surface temperatures recorded at the electrical panel fall within the safe temperature range defined by the InterNational Electrical Testing Association (NETA).

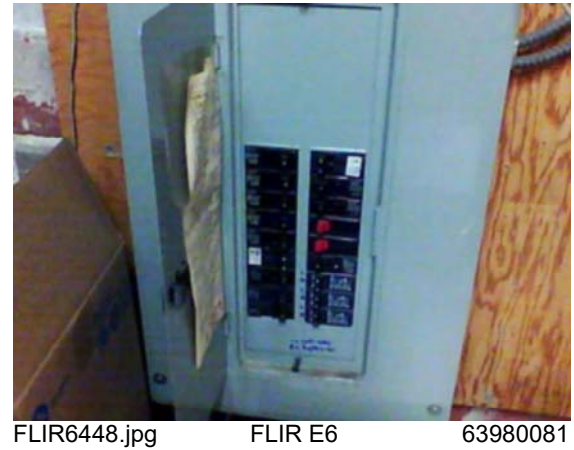
Distribution Panel - No Tag (4th Floor)

Bx1	Max	78.7 °F
	Min	72.3 °F
	Average	74.3 °F

The surface temperatures recorded at the electrical panel fall within the safe temperature range defined by the InterNational Electrical Testing Association (NETA).
