# Inspection Report

Date <b>6/4/2019</b>	P/O. No.	Weather <b>Dry</b>	Surveyor's Name <b>BRIAN GROM</b>	Pipe Segment Reference <b>SM00463</b>	Section No. <b>6</b>
Certificate No. <b>U-0218030700746</b>	Survey Customer	System Owner	Date Cleaned <b>6/4/2019</b>	Pre-Cleaning <b>No Pre-Cleaning</b>	Sewer Category

Street <b>123 GARRISON AVE</b>	Use of Sewer <b>Sanitary</b>	Upstream MH <b>SS02758</b>
City <b>WORCESTER MA</b>	Drainage Area	Dowstream MH <b>SS02759</b>
Loc. details	Flow Control <b>Not Controlled</b>	Dir. of Survey <b>Downstream</b>
Location Code <b>Easement/Right of way</b>	Length surveyed <b>156.12 ft</b>	Section Length <b>156.12 ft</b>

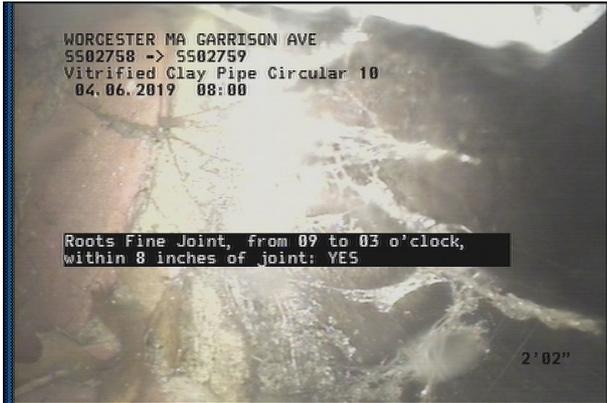
1:375 Position	Observation	
	Upstream Manhole, Survey Begins	<p>2.2 FT</p>
0.00	Water Level, 5 %of cross sectional area	
2.20	Roots Fine Joint, from 09 to 03 o'clock, within 8 inches of joint: YES	<p>15.11 FT</p>

Photo:  
SS02758-SS02759\_04062019\_RFJ\_2.2017\_090839\_A.JPG  
2.2FT, Roots Fine Joint, from 09 to 03 o'clock, within 8 inches of joint: YES

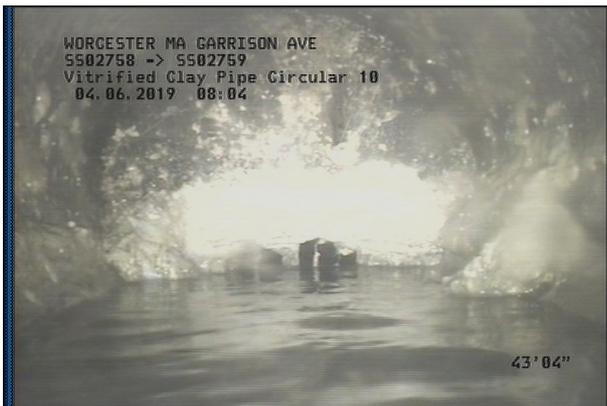
15.91	S1 Deposits Attached Grease, 5 %of cross sectional area, from 04 to 08 o'clock, , within 8 inches of joint: YES, Start	<p>15.91 FT</p>
43.33	Deposits Attached Grease, 95 %of cross sectional area, from 12 to 12 o'clock, , within 8 inches of joint: YES	<p>43.33 FT</p>

Photo:  
SS02758-SS02759\_04062019\_DAGS\_43.3332\_091300\_A.JPG  
43.33FT, Deposits Attached Grease, 95 %of cross sectional area, from 12 to 12 o'clock, , within 8 inches of joint: YES

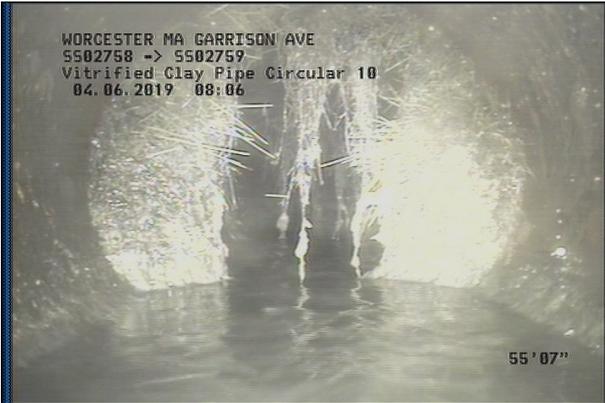
Photo:  
SS02758-SS02759\_04062019\_RBB\_46.0352\_091453\_B.JPG  
46.04FT, Roots Ball Barrell, from 07 to 05 o'clock, 80 %, Start

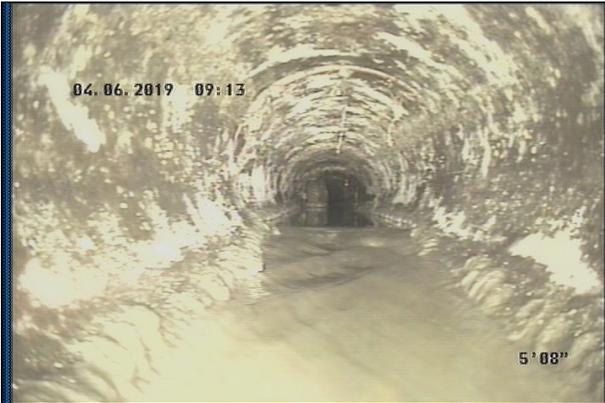
Photo:  
SS02759-SS03746\_04062019\_DAGS\_5.7044\_102209\_A.JPG  
5.7FT, Deposits Attached Grease, 5 %of cross sectional area, from 04 to 08 o'clock, , within 8 inches of joint: YES, Start

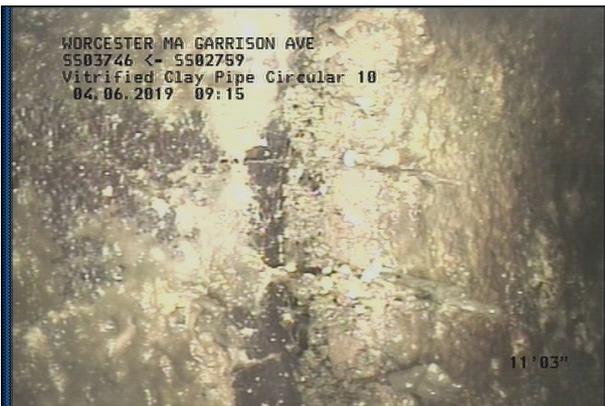
Photo:  
SS02759-SS03746\_04062019\_DAGS\_11.2086\_102343\_A.JPG  
11.21FT, Deposits Attached Grease, 15 %of cross sectional area, from 11 to 01 o'clock, , within 8 inches of joint: YES

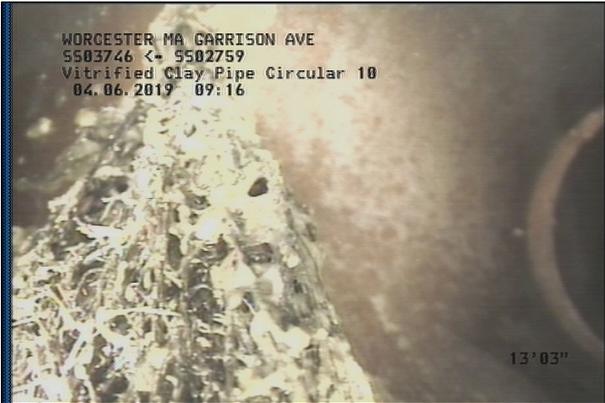
Photo:  
SS02759-SS03746\_04062019\_RTL\_13.2101\_102436\_A.JPG  
13.21FT, Roots Tap Lateral, at 09 o'clock, 10 %

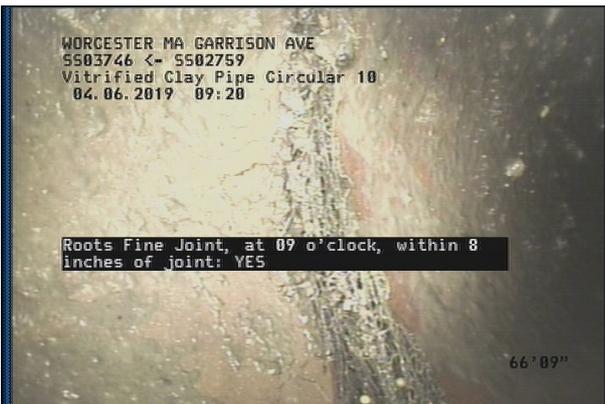
Photo:  
SS02759-SS03746\_04062019\_RFJ\_66.7511\_102902\_A.JPG  
66.75FT, Roots Fine Joint, at 09 o'clock, within 8 inches of joint: YES

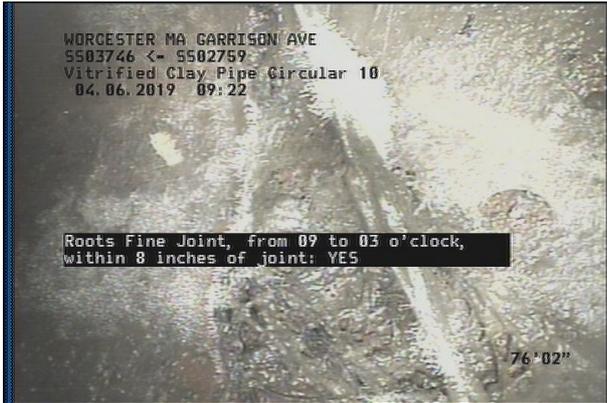
Photo:  
SS02759-SS03746\_04062019\_RFJ\_76.1583\_103027\_A.JPG  
76.16FT, Roots Fine Joint, from 09 to 03 o'clock, within 8 inches of joint: YES

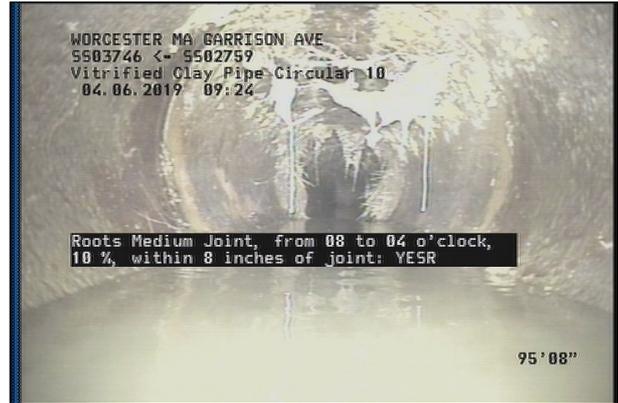
Photo:  
SS02759-SS03746\_04062019\_RMJ\_95.6733\_103232\_A.JPG  
95.67FT, Roots Medium Joint, from 08 to 04 o'clock, 10 %, within 8 inches of joint: YESR

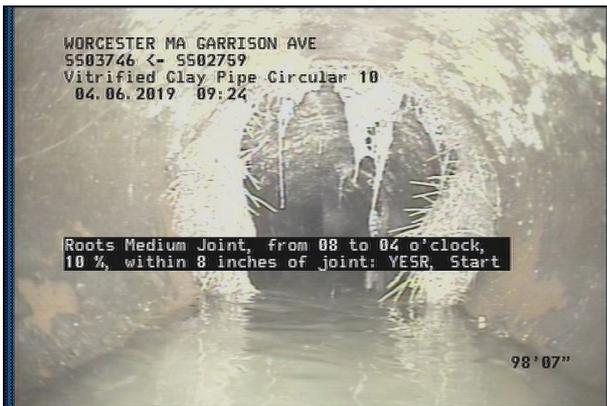
Photo:  
SS02759-SS03746\_04062019\_RMJ\_98.5755\_103301\_A.JPG  
98.58FT, Roots Medium Joint, from 08 to 04 o'clock, 10 %, within 8 inches of joint: YESR, Start

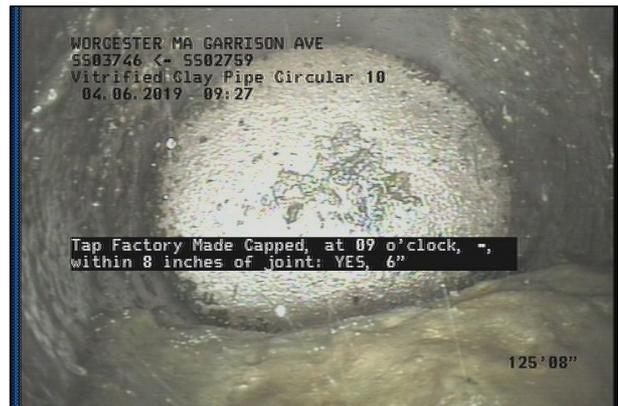
Photo:  
SS02759-SS03746\_04062019\_TFC\_125.6963\_103514\_A.JPG  
125.7FT, Tap Factory Made Capped, at 09 o'clock, -, within 8 inches of joint: YES, 6"

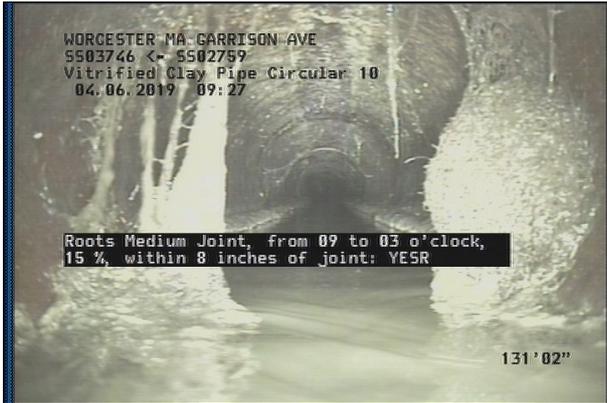
Photo:  
SS02759-SS03746\_04062019\_RMJ\_131.2005\_103602\_A.JPG  
131.2FT, Roots Medium Joint, from 09 to 03 o'clock, 15 %, within 8 inches of joint: YESR

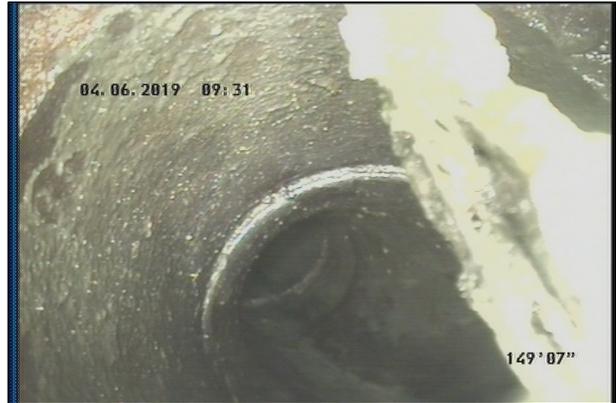
Photo:  
SS02759-SS03746\_04062019\_TB\_149.6146\_103919\_A.JPG  
149.61FT, Tap Break-In, at 09 o'clock, -, within 8 inches of joint: YES, 6"

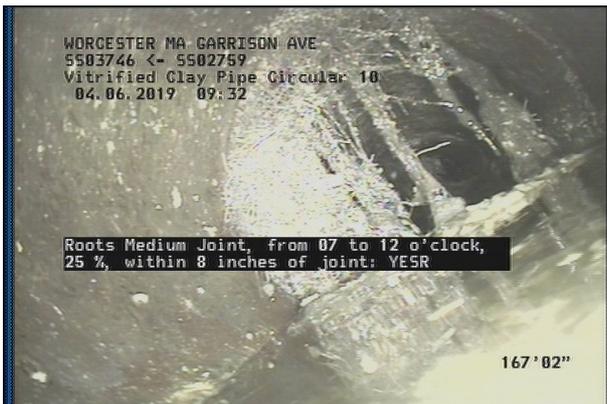
Photo:  
SS02759-SS03746\_04062019\_RMJ\_167.128\_104102\_A.JPG  
167.13FT, Roots Medium Joint, from 07 to 12 o'clock, 25 %, within 8 inches of joint: YESR

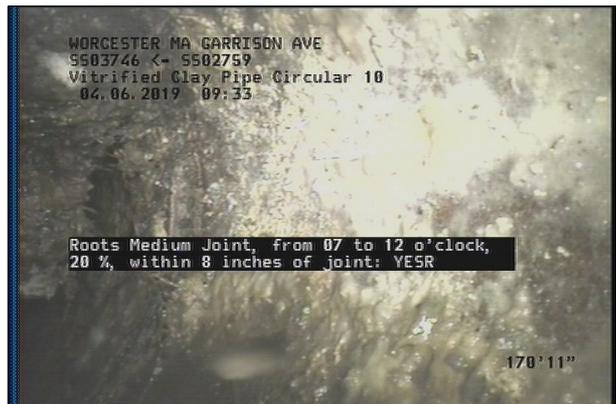
Photo:  
SS02759-SS03746\_04062019\_RMJ\_170.9309\_104138\_A.JPG  
170.93FT, Roots Medium Joint, from 07 to 12 o'clock, 20 %, within 8 inches of joint: YESR

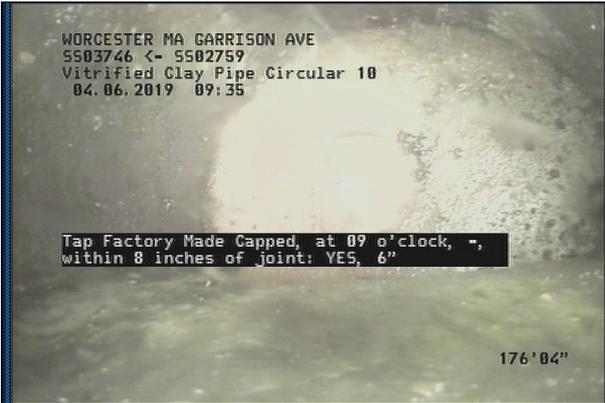
Photo:  
SS02759-SS03746\_04062019\_TFC\_176.335\_104347\_A.JPG  
176.34FT, Tap Factory Made Capped, at 09 o'clock, -, within 8 inches of joint: YES, 6"

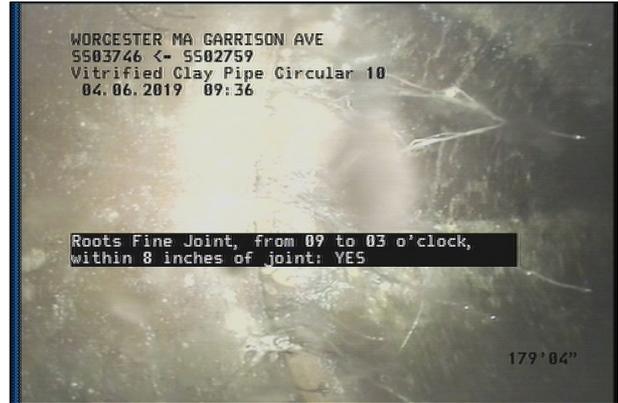
Photo:  
SS02759-SS03746\_04062019\_RFJ\_179.3373\_104423\_A.JPG  
179.34FT, Roots Fine Joint, from 09 to 03 o'clock, within 8 inches of joint: YES

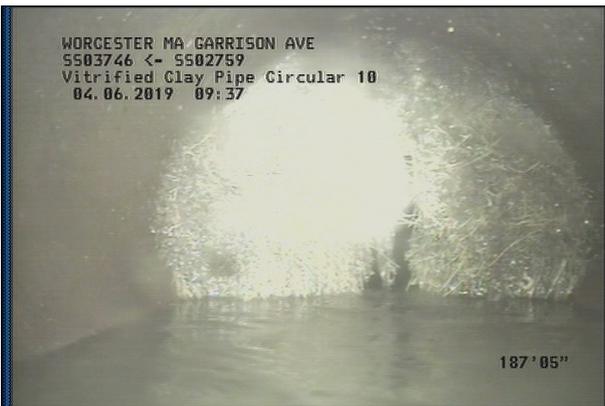
Photo:  
SS02759-SS03746\_04062019\_RBB\_187.4435\_104534\_A.JPG  
187.44FT, Roots Ball Barrell, from 07 to 05 o'clock, 90 %

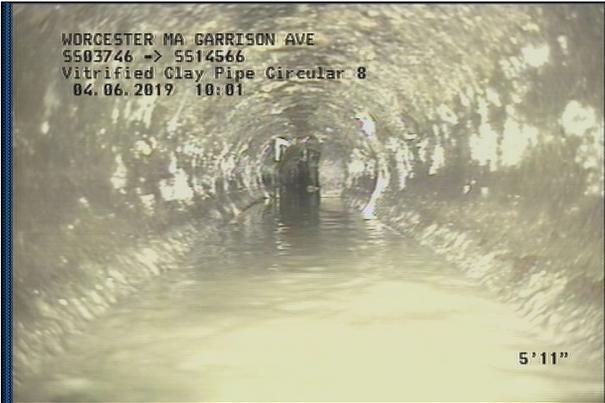
Photo:  
SS03746-SS14566\_04062019\_DAGS\_5.9045\_110952\_A.JPG  
5.9FT, Deposits Attached Grease, 5 %of cross sectional area, from 04 to 08 o'clock, , within 8 inches of joint: YES, Start

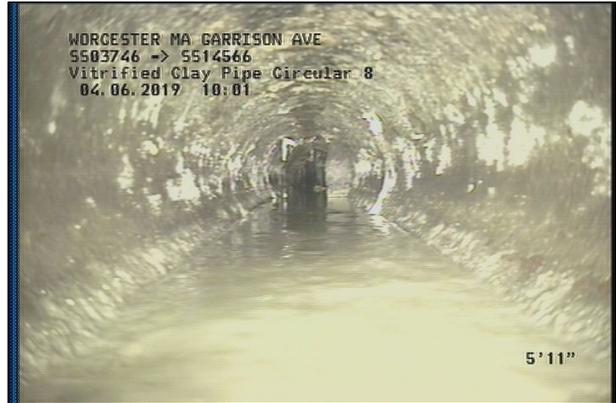
Photo:  
SS03746-SS14566\_04062019\_DAGS\_5.9045\_110954\_A.JPG  
5.9FT, Deposits Attached Grease, 5 %of cross sectional area, from 09 to 03 o'clock, , within 8 inches of joint: YES, Start

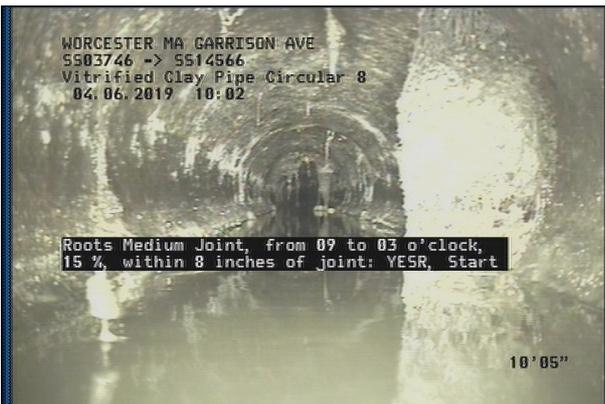
Photo:  
SS03746-SS14566\_04062019\_RMJ\_10.408\_111040\_A.JPG  
10.41FT, Roots Medium Joint, from 09 to 03 o'clock, 15 %, within 8 inches of joint: YESR, Start

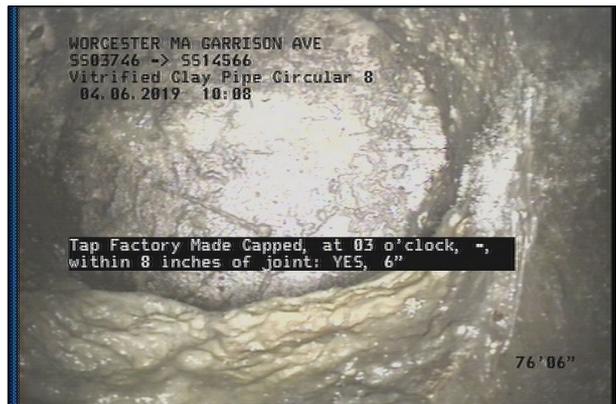
Photo:  
SS03746-SS14566\_04062019\_TFC\_76.4585\_111616\_A.JPG  
76.46FT, Tap Factory Made Capped, at 03 o'clock, -, within 8 inches of joint: YES, 6"

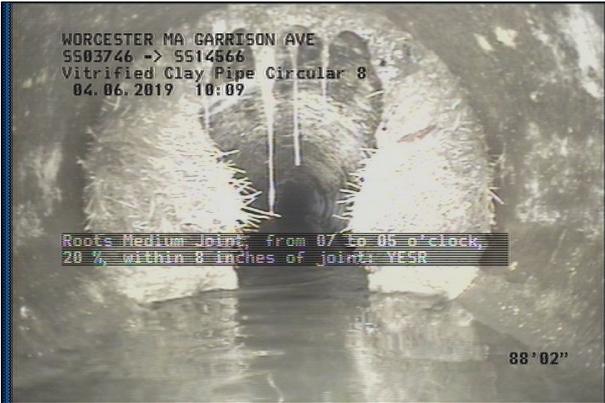
Photo:  
SS03746-SS14566\_04062019\_RMJ\_88.1675\_111729\_A.JPG  
88.17FT, Roots Medium Joint, from 07 to 05 o'clock, 20 %, within 8 inches of joint: YESR

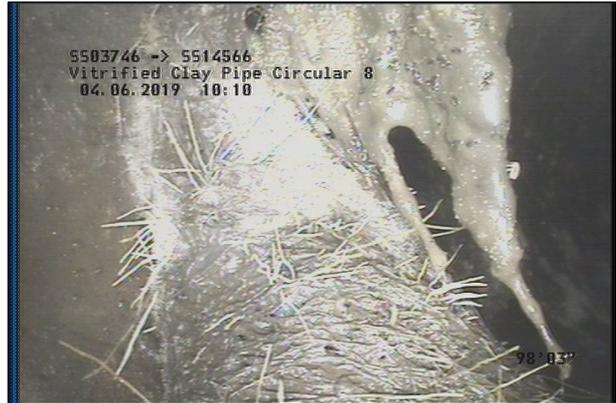
Photo:  
SS03746-SS14566\_04062019\_RMJ\_98.2753\_111840\_A.JPG  
98.28FT, Roots Medium Joint, from 07 to 11 o'clock, 15 %, within 8 inches of joint: YESR

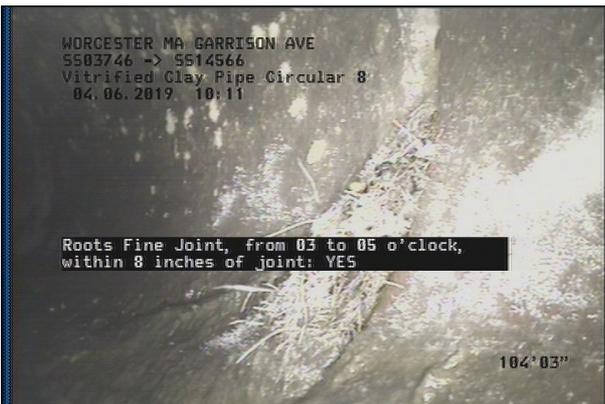
Photo:  
SS03746-SS14566\_04062019\_RFJ\_104.2798\_111921\_A.JPG  
104.28FT, Roots Fine Joint, from 03 to 05 o'clock, within 8 inches of joint: YES

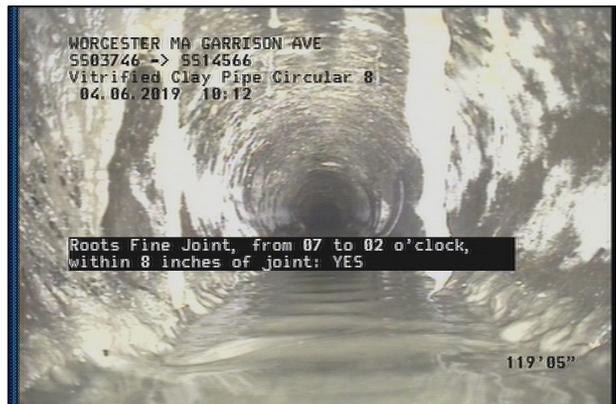
Photo:  
SS03746-SS14566\_04062019\_RFJ\_119.3914\_112036\_A.JPG  
119.39FT, Roots Fine Joint, from 07 to 02 o'clock, within 8 inches of joint: YES

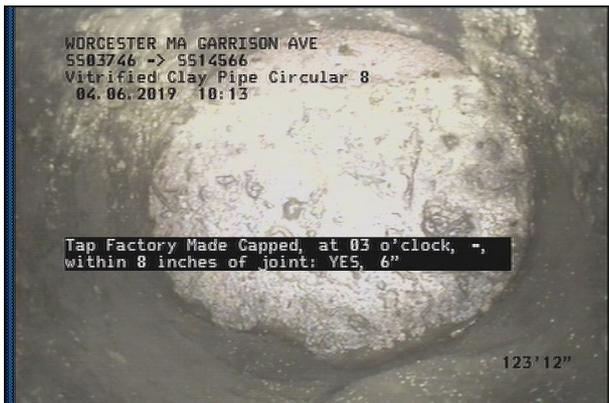
Photo:  
SS03746-SS14566\_04062019\_TFC\_123.9949\_112111\_A.JPG  
123.99FT, Tap Factory Made Capped, at 03 o'clock, -, within 8 inches of joint: YES, 6"

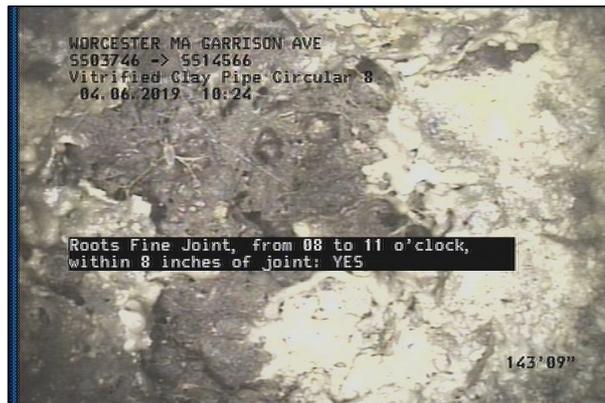
Photo:  
SS03746-SS14566\_04062019\_RFJ\_143.7101\_113309\_A.JPG  
143.71FT, Roots Fine Joint, from 08 to 11 o'clock, within 8 inches of joint: YES

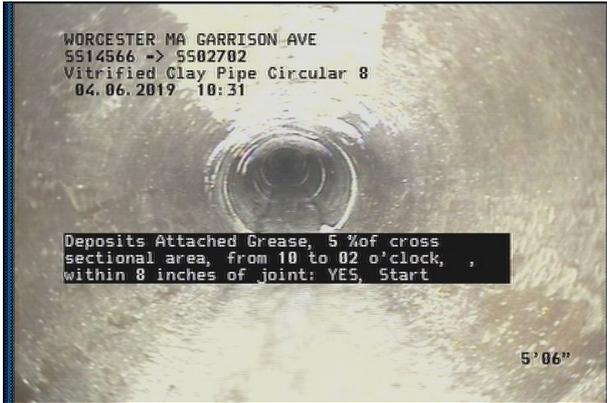
Photo:  
SS14566-SS02702\_04062019\_DAGS\_5.5042\_114008\_A.JPG  
5.5FT, Deposits Attached Grease, 5 %of cross sectional area, from 10 to 02 o'clock, , within 8 inches of joint: YES, Start

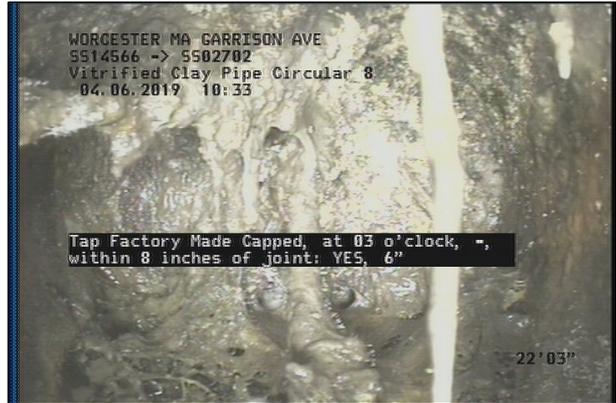
Photo:  
SS14566-SS02702\_04062019\_TFC\_22.217\_114149\_A.JPG  
22.22FT, Tap Factory Made Capped, at 03 o'clock, -, within 8 inches of joint: YES, 6"

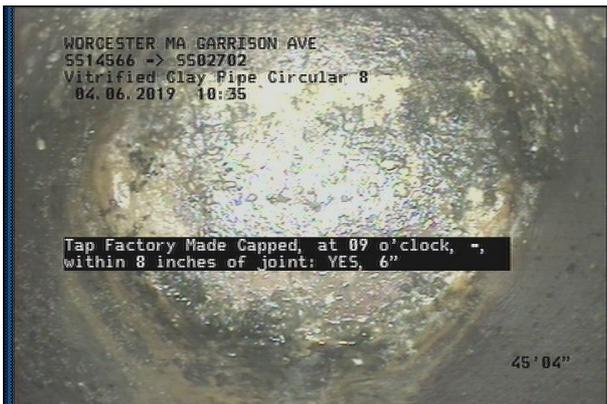
Photo:  
SS14566-SS02702\_04062019\_TFC\_45.3347\_114406\_A.JPG  
45.33FT, Tap Factory Made Capped, at 09 o'clock, -, within 8 inches of joint: YES, 6"

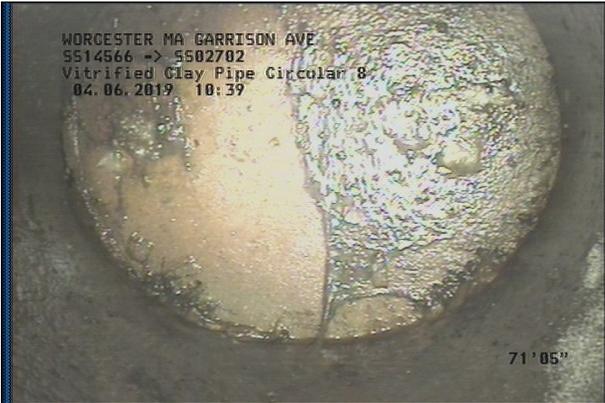
Photo:  
SS14566-SS02702\_04062019\_TFC\_71.4547\_114730\_A.JPG  
71.45FT, Tap Factory Made Capped, at 03 o'clock, -, within 8 inches of joint: YES, 6"

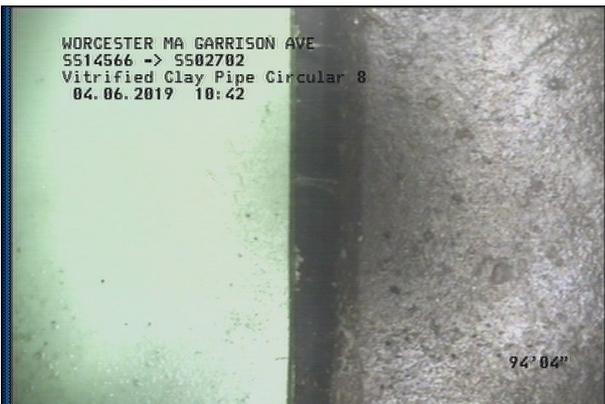
Photo:  
SS14566-SS02702\_04062019 MMC\_94.3723\_115025\_A.JPG  
94.37FT, Material Change, Polyvinyl Chloride (PVC)

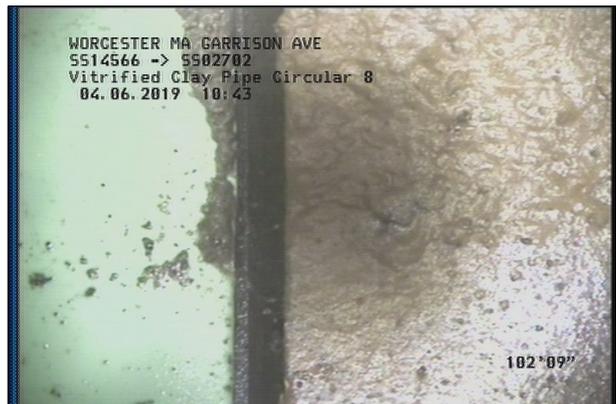
Photo:  
SS14566-SS02702\_04062019 MMC\_102.7787\_115114\_A.JPG  
102.78FT, Material Change, Vitrified clay pipe

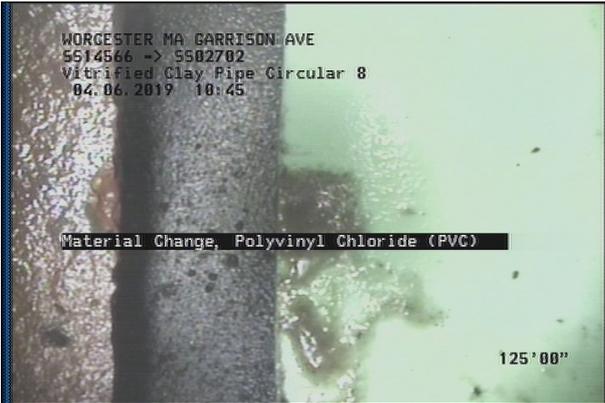
Photo:  
SS14566-SS02702\_04062019\_MMC\_124.9957\_115318\_A.JPG  
G  
125FT, Material Change, Polyvinyl Chloride (PVC)

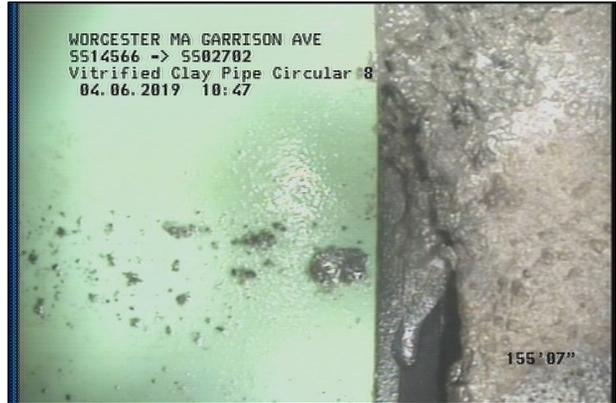
Photo:  
SS14566-SS02702\_04062019\_MMC\_155.6192\_115552\_A.JPG  
G  
155.62FT, Material Change, Vitrified clay pipe

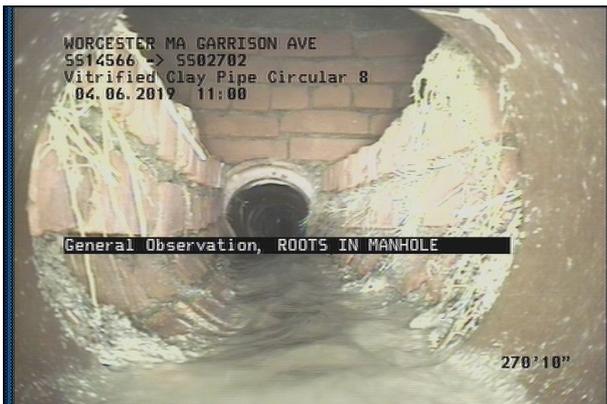
1:540	Position	Observation
	<u>220.27</u>	Tap Break-In Defective, at 03 o'clock, -, , within 8 inches of joint: YES, 6" / ROOTS AND LATERAL ISNT LINED UP WITH CONNECTION
	<u>220.27</u>	Broken Soil Visible, at 05 o'clock, within 8 inches of joint: YES
	<u>220.77</u>	<b>F2</b> Crack Longitudinal, at 12 o'clock, within 8 inches of joint: YES, Finish
	<u>220.77</u>	<b>F1</b> Deposits Attached Grease, 5 %of cross sectional area, from 10 to 02 o'clock, , within 8 inches of joint: YES, Finish
	<u>234.38</u>	Roots Fine Joint, from 10 to 02 o'clock, within 8 inches of joint: YES
	<u>244.19</u>	<b>S3</b> Crack Longitudinal, at 12 o'clock, within 8 inches of joint: YES, Start
	<u>267.81</u>	Roots Fine Joint, from 02 to 05 o'clock, within 8 inches of joint: YES
	<u>270.71</u>	<b>F3</b> Crack Longitudinal, at 12 o'clock, within 8 inches of joint: YES, Finish
	<u>270.81</u>	General Observation / ROOTS IN MANHOLE

Photo:  
SS14566-SS02702\_04062019\_MGO\_270.8074\_120848\_A.JPG  
270.81FT, General Observation

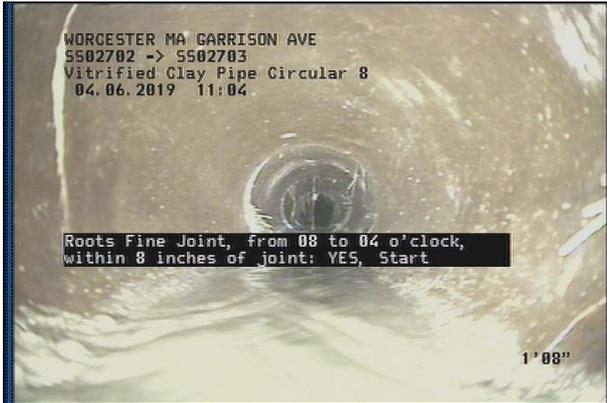
Photo:  
SS02702-SS02703\_04062019\_RFJ\_1.7013\_121302\_A.JPG  
1.7FT, Roots Fine Joint, from 08 to 04 o'clock, within 8 inches of joint: YES, Start

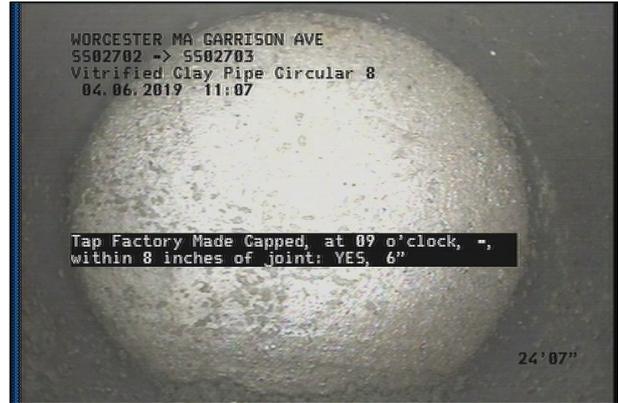
Photo:  
SS02702-SS02703\_04062019\_TFC\_24.6189\_121517\_A.JPG  
24.62FT, Tap Factory Made Capped, at 09 o'clock, -, within 8 inches of joint: YES, 6"

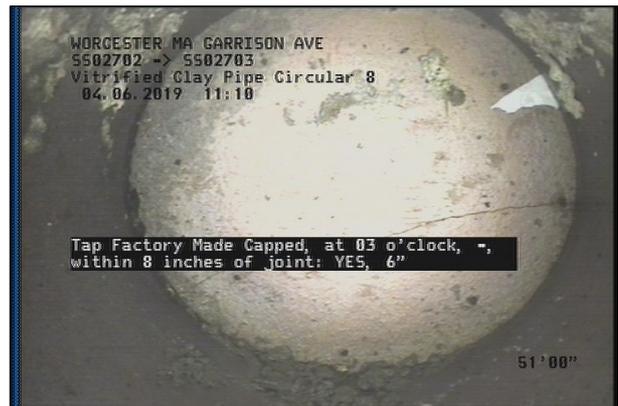
Photo:  
SS02702-SS02703\_04062019\_TFC\_50.939\_121850\_A.JPG  
50.94FT, Tap Factory Made Capped, at 03 o'clock, -, within 8 inches of joint: YES, 6"

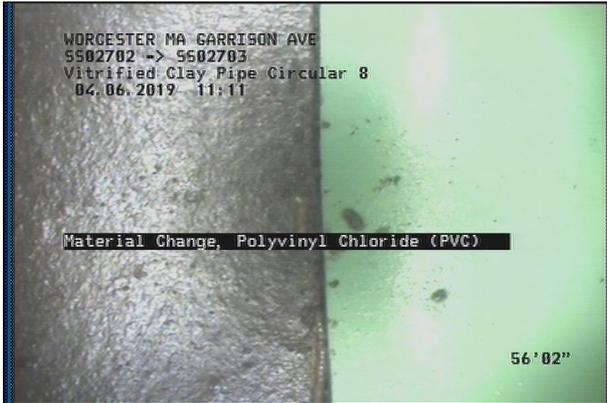
Photo:  
SS02702-SS02703\_04062019\_MMC\_56.143\_121932\_A.JPG  
56.14FT, Material Change, Polyvinyl Chloride (PVC)

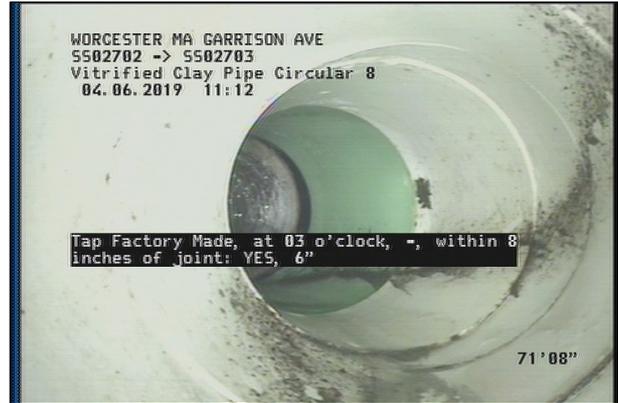
Photo:  
SS02702-SS02703\_04062019\_TF\_71.6549\_122045\_A.JPG  
71.65FT, Tap Factory Made, at 03 o'clock, -, within 8 inches of joint: YES, 6"

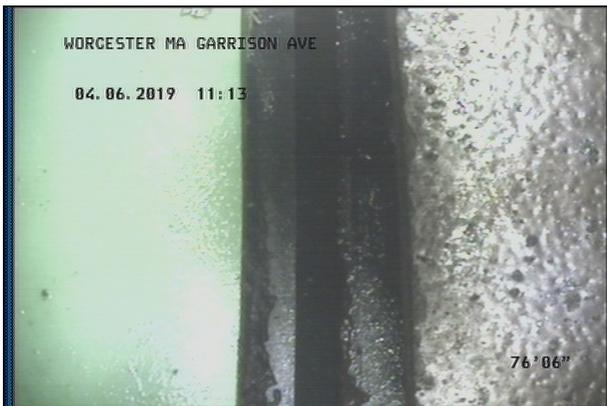
Photo:  
SS02702-SS02703\_04062019\_MMC\_76.4585\_122128\_A.JPG  
76.46FT, Material Change, Vitrified clay pipe

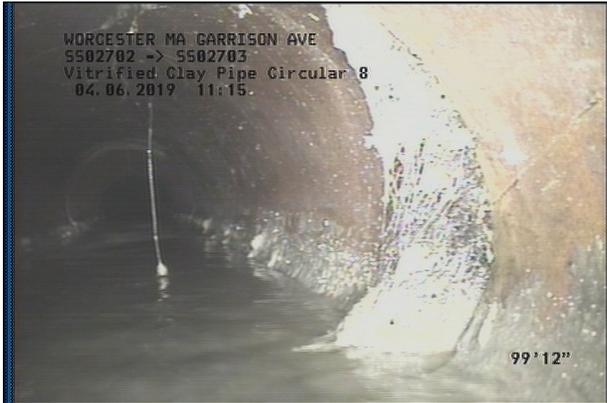
Photo:  
SS02702-SS02703\_04062019\_RFJ\_99.9765\_122338\_A.JPG  
99.98FT, Roots Fine Joint, from 01 to 04 o'clock, within 8  
inches of joint: YES

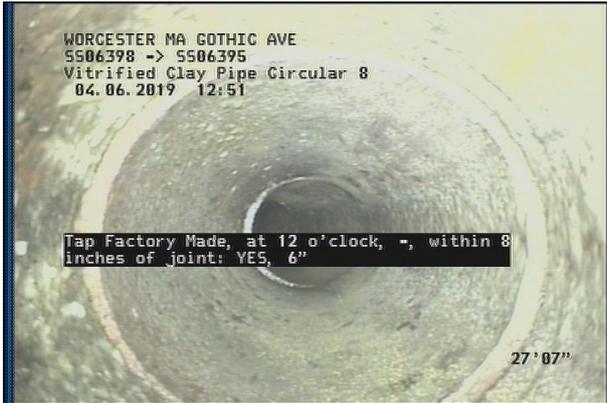
Photo:  
SS06398-SS06395\_04062019\_TF\_27.6211\_135944\_A.JPG  
27.62FT, Tap Factory Made, at 12 o'clock, -, within 8 inches of joint: YES, 6"

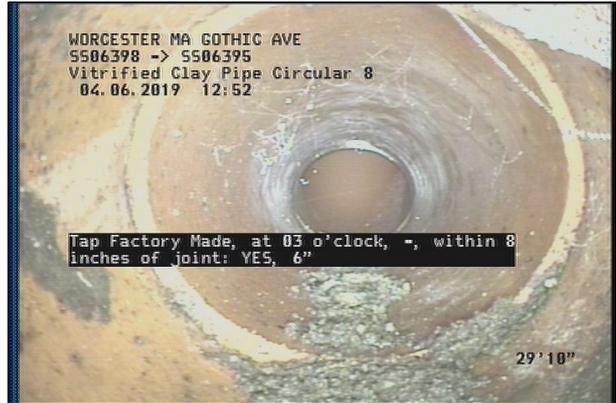
Photo:  
SS06398-SS06395\_04062019\_TF\_29.8228\_140018\_A.JPG  
29.82FT, Tap Factory Made, at 03 o'clock, -, within 8 inches of joint: YES, 6"

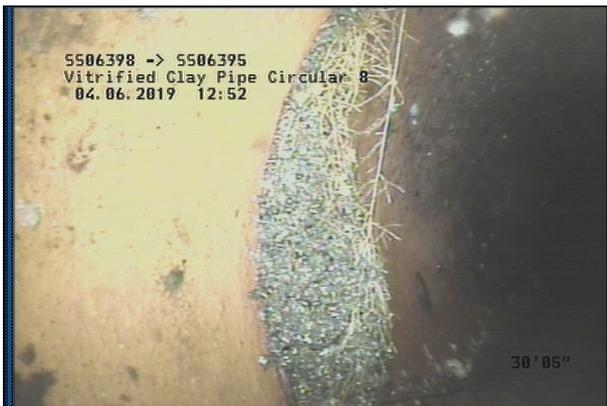
Photo:  
SS06398-SS06395\_04062019\_RFJ\_30.4233\_140042\_A.JPG  
30.42FT, Roots Fine Joint, from 07 to 10 o'clock, within 8 inches of joint: YES

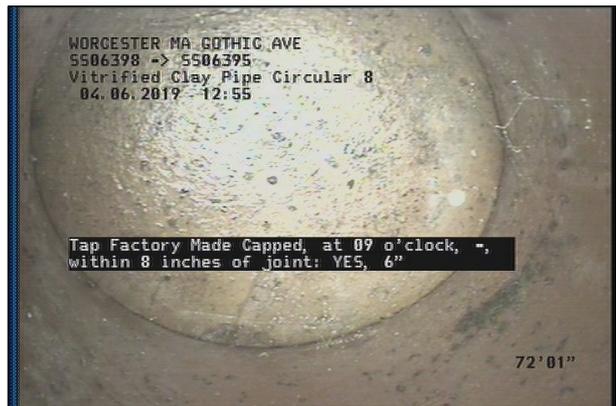
Photo:  
SS06398-SS06395\_04062019\_TFC\_72.0552\_140358\_A.JPG  
72.06FT, Tap Factory Made Capped, at 09 o'clock, -, within 8 inches of joint: YES, 6"

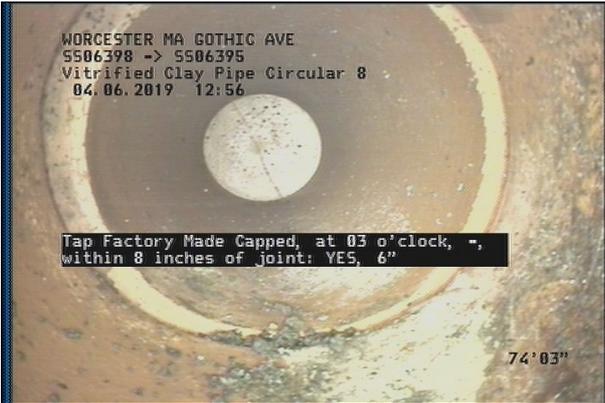
Photo:  
SS06398-SS06395\_04062019\_TFC\_74.2569\_140432\_A.JPG  
74.26FT, Tap Factory Made Capped, at 03 o'clock, -, within 8 inches of joint: YES, 6"

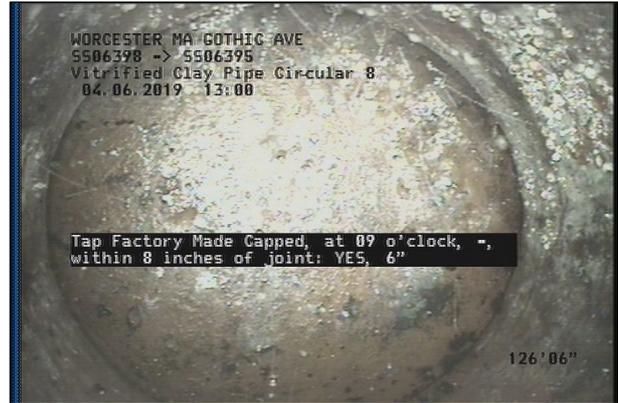
Photo:  
SS06398-SS06395\_04062019\_TFC\_126.4969\_140828\_A.JPG  
126.5FT, Tap Factory Made Capped, at 09 o'clock, -, within 8 inches of joint: YES, 6"

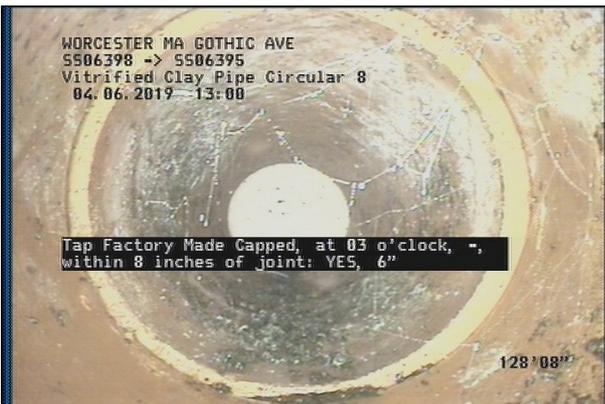
Photo:  
SS06398-SS06395\_04062019\_TFC\_128.6985\_140859\_A.JPG  
128.7FT, Tap Factory Made Capped, at 03 o'clock, -, within 8 inches of joint: YES, 6"

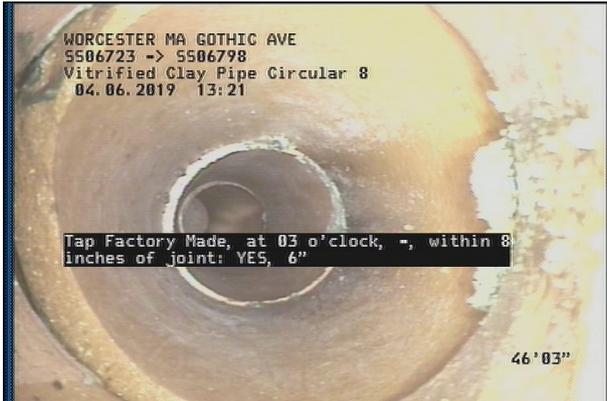
Photo:  
SS06723-SS06798\_04062019\_TF\_46.2354\_142918\_A.JPG  
46.24FT, Tap Factory Made, at 03 o'clock, -, within 8 inches of joint: YES, 6"

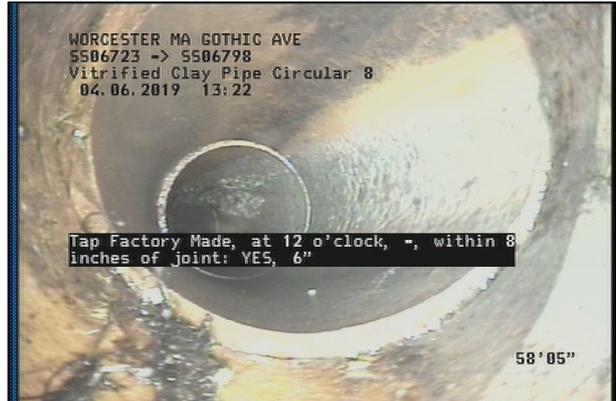
Photo:  
SS06723-SS06798\_04062019\_TF\_58.4448\_143017\_A.JPG  
58.44FT, Tap Factory Made, at 12 o'clock, -, within 8 inches of joint: YES, 6"

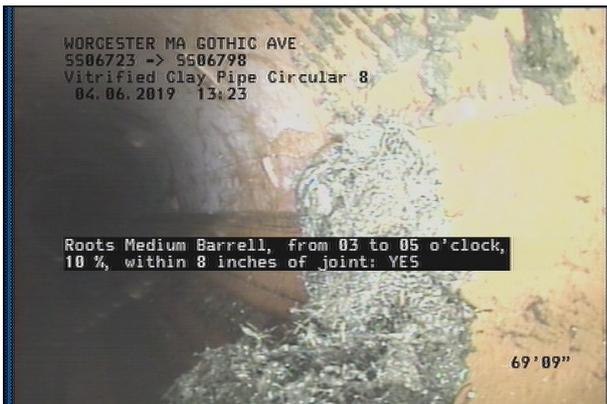
Photo:  
SS06723-SS06798\_04062019\_RMB\_69.7534\_143124\_A.JPG  
69.75FT, Roots Medium Barrell, from 03 to 05 o'clock, 10 %, within 8 inches of joint: YES

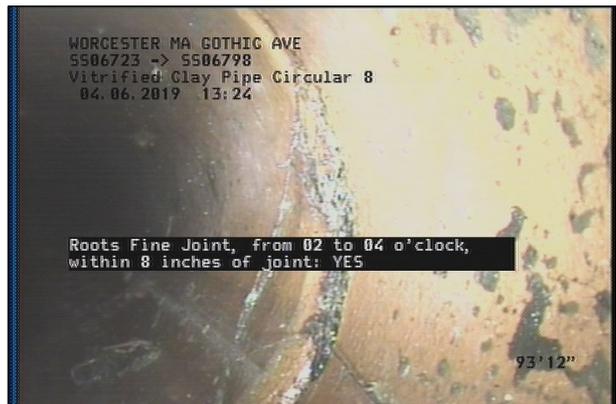
Photo:  
SS06723-SS06798\_04062019\_RFJ\_93.972\_143246\_A.JPG  
93.97FT, Roots Fine Joint, from 02 to 04 o'clock, within 8 inches of joint: YES

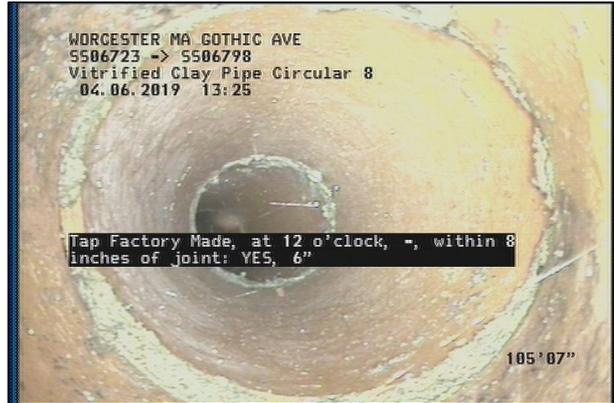
Photo:  
SS06723-SS06798\_04062019\_TF\_105.5808\_143408\_A.JPG  
105.58FT, Tap Factory Made, at 12 o'clock, -, within 8 inches of joint: YES, 6"

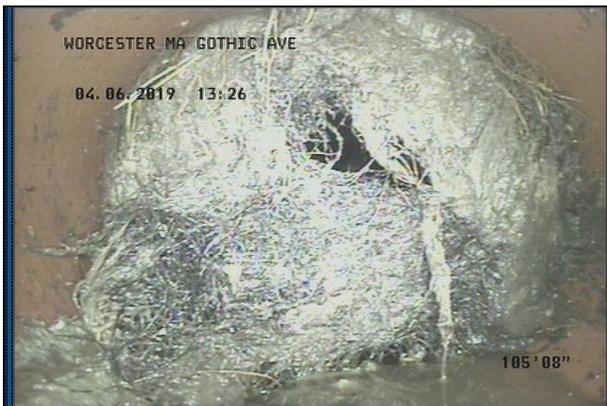
Photo:  
SS06723-SS06798\_04062019\_RBB\_105.6809\_143434\_A.JPG  
105.68FT, Roots Ball Barrell, from 12 to 12 o'clock, 90 %

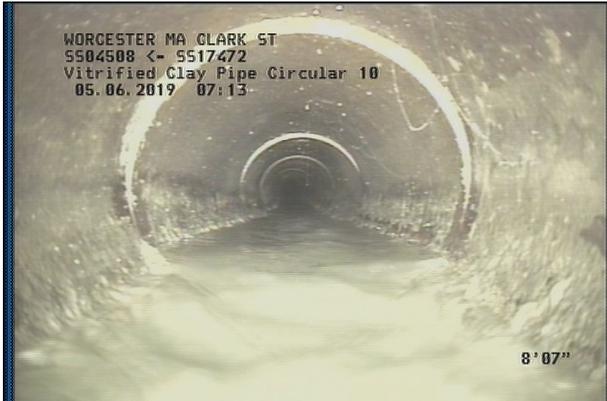
Photo:  
SS17472-SS04508\_05062019\_DAGS\_8.6066\_082208\_A.JPG  
8.61FT, Deposits Attached Grease, 5 %of cross sectional area, from 07 to 05 o'clock, , within 8 inches of joint: YES, Start

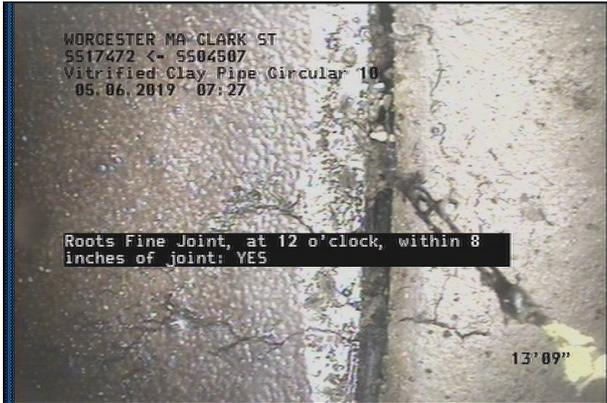
Photo:  
SS04507-SS17472\_05062019\_RFJ\_13.7105\_083516\_A.JPG  
13.71FT, Roots Fine Joint, at 12 o'clock, within 8 inches of joint: YES

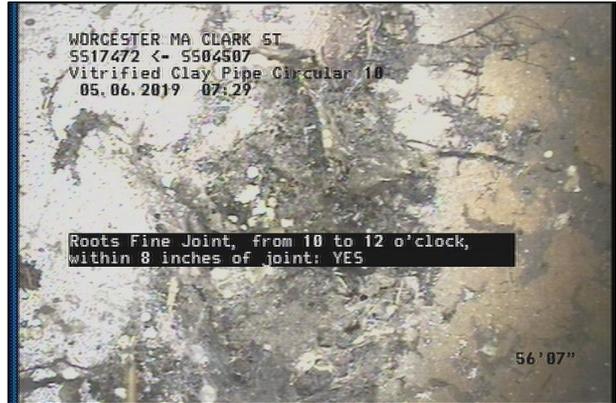
Photo:  
SS04507-SS17472\_05062019\_RFJ\_56.5433\_083720\_A.JPG  
56.54FT, Roots Fine Joint, from 10 to 12 o'clock, within 8 inches of joint: YES

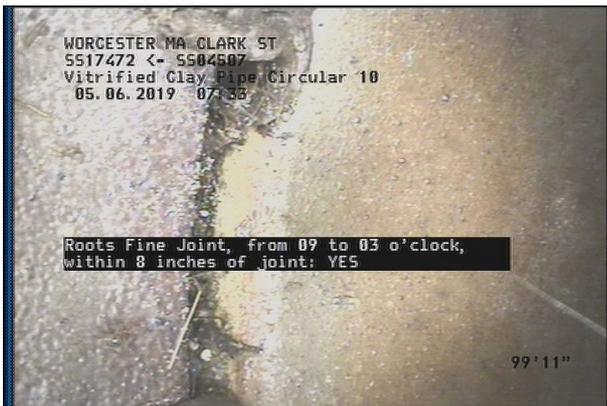
Photo:  
SS04507-SS17472\_05062019\_RFJ\_99.8765\_084126\_A.JPG  
99.88FT, Roots Fine Joint, from 09 to 03 o'clock, within 8 inches of joint: YES

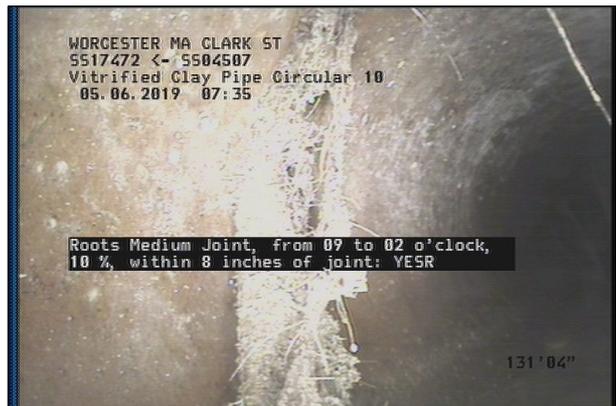
Photo:  
SS04507-SS17472\_05062019\_RMJ\_131.3005\_084338\_A.JPG  
131.3FT, Roots Medium Joint, from 09 to 02 o'clock, 10 %, within 8 inches of joint: YESR

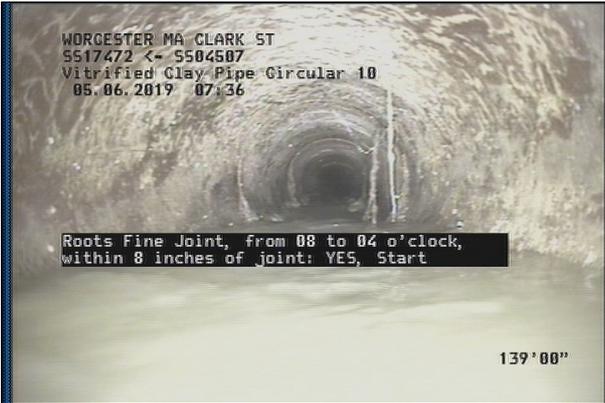
Photo:  
SS04507-SS17472\_05062019\_RFJ\_138.9064\_084415\_A.JPG  
138.91FT, Roots Fine Joint, from 08 to 04 o'clock, within 8 inches of joint: YES, Start

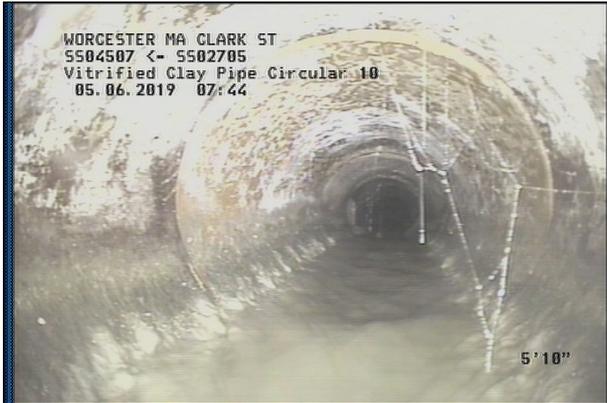
Photo:  
SS02705-SS04507\_05062019\_DAE\_5.8044\_085215\_A.JPG  
5.8FT, Deposits Attached Encrustation, 5 %of cross sectional area, from 08 to 04 o'clock, , within 8 inches of joint: YES, Start

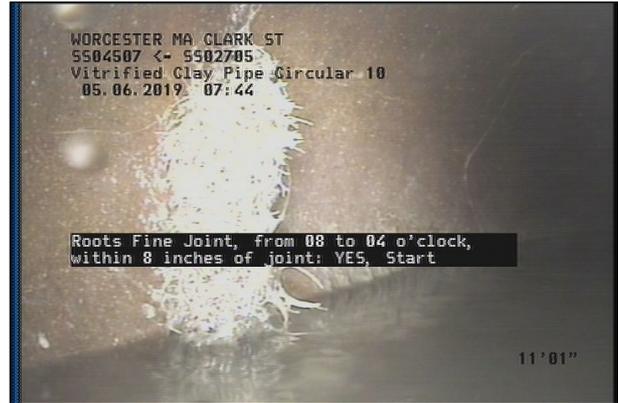
Photo:  
SS02705-SS04507\_05062019\_RFJ\_11.1085\_085302\_A.JPG  
11.11FT, Roots Fine Joint, from 08 to 04 o'clock, within 8 inches of joint: YES, Start

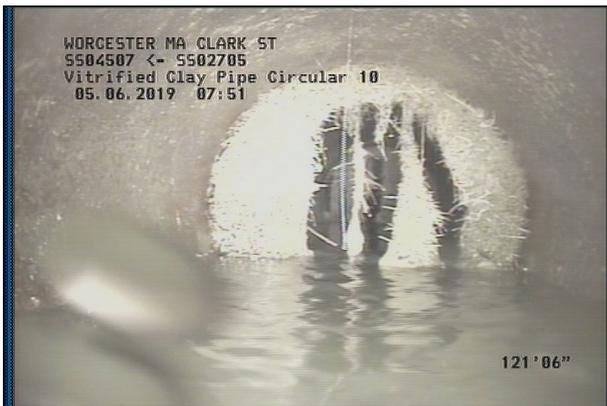
Photo:  
SS02705-SS04507\_05062019\_RMB\_121.493\_085949\_A.JPG  
121.49FT, Roots Medium Barrell, from 07 to 05 o'clock, 40 %, within 8 inches of joint: YES

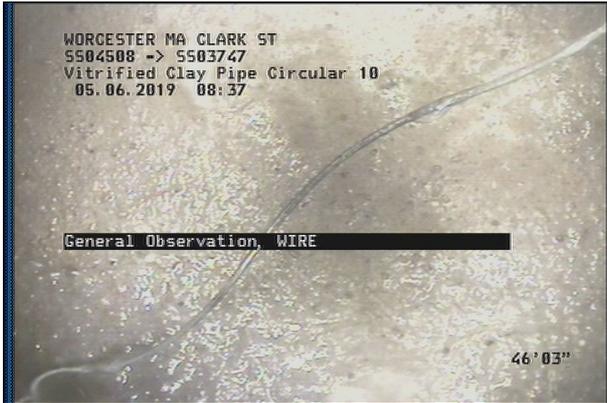
Photo:  
SS04508-SS03747\_05062019\_MGO\_46.2354\_094556\_A.JPG  
46.24FT, General Observation

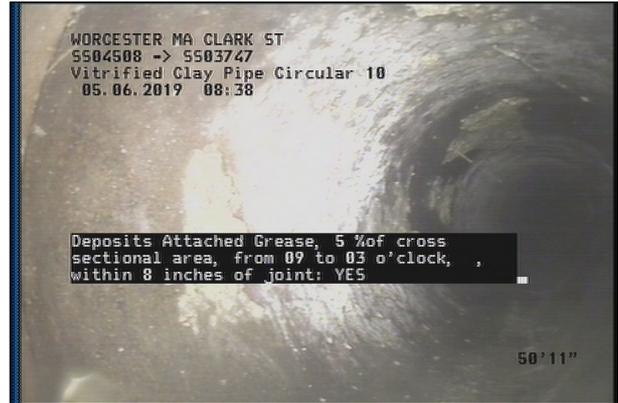
Photo:  
SS04508-SS03747\_05062019\_DAGS\_50.939\_094632\_A.JPG  
50.94FT, Deposits Attached Grease, 5 %of cross sectional area, from 09 to 03 o'clock, , within 8 inches of joint: YES

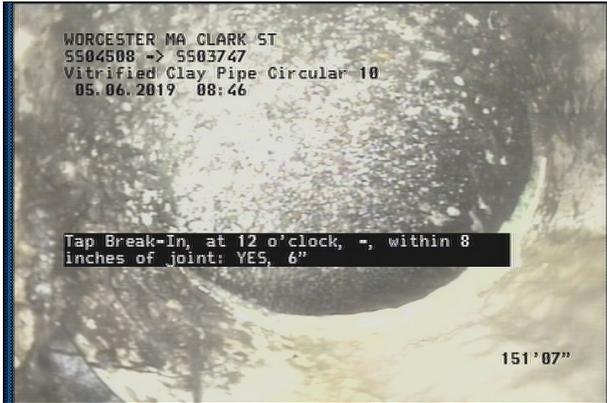
Photo:  
SS04508-SS03747\_05062019\_TB\_151.6161\_095446\_A.JPG  
151.62FT, Tap Break-In, at 12 o'clock, -, within 8 inches of joint: YES, 6"

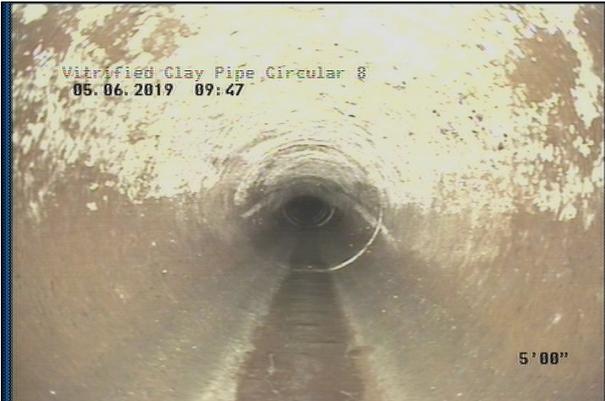
Photo:  
SS17149-SS14566\_05062019\_DAGS\_5.0038\_105551\_A.JPG  
5FT, Deposits Attached Grease, 5 %of cross sectional area, from 09 to 03 o'clock, , within 8 inches of joint: YES, Start

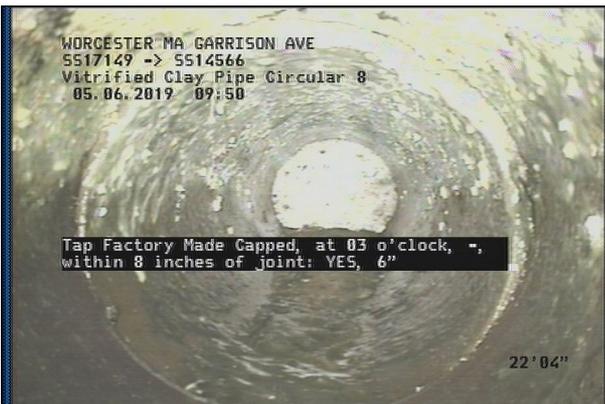
Photo:  
SS17149-SS14566\_05062019\_TFC\_22.3171\_105910\_A.JPG  
22.32FT, Tap Factory Made Capped, at 03 o'clock, -, within 8 inches of joint: YES, 6"

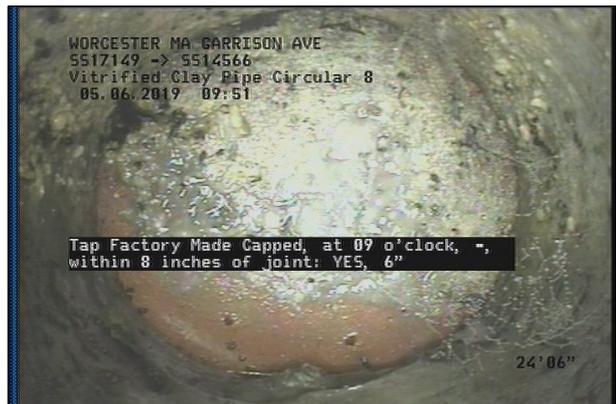
Photo:  
SS17149-SS14566\_05062019\_TFC\_24.5188\_105938\_A.JPG  
24.52FT, Tap Factory Made Capped, at 09 o'clock, -, within 8 inches of joint: YES, 6"

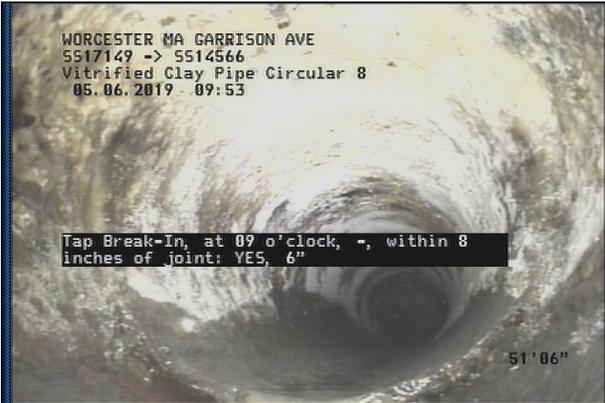
Photo:  
SS17149-SS14566\_05062019\_TB\_51.5395\_110139\_A.JPG  
51.54FT, Tap Break-In, at 09 o'clock, -, within 8 inches of joint:  
YES, 6"

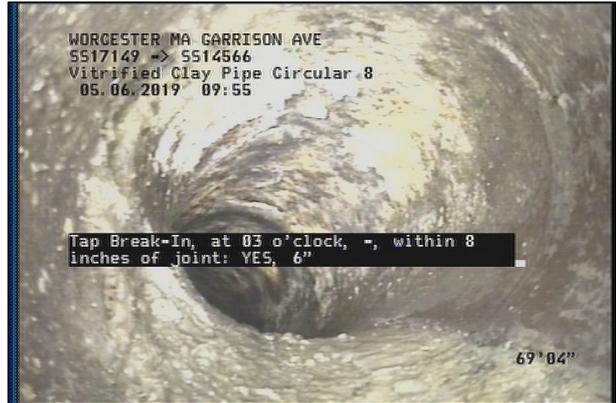
Photo:  
SS17149-SS14566\_05062019\_TB\_69.3531\_110312\_A.JPG  
69.35FT, Tap Break-In, at 03 o'clock, -, within 8 inches of joint:  
YES, 6"

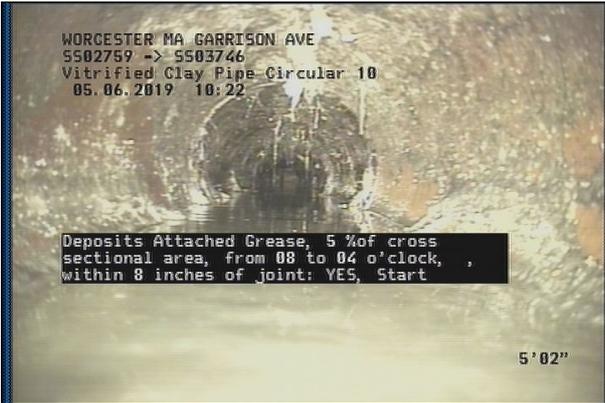
Photo:  
SS02759-SS03746\_05062019\_DAGS\_5.204\_113058\_A.JPG  
5.2FT, Deposits Attached Grease, 5 %of cross sectional area, from 08 to 04 o'clock, within 8 inches of joint: YES, Start

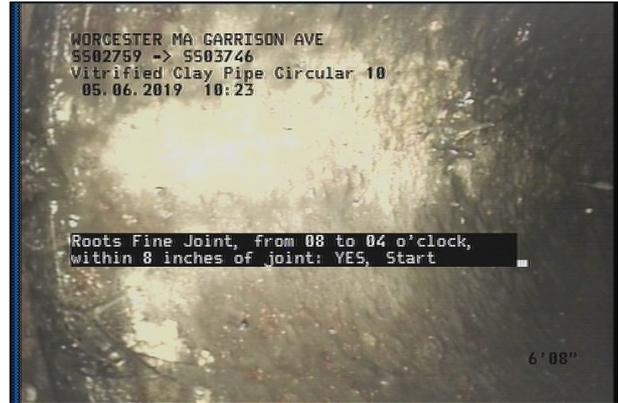
Photo:  
SS02759-SS03746\_05062019\_RFJ\_6.7051\_113141\_A.JPG  
6.71FT, Roots Fine Joint, from 08 to 04 o'clock, within 8 inches of joint: YES, Start

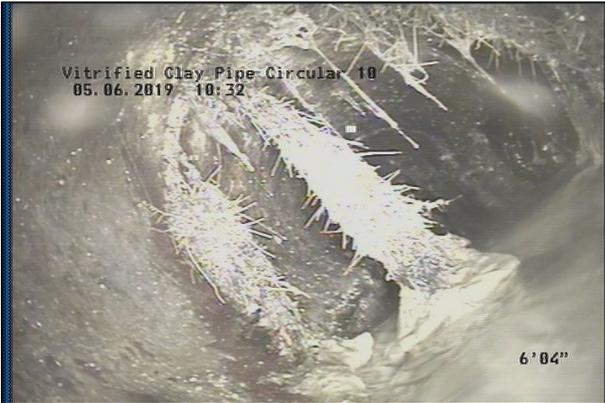
Photo:  
SS02758-SS02759\_05062019\_RMJ\_6.3048\_114104\_A.JPG  
6.3FT, Roots Medium Joint, from 08 to 04 o'clock, 20 %, within 8 inches of joint: YESR, Start
