APPENDIX A
TELEVISION INSPECTION LOGS

Main Inspections Pipe Run with Images

Project name: WEST05-65	Mainline ID: SM00768	City: WORCESTER MA	Street: ASH ST
Start date/time: 20190510-121424	Direction: D	Weather: 1	Location code:
Shape: C	Material: VCP	Height: 12 in.	Width:

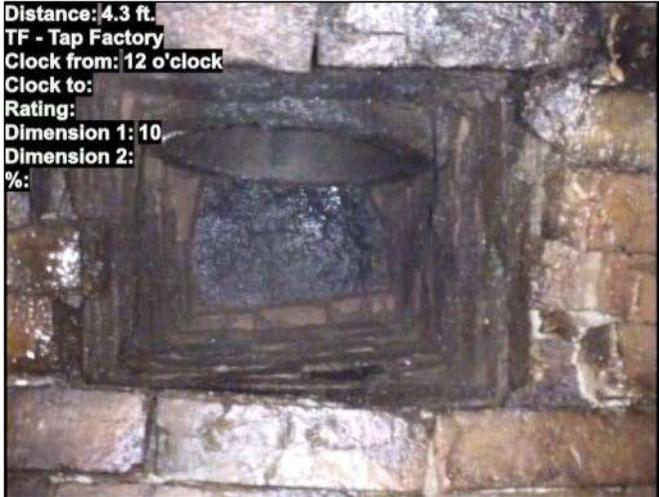
Photo: DS08399-DS09468-20200121-102911-103034.JPG
At: 4.303 ft. 12/. TF - Tap Factory
Joint: No

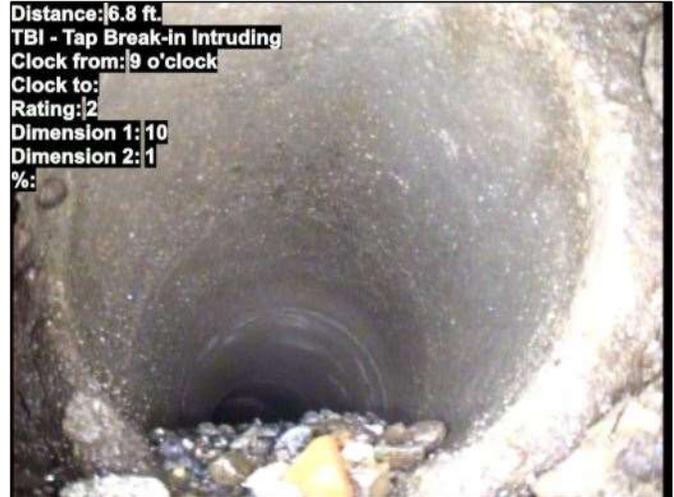
Photo: DS08399-DS09468-20200121-102911-103057.JPG
At: 6.805 ft. 9/. TBI - Tap Break-in Intruding
Joint: No

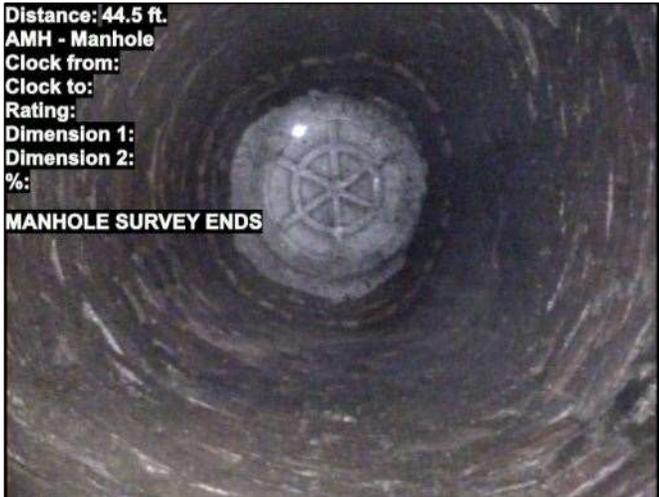
Photo: DS08399-DS09468-20200121-102911-103858.JPG
At: 44.534 ft. AMH - Manhole
Joint: No MANHOLE SURVEY ENDS

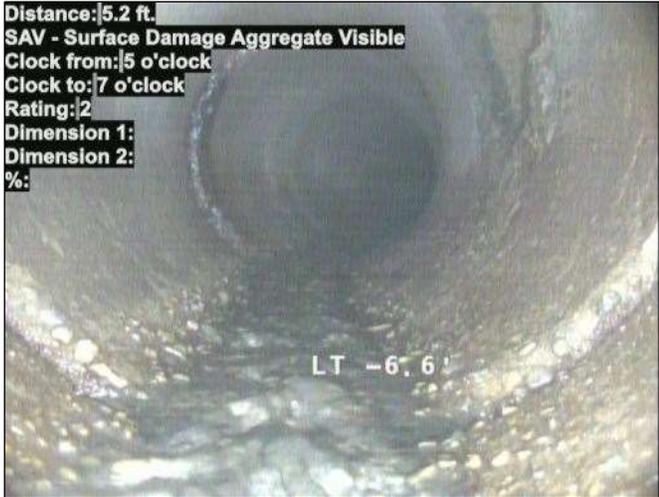
Photo: DS08728-DS11650-20200211-101659-101937.JPG
At: 5.204 ft. 5/7 SAV - Surface Damage Aggregate Visible
Joint: Yes

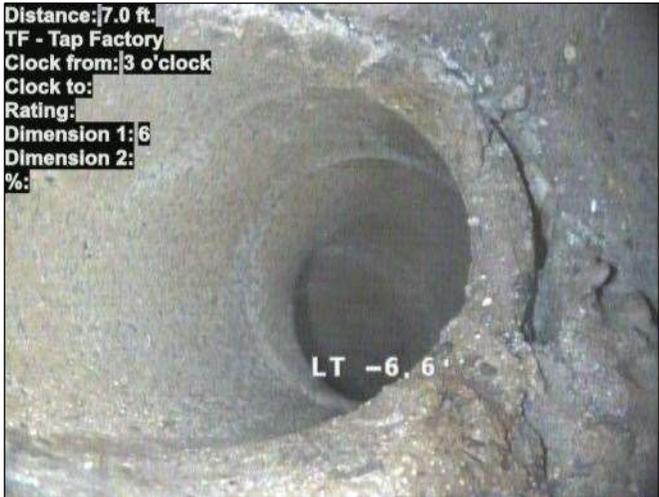
Photo: DS08728-DS11650-20200211-101659-102027.JPG
At: 7.005 ft. 3/. TF - Tap Factory
Joint: No

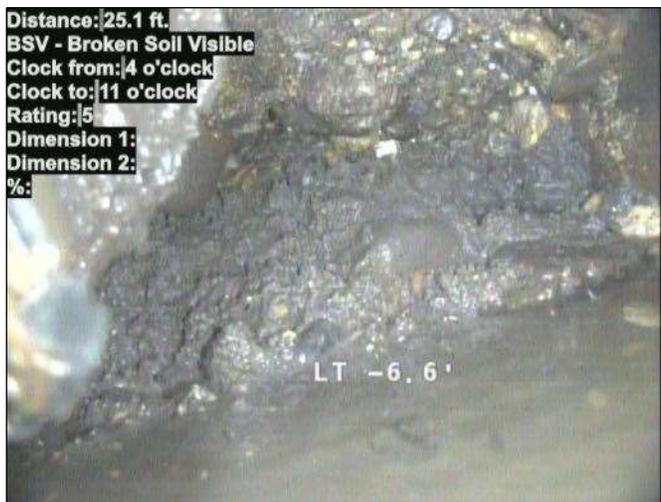
Distance: 25.1 ft.
BSV - Broken Soil Visible
Clock from: 4 o'clock
Clock to: 11 o'clock
Rating: 5
Dimension 1:
Dimension 2:
%:
Photo: DS08728-DS11650-20200211-101659-102633.JPG
At: 25.119 ft. BSV - Broken Soil Visible
4/11
Joint: Yes

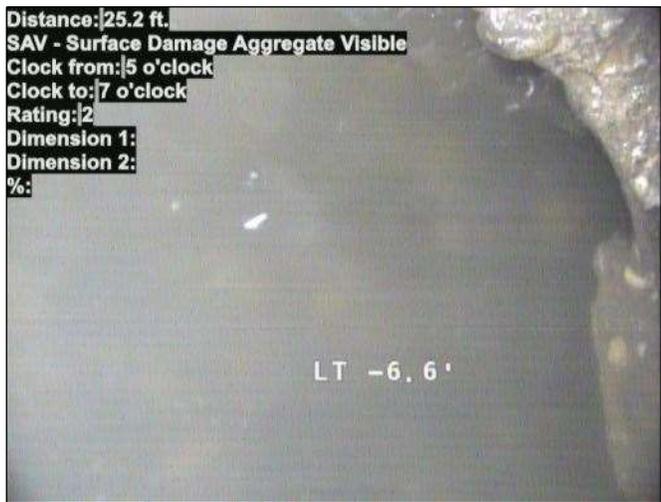
Distance: 25.2 ft.
SAV - Surface Damage Aggregate Visible
Clock from: 5 o'clock
Clock to: 7 o'clock
Rating: 2
Dimension 1:
Dimension 2:
%:
Photo: DS08728-DS11650-20200211-101659-102807.JPG
At: 25.219 ft. SAV - Surface Damage Aggregate Visible
5/7
Joint: Yes

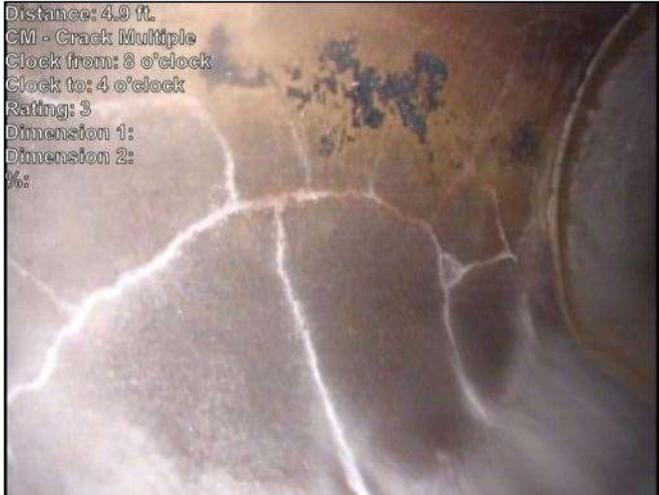
Distance: 4.9 ft.
CM - Crack Multiple
Clock from: 8 o'clock
Clock to: 4 o'clock
Rating: 3
Dimension 1:
Dimension 2:
%:

Photo: **DS03985-DS06019-20200124-103206-103332.JPG**
At: **4.904 ft. 8/4 CM - Crack Multiple**
Joint: **No**

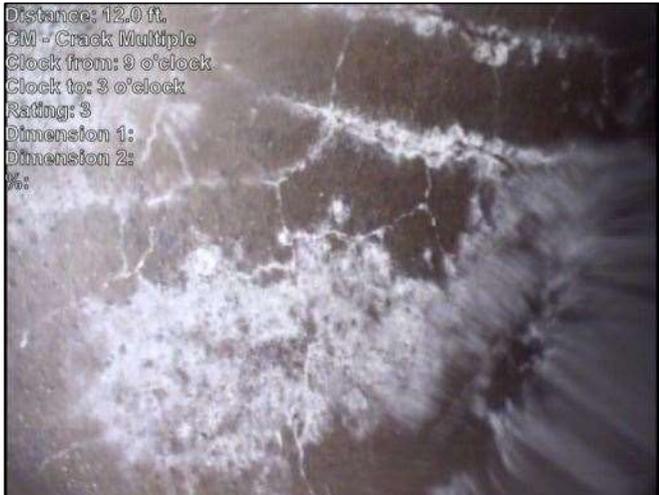
Distance: 12.0 ft.
CM - Crack Multiple
Clock from: 9 o'clock
Clock to: 3 o'clock
Rating: 3
Dimension 1:
Dimension 2:
%:

Photo: **DS03985-DS06019-20200124-103206-103701.JPG**
At: **12.009 ft. CM - Crack Multiple 9/3**
Joint: **No**

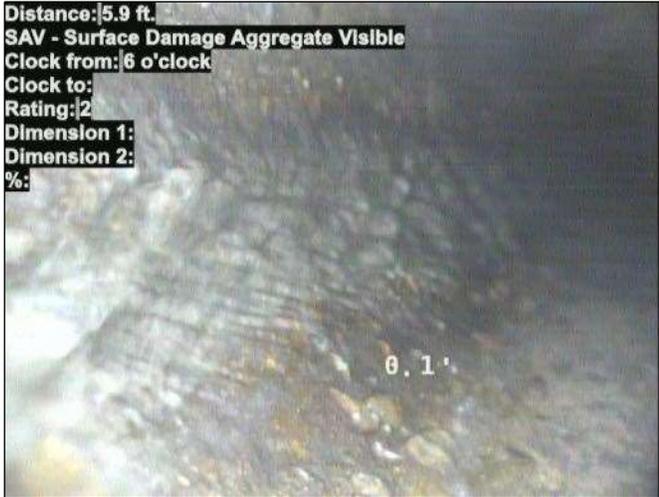
Photo: DS09203-DS08728-20200211-094057-094324.JPG
At: 5.905 ft. 6/. SAV - Surface Damage Aggregate Visible
Joint: Yes

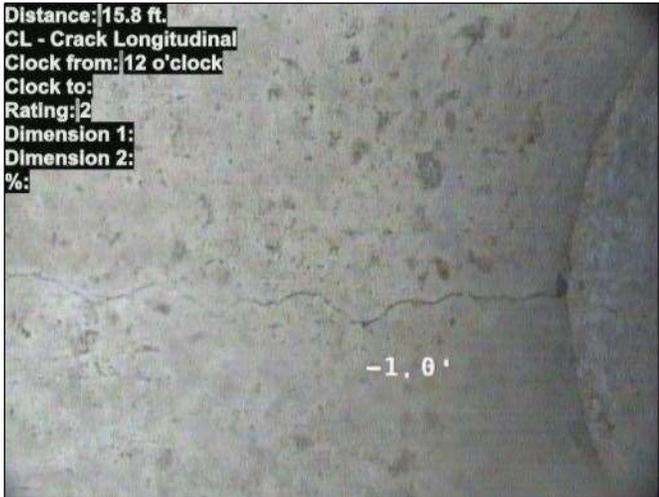
Photo: DS09203-DS08728-20200211-094057-094525.JPG
At: 15.812 ft. CL - Crack Longitudinal
12/.
Joint: Yes

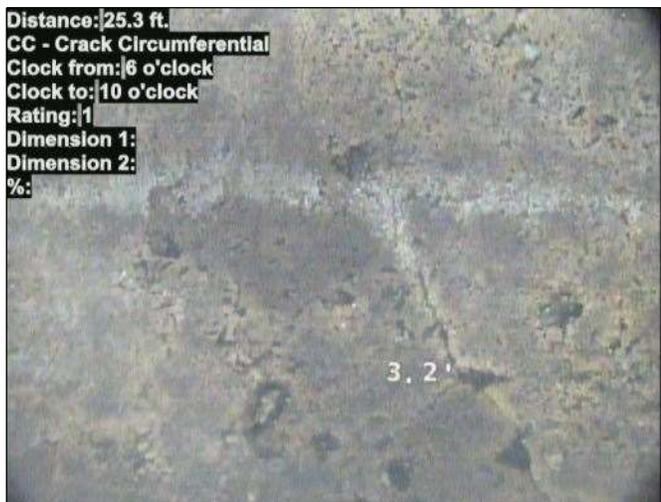
Distance: 25.3 ft.
CC - Crack Circumferential
Clock from: 6 o'clock
Clock to: 10 o'clock
Rating: 1
Dimension 1:
Dimension 2:
%:
Photo: DS09203-DS08728-20200211-094057-094817.JPG
At: 25.319 ft. CC - Crack Circumferential
6/10
Joint: No

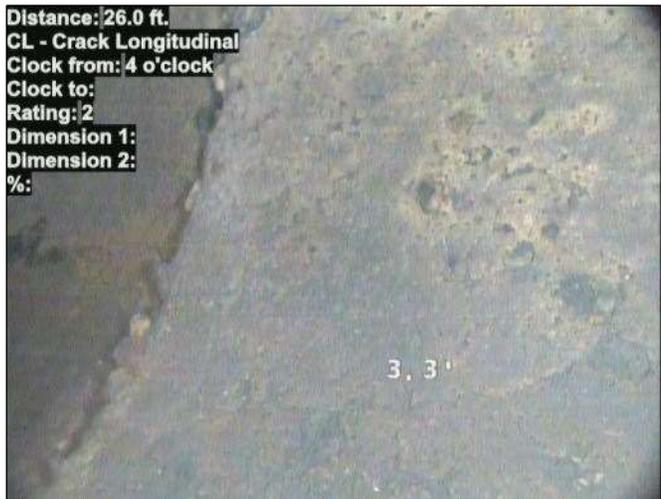
Distance: 26.0 ft.
CL - Crack Longitudinal
Clock from: 4 o'clock
Clock to:
Rating: 2
Dimension 1:
Dimension 2:
%:
Photo: DS09203-DS08728-20200211-094057-094901.JPG
At: 26.02 ft. 4/. CL - Crack Longitudinal
Joint: Yes

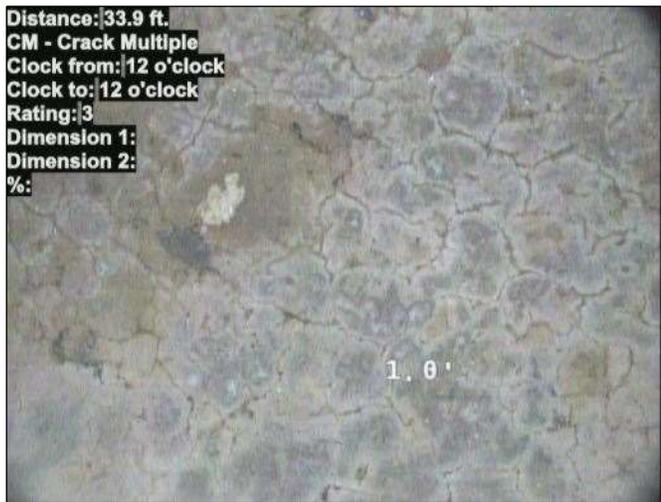
Distance: 33.9 ft.
CM - Crack Multiple
Clock from: 12 o'clock
Clock to: 12 o'clock
Rating: 3
Dimension 1:
Dimension 2:
%:

Photo: DS09203-DS08728-20200211-094057-095109.JPG
At: 33.926 ft. CM - Crack Multiple
12/12
Joint: Yes

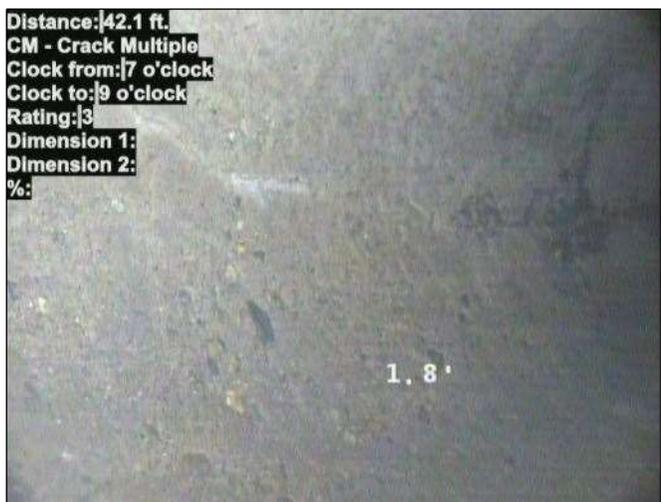
Distance: 42.1 ft.
CM - Crack Multiple
Clock from: 7 o'clock
Clock to: 9 o'clock
Rating: 3
Dimension 1:
Dimension 2:
%:

Photo: DS09203-DS08728-20200211-094057-095250.JPG
At: 42.132 ft. CM - Crack Multiple
7/9
Joint: Yes

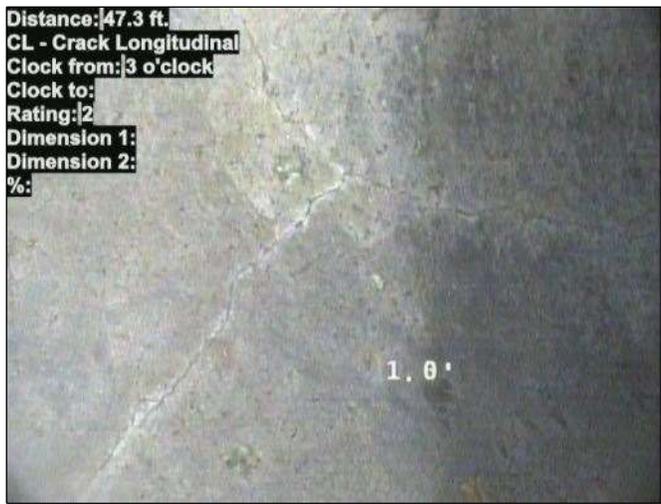
Distance: 47.3 ft.
CL - Crack Longitudinal
Clock from: 3 o'clock
Clock to:
Rating: 2
Dimension 1:
Dimension 2:
%:

Photo: DS09203-DS08728-20200211-094057-095402.JPG
At: 47.336 ft. 3/. CL - Crack Longitudinal
Joint: No

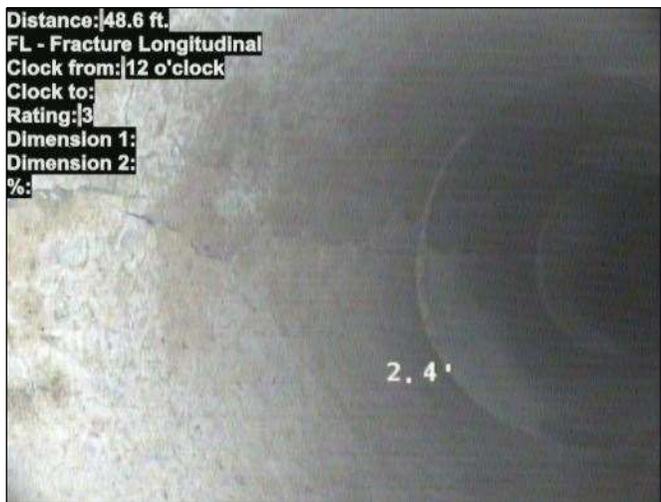
Distance: 48.6 ft.
FL - Fracture Longitudinal
Clock from: 12 o'clock
Clock to:
Rating: 3
Dimension 1:
Dimension 2:
%:

Photo: DS09203-DS08728-20200211-094057-095435.JPG
At: 48.637 ft. FL - Fracture Longitudinal
12/.
Joint: Yes

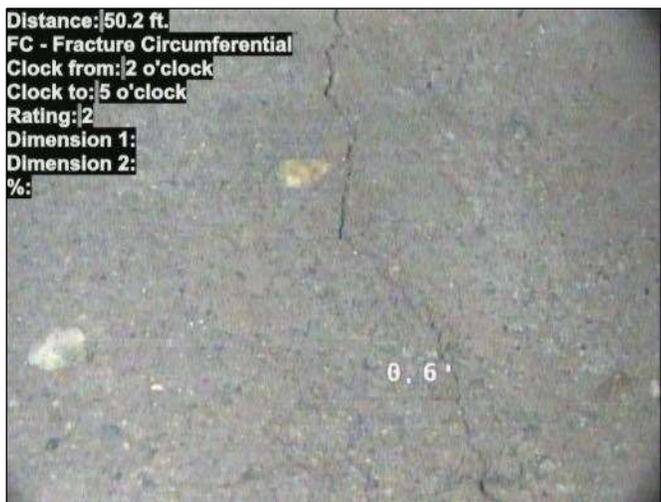
Distance: 50.2 ft.
FC - Fracture Circumferential
Clock from: 2 o'clock
Clock to: 5 o'clock
Rating: 2
Dimension 1:
Dimension 2:
%:

Photo: DS09203-DS08728-20200211-094057-095501.JPG
At: 50.238 ft. FC - Fracture Circumferential
2/5
Joint: No

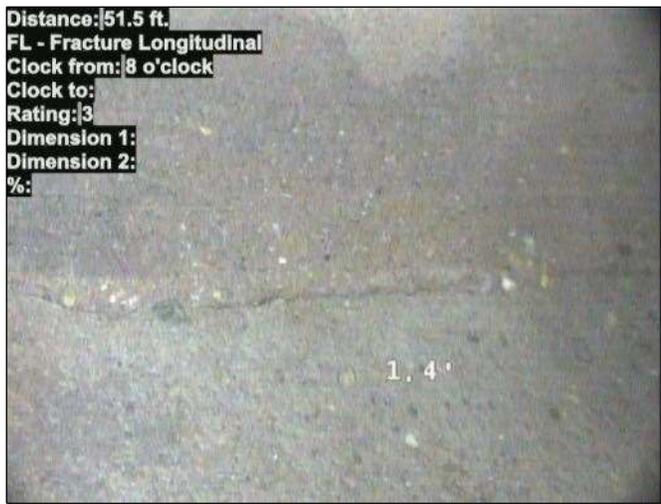
Distance: 51.5 ft.
FL - Fracture Longitudinal
Clock from: 8 o'clock
Clock to:
Rating: 3
Dimension 1:
Dimension 2:
%:

Photo: DS09203-DS08728-20200211-094057-095557.JPG
At: 51.539 ft. 8/. FL - Fracture Longitudinal
Joint: No

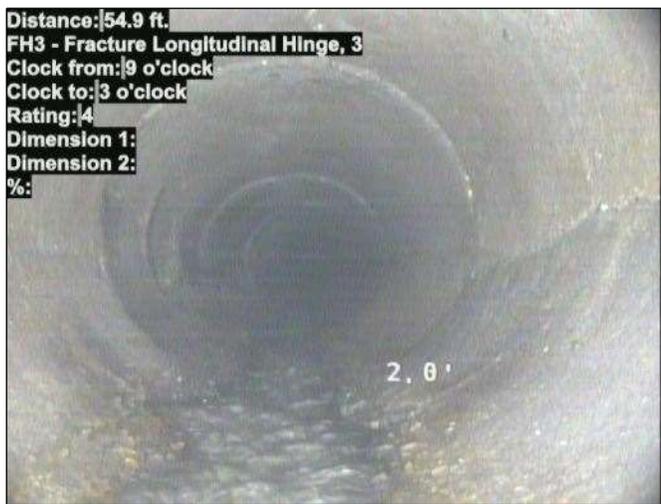
Distance: 54.9 ft.
FH3 - Fracture Longitudinal Hinge, 3
Clock from: 9 o'clock
Clock to: 3 o'clock
Rating: 4
Dimension 1:
Dimension 2:
%:

Photo: DS09203-DS08728-20200211-094057-095724.JPG
At: 54.942 ft. FH3 - Fracture Longitudinal Hinge, 3
9/3
Joint: Yes

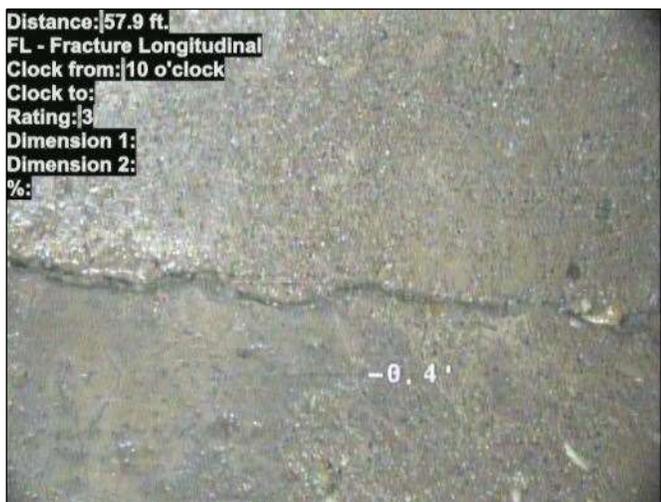
Distance: 57.9 ft.
FL - Fracture Longitudinal
Clock from: 10 o'clock
Clock to:
Rating: 3
Dimension 1:
Dimension 2:
%:

Photo: DS09203-DS08728-20200211-094057-095814.JPG
At: 57.944 ft. FL - Fracture Longitudinal
10/.
Joint: Yes

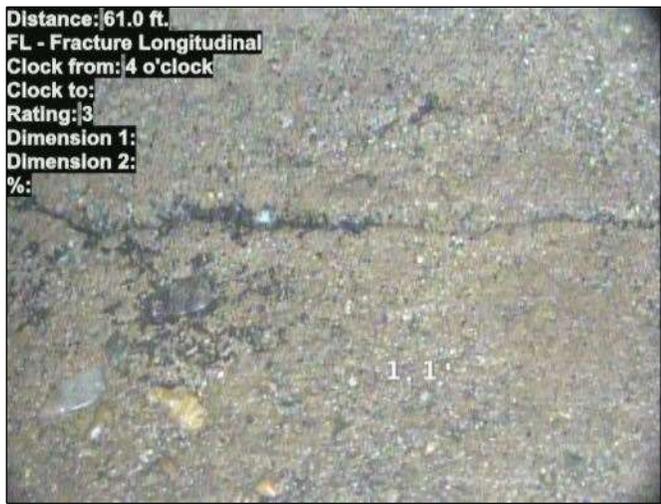
Distance: 61.0 ft.
FL - Fracture Longitudinal
Clock from: 4 o'clock
Clock to:
Rating: 3
Dimension 1:
Dimension 2:
%:

Photo: DS09203-DS08728-20200211-094057-095908.JPG
At: 61.047 ft. 4/. FL - Fracture Longitudinal
Joint: Yes

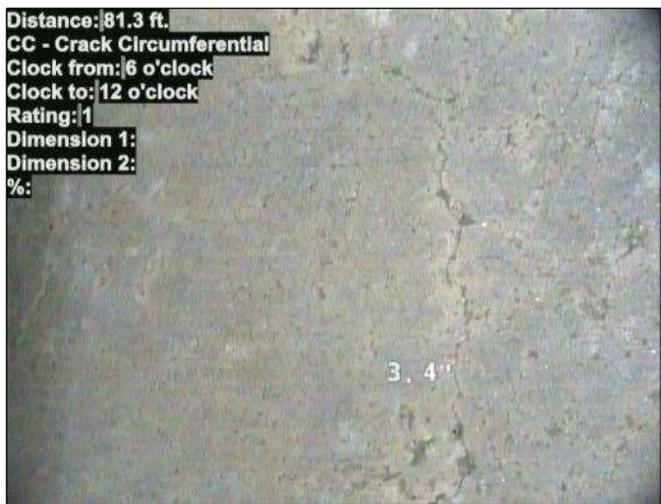
Distance: 81.3 ft.
CC - Crack Circumferential
Clock from: 6 o'clock
Clock to: 12 o'clock
Rating: 1
Dimension 1:
Dimension 2:
%:

Photo: DS09203-DS08728-20200211-094057-100233.JPG
At: 81.262 ft. CC - Crack Circumferential
6/12
Joint: No

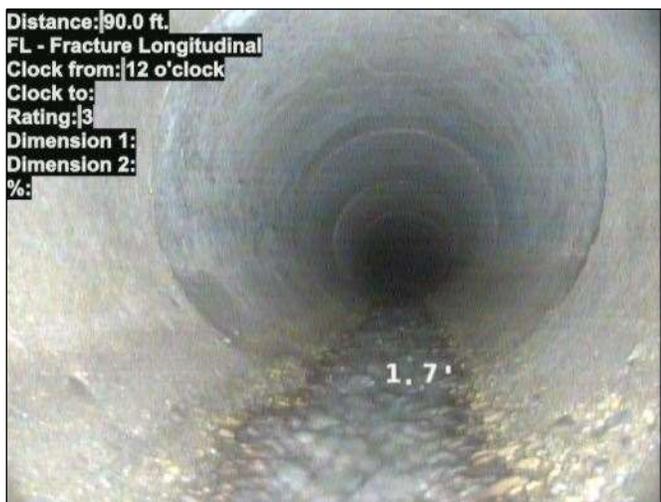
Distance: 90.0 ft.
FL - Fracture Longitudinal
Clock from: 12 o'clock
Clock to:
Rating: 3
Dimension 1:
Dimension 2:
%:

Photo: DS09203-DS08728-20200211-094057-100422.JPG
At: 89.969 ft. FL - Fracture Longitudinal
12/.
Joint: Yes

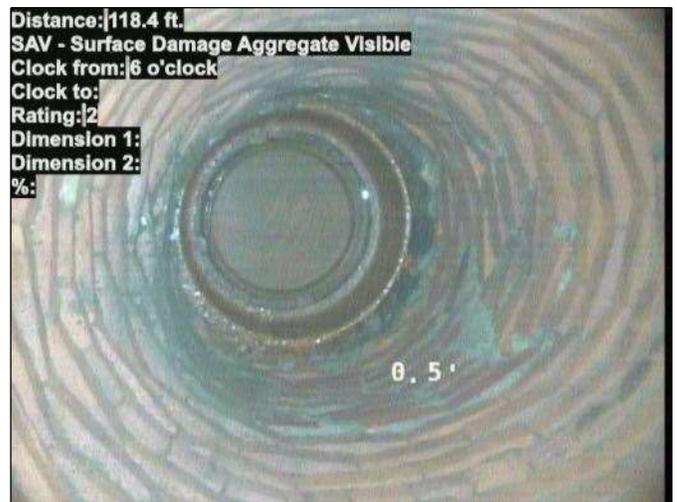
Distance: 118.4 ft.
SAV - Surface Damage Aggregate Visible
Clock from: 6 o'clock
Clock to:
Rating: 2
Dimension 1:
Dimension 2:
%:

At: 118.391 ft. SAV - Surface Damage Aggregate Visible
6/.

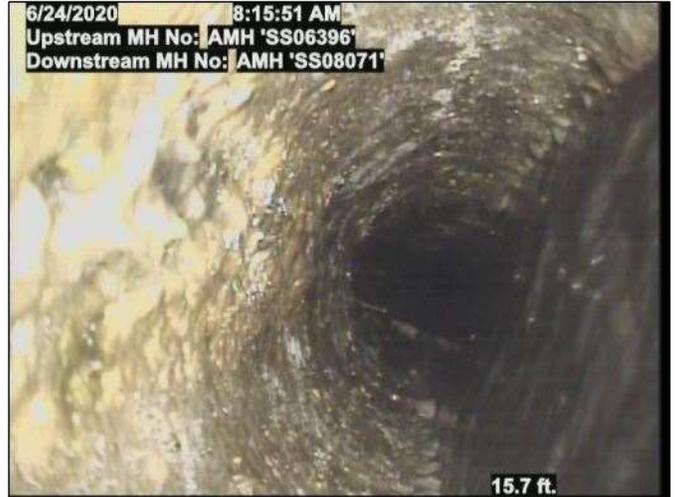
Photo: SS06396-SS08071-20200624-081155-081337_4.JPG
At: 5.2 ft. 10/2 DAGS - Deposits Attached Grease
Joint: No 5 %

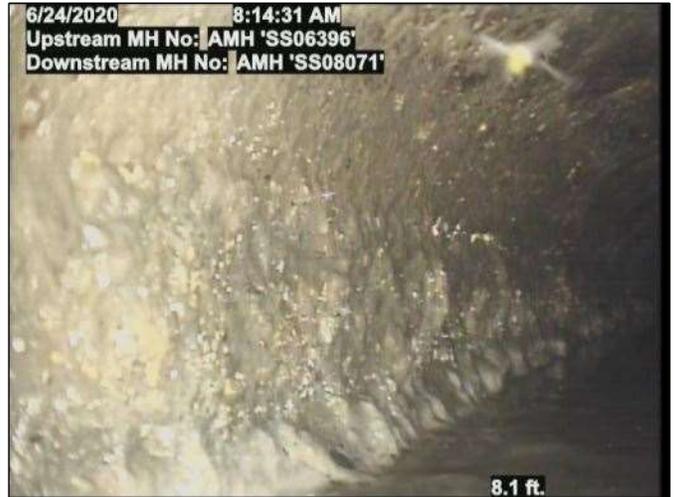
Photo: SS06396-SS08071-20200624-081155-081337_2.JPG
At: 5.2 ft. 10/2 DAGS - Deposits Attached Grease
Joint: No 5 %

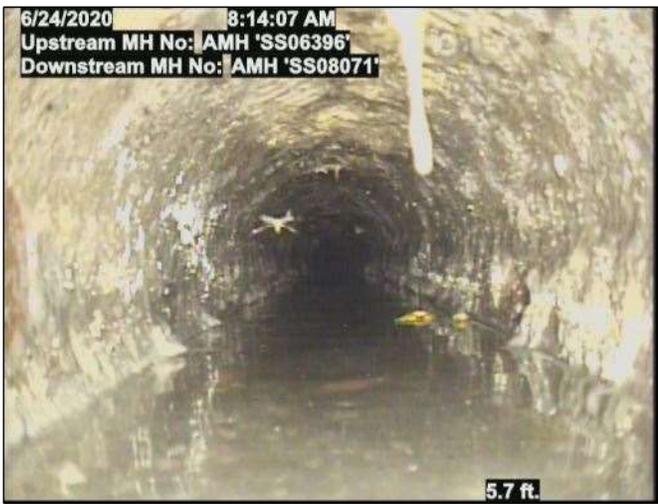
Photo: SS06396-SS08071-20200624-081155-081337_1.JPG
At: 5.2 ft. 10/2 DAGS - Deposits Attached Grease
Joint: No 5 %

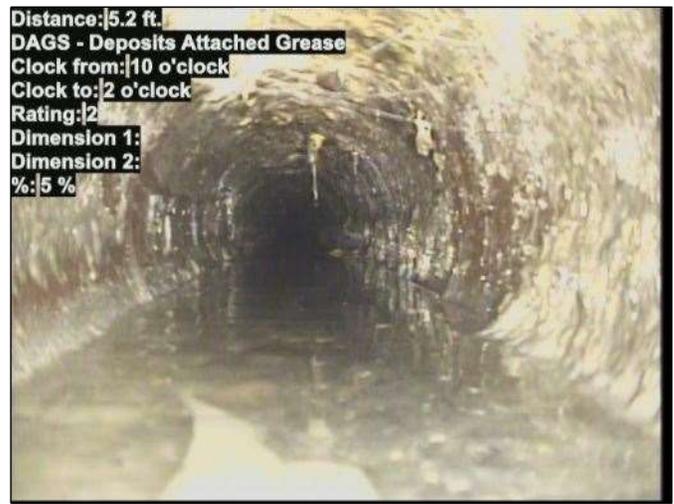
Photo: SS06396-SS08071-20200624-081155-081337.JPG
At: 5.2 ft. 10/2 DAGS - Deposits Attached Grease
Joint: No 5 %

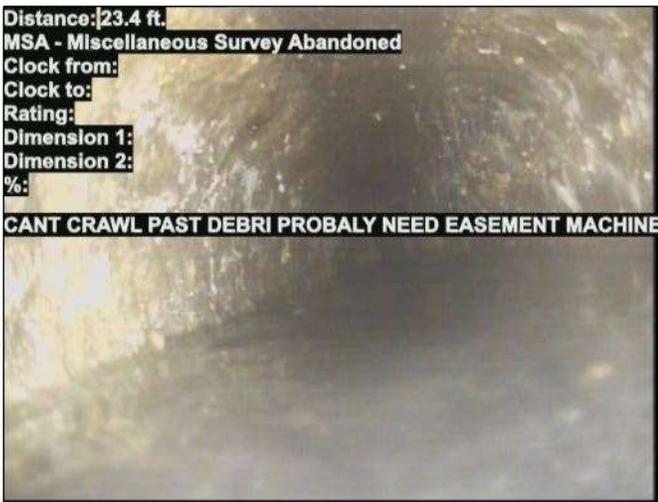
Photo: SS06396-SS08071-20200624-081155-082359.JPG
At: 23.4 ft. MSA - Miscellaneous Survey Abandoned
Joint: No CANT CRAWL PAST DEBRI PROBABLY NEED EASEMENT MACHINE

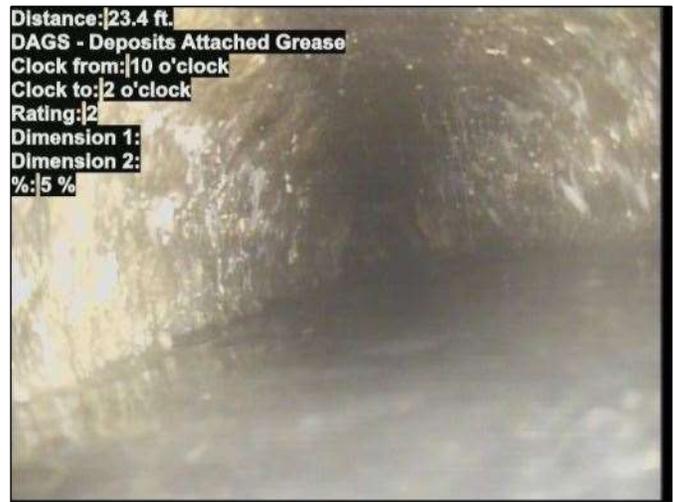
Photo: SS06396-SS08071-20200624-081155-082352.JPG
At: 23.4 ft. 10/2 DAGS - Deposits Attached Grease
Joint: No 5 %

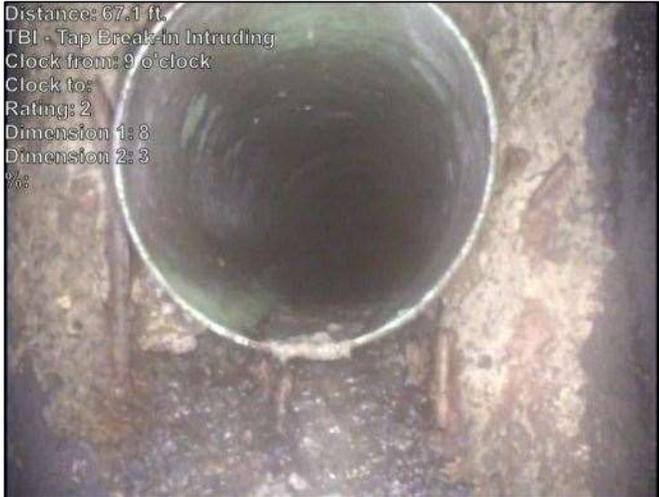
Photo: **SS01510-SS01512-20200124-083348-083804.JPG**
At: **67.051 ft. 9/. TBI - Tap Break-in Intruding**
Joint: **No**

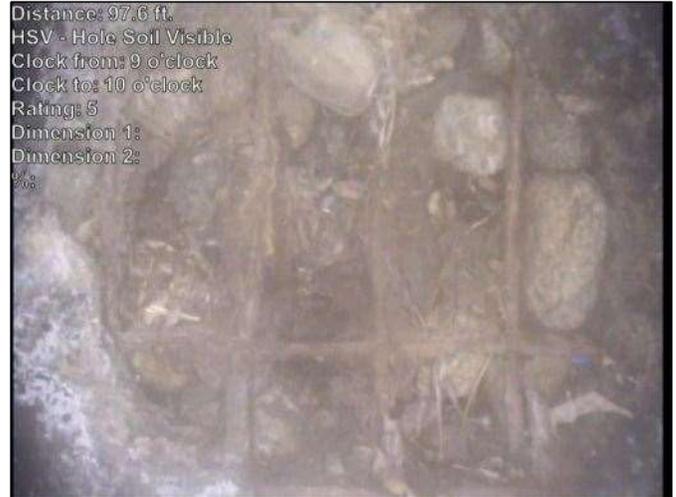
Photo: **SS01510-SS01512-20200124-083348-083927.JPG**
At: **97.575 ft. HSV - Hole Soil Visible**
9/10
Joint: **No**

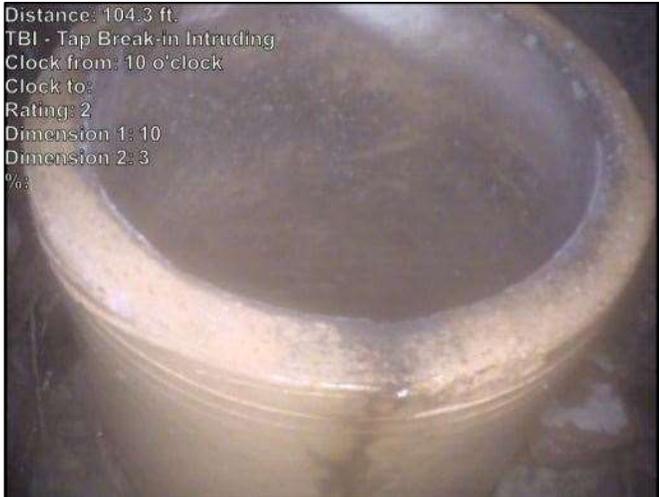
Photo: **SS01510-SS01512-20200124-083348-084014.JPG**
At: **104.28 ft. TBI - Tap Break-in Intruding**
10/.
Joint: **No**

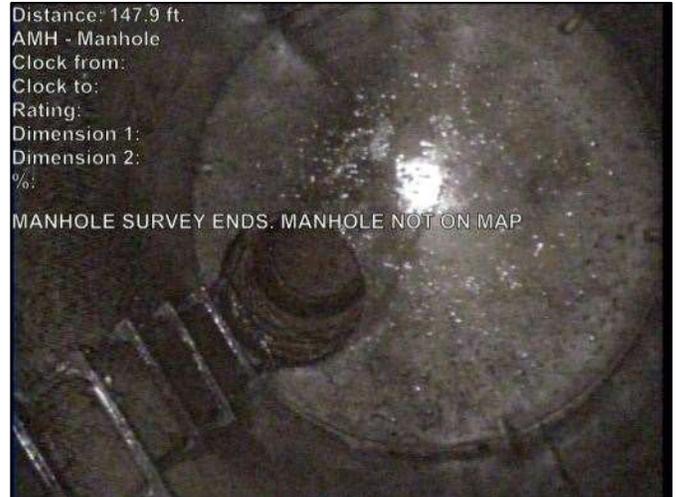
Photo: **SS01510-SS01510A-20200124-083348-084904.JPG**
At: **147.913 ft. AMH - Manhole**
Joint: **No** **MANHOLE SURVEY ENDS. MANHOLE NOT ON MAP**

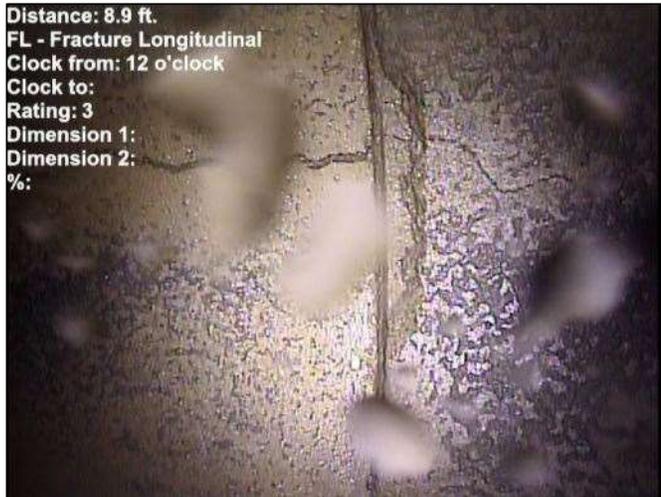
Photo: **SS08241-SS08242-20200103-083233-083449.JPG**
At: **8.9 ft. 12/. FL - Fracture Longitudinal**
Joint: **No**

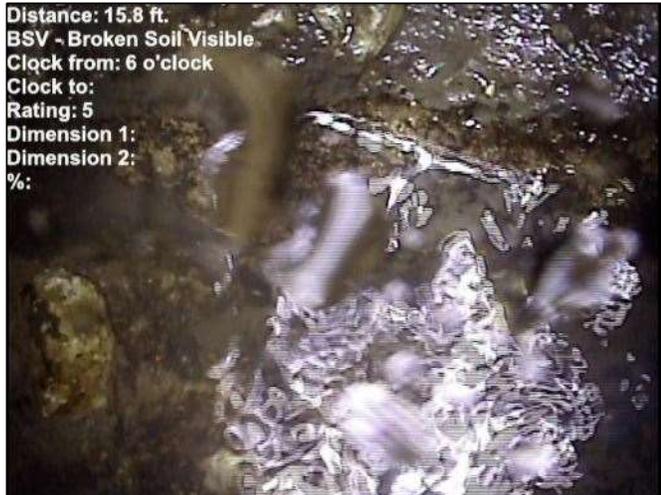
Photo: **SS08241-SS08242-20200103-083233-083604.JPG**
At: **15.8 ft. 6/. BSV - Broken Soil Visible**
Joint: **No**

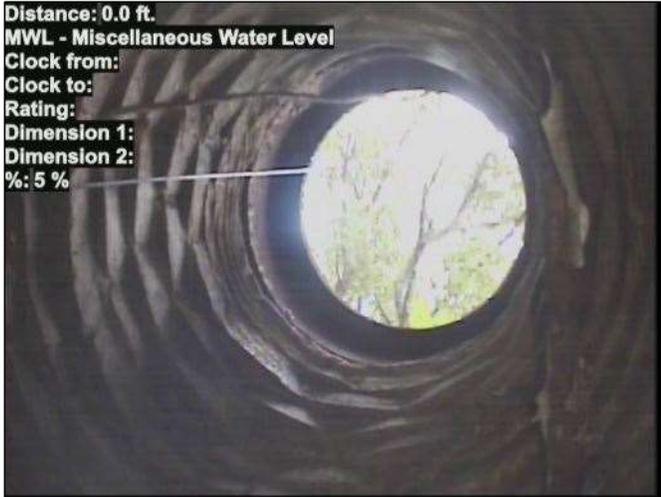
Photo: **SS08072-SS08073-20200624-094710-094712.JPG**
At: **0 ft. MWL - Miscellaneous Water Level**
Joint: **No 5 %**

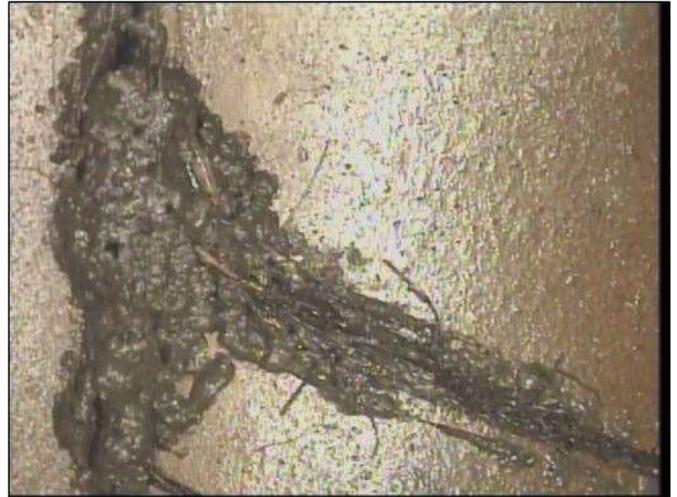
Photo: **SS08072-SS08073-20200624-094710-094848.JPG**
At: **6.3 ft. 7/8 RFJ - Roots Fine Joint**
Joint: **Yes**

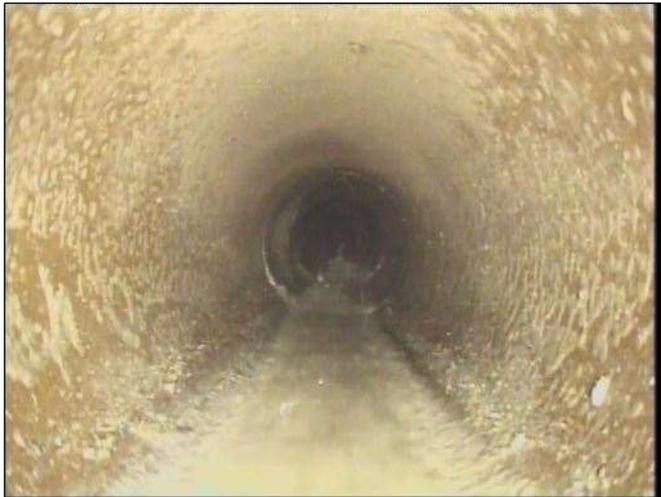
Photo: **SS08072-SS08073-20200624-094710-094902_1.JPG**
At: **6.4 ft. 5/7 DAGS - Deposits Attached Grease**
Joint: **No 5 %**

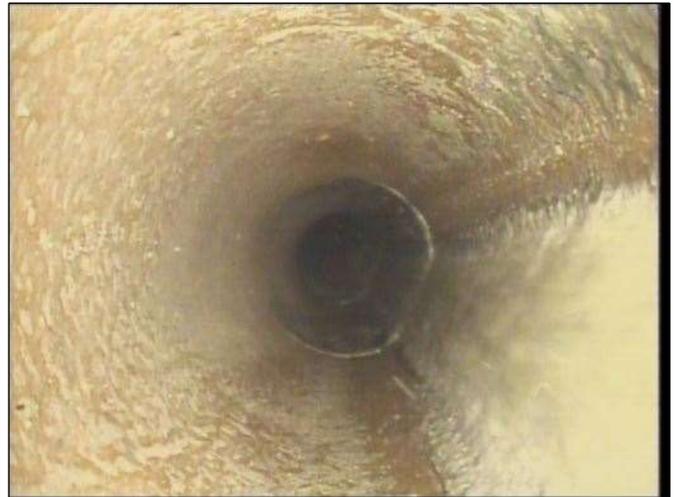
Photo: **SS08072-SS08073-20200624-094710-094902.JPG**
At: **6.4 ft. 5/7 DAGS - Deposits Attached Grease**
Joint: **No 5 %**

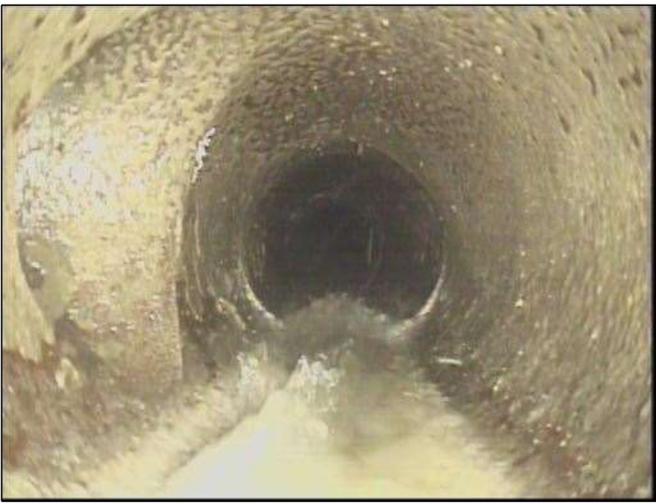
Photo: **SS08072-SS08073-20200624-094710-094936.JPG**
At: **11.7 ft. 8/4 DAGS - Deposits Attached Grease**
Joint: **No 5%**

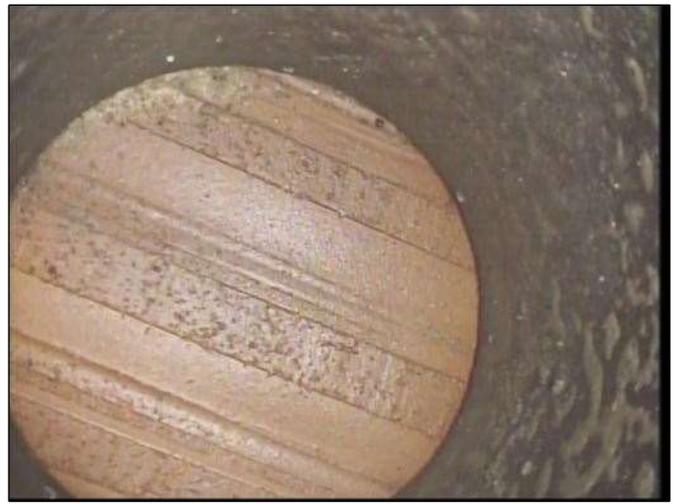
Photo: **SS08072-SS08073-20200624-094710-094949.JPG**
At: **12.9 ft. 9/. TFC - Tap Factory Capped**
Joint: **Yes**

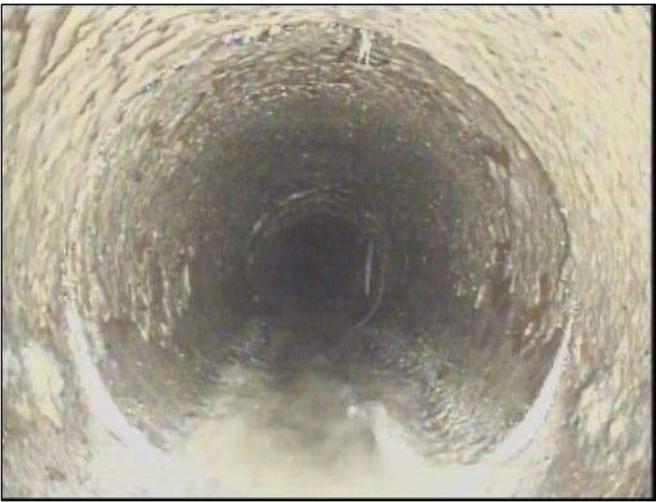
Photo: **SS08072-SS08073-20200624-094710-095002.JPG**
At: **13.1 ft. 8/4 DAGS - Deposits Attached Grease**
Joint: **No 5%**

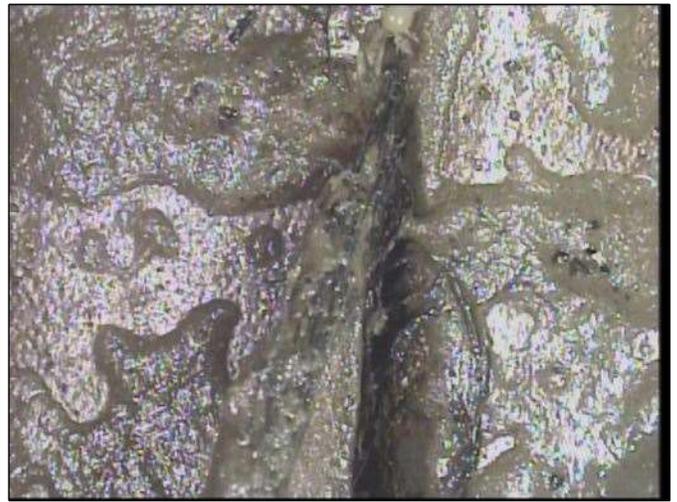
Photo: **SS08072-SS08073-20200624-094710-095031.JPG**
At: **17.2 ft. 3/4 RFJ - Roots Fine Joint**
Joint: **Yes**

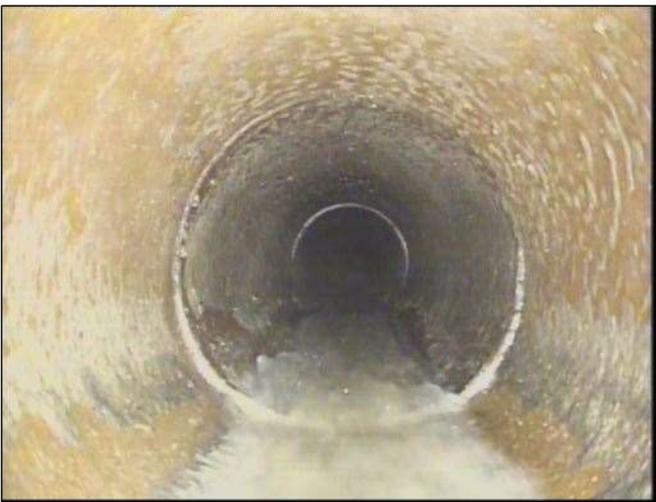
Photo: **SS08072-SS08073-20200624-094710-095228.JPG**
At: **27.8 ft. 5/7 DAGS - Deposits Attached Grease**
Joint: **No 5%**

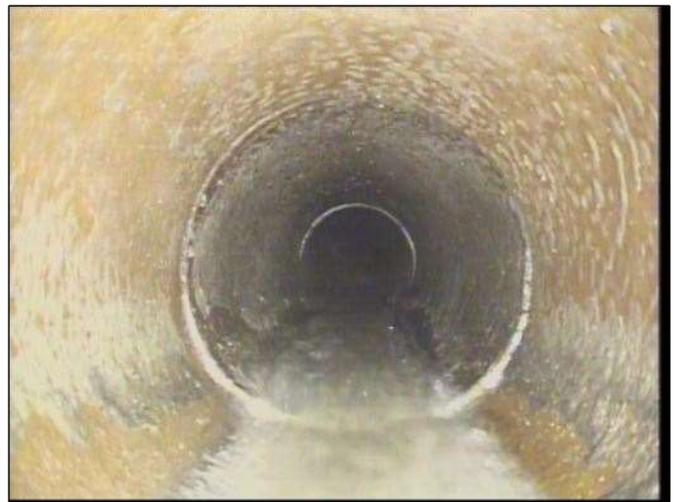
Photo: **SS08072-SS08073-20200624-094710-095203.JPG**
At: **27.8 ft. MSA - Miscellaneous Survey Abandoned**
Joint: **No REDO HEADER NOT ON SCREEN**

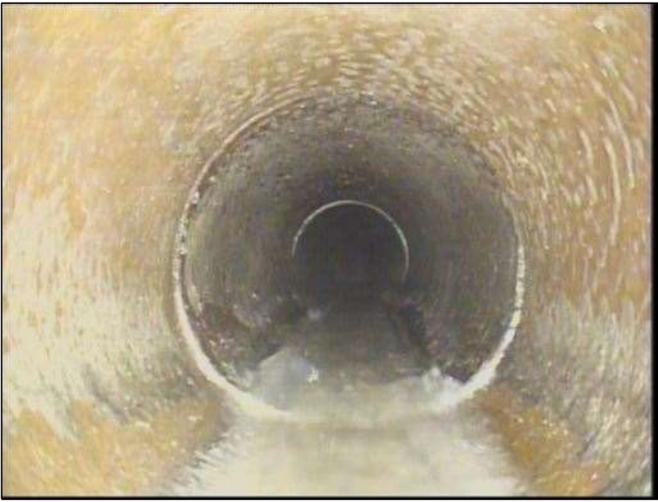
Photo: **SS08072-SS08073-20200624-094710-095231.JPG**

At: **27.8 ft. 8/4 DAGS - Deposits Attached Grease**

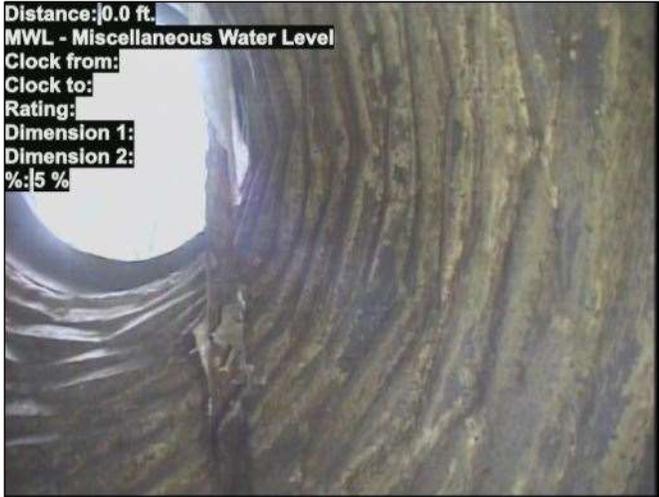
Distance: 0.0 ft.
MWL - Miscellaneous Water Level
Clock from:
Clock to:
Rating:
Dimension 1:
Dimension 2:
%: 5 %
Photo: SS08072-SS08073-20200624-095533-095534.JPG
At: 0 ft. MWL - Miscellaneous Water Level
Joint: No 5 %

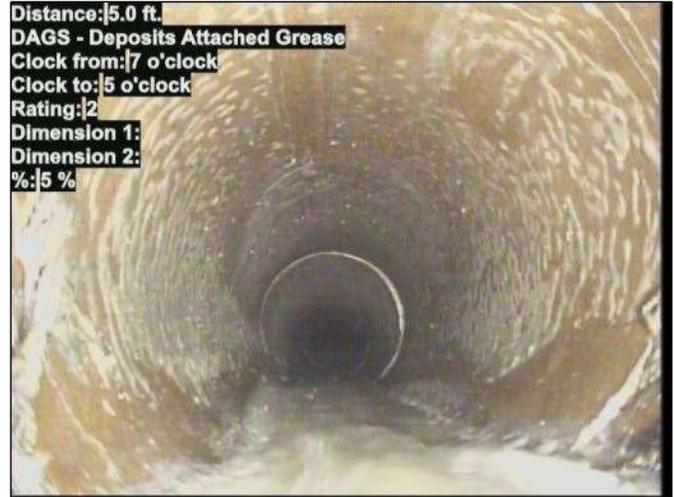
Distance: 5.0 ft.
DAGS - Deposits Attached Grease
Clock from: 7 o'clock
Clock to: 5 o'clock
Rating: 2
Dimension 1:
Dimension 2:
%: 5 %
Photo: SS08072-SS08073-20200624-095533-095627.JPG
At: 5 ft. 7/5 DAGS - Deposits Attached Grease
Joint: No 5 %

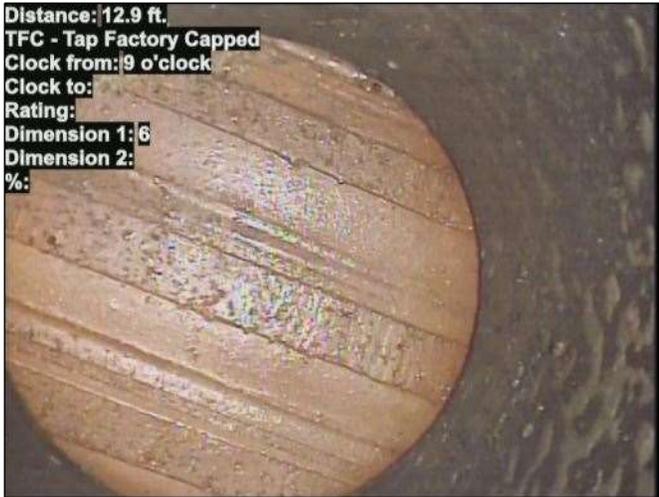
Distance: 12.9 ft.
TFC - Tap Factory Capped
Clock from: 9 o'clock
Clock to:
Rating:
Dimension 1: 6
Dimension 2:
%:
Photo: SS08072-SS08073-20200624-095533-095724.JPG
At: 12.9 ft. 9/. TFC - Tap Factory Capped
Joint: Yes

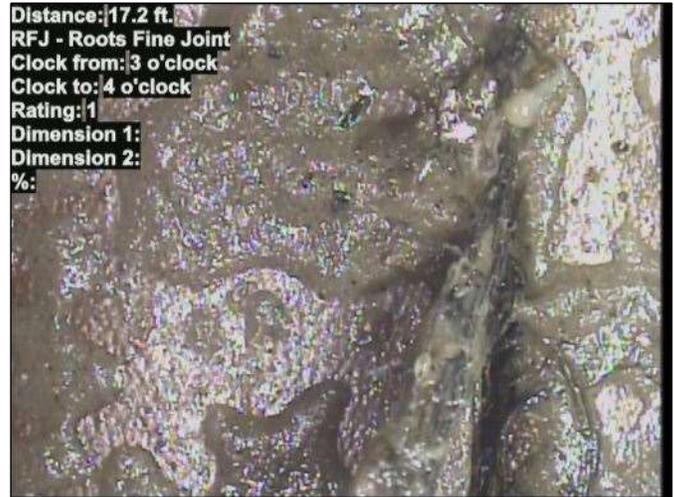
Distance: 17.2 ft.
RFJ - Roots Fine Joint
Clock from: 3 o'clock
Clock to: 4 o'clock
Rating: 1
Dimension 1:
Dimension 2:
%:
Photo: SS08072-SS08073-20200624-095533-095752.JPG
At: 17.2 ft. 3/4 RFJ - Roots Fine Joint
Joint: Yes

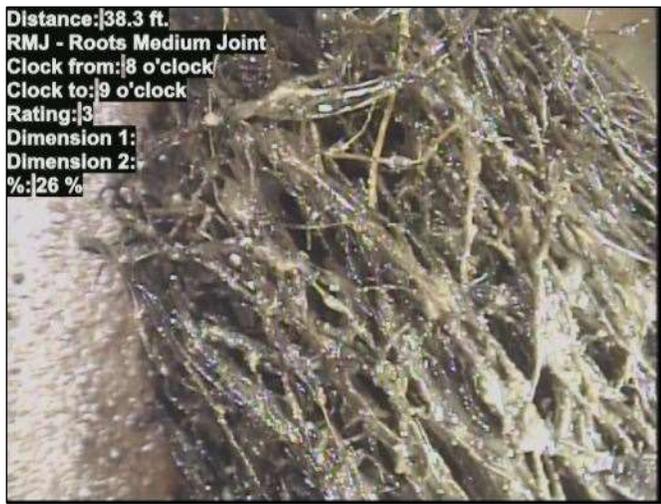
Distance: 38.3 ft.
RMJ - Roots Medium Joint
Clock from: 8 o'clock
Clock to: 9 o'clock
Rating: 3
Dimension 1:
Dimension 2:
%: 26 %

Photo: SS08072-SS08073-20200624-095533-095922.JPG
At: 38.3 ft. 8/9 RMJ - Roots Medium Joint
Joint: Yes 26 %

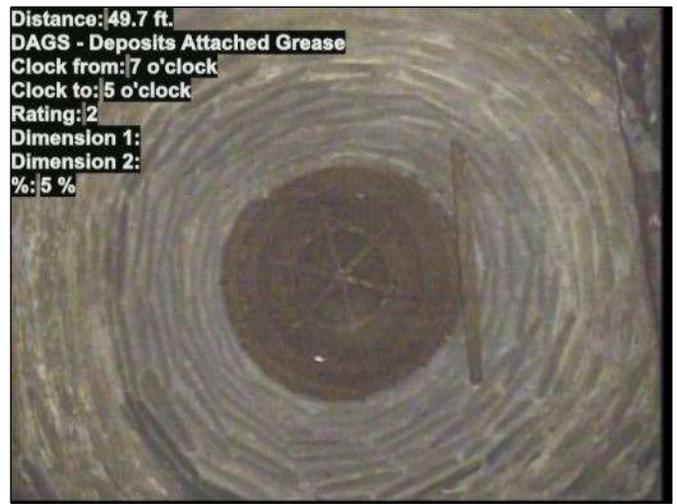
Distance: 49.7 ft.
DAGS - Deposits Attached Grease
Clock from: 7 o'clock
Clock to: 5 o'clock
Rating: 2
Dimension 1:
Dimension 2:
%: 5 %

Photo: SS08072-SS08073-20200624-095533-100028.JPG
At: 49.7 ft. 7/5 DAGS - Deposits Attached Grease
Joint: No 5 %

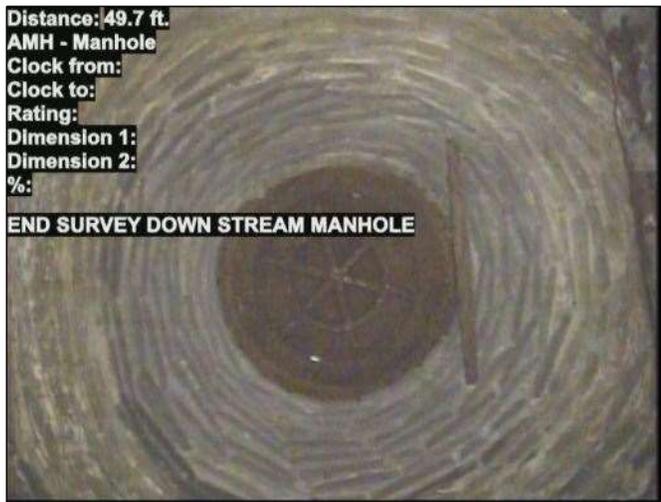
Distance: 49.7 ft.
AMH - Manhole
Clock from:
Clock to:
Rating:
Dimension 1:
Dimension 2:
%:

END SURVEY DOWN STREAM MANHOLE

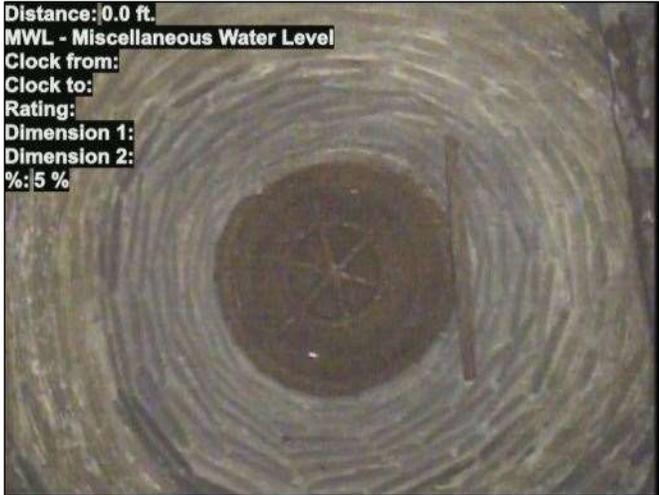
Distance: 0.0 ft.
MWL - Miscellaneous Water Level
Clock from:
Clock to:
Rating:
Dimension 1:
Dimension 2:
%: 5 %
Photo: SS08073-SS02704-20200624-100353-100354.JPG
At: 0 ft. MWL - Miscellaneous Water Level
Joint: No 5 %

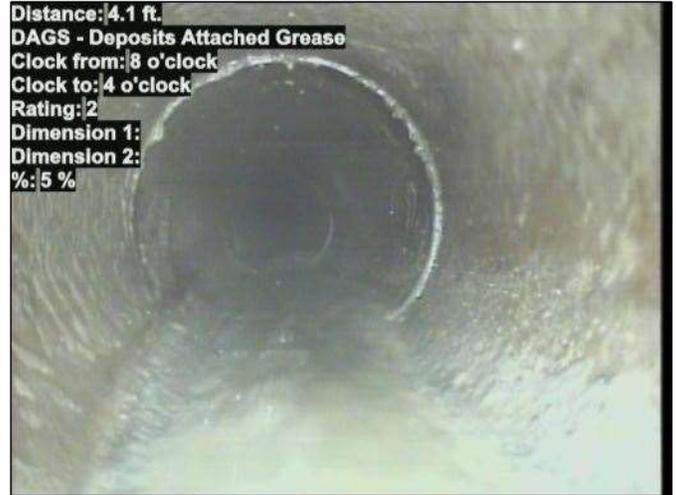
Distance: 4.1 ft.
DAGS - Deposits Attached Grease
Clock from: 8 o'clock
Clock to: 4 o'clock
Rating: 2
Dimension 1:
Dimension 2:
%: 5 %
Photo: SS08073-SS02704-20200624-100353-101436.JPG
At: 4.1 ft. 8/4 DAGS - Deposits Attached Grease
Joint: No 5 %

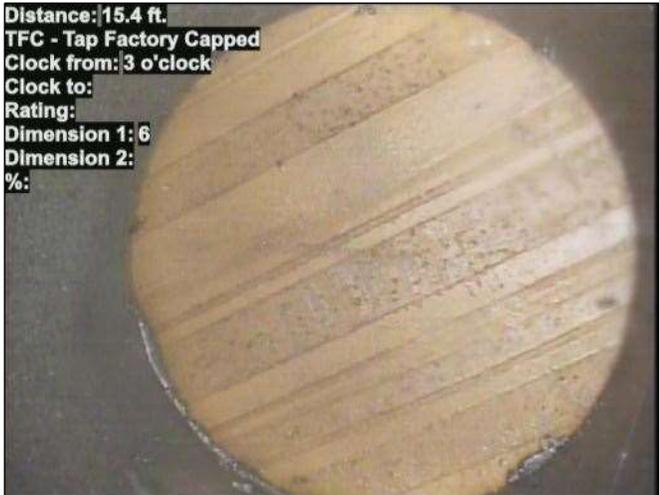
Distance: 15.4 ft.
TFC - Tap Factory Capped
Clock from: 3 o'clock
Clock to:
Rating:
Dimension 1: 6
Dimension 2:
%:
Photo: SS08073-SS02704-20200624-100353-101555.JPG
At: 15.4 ft. 3/. TFC - Tap Factory Capped
Joint: Yes

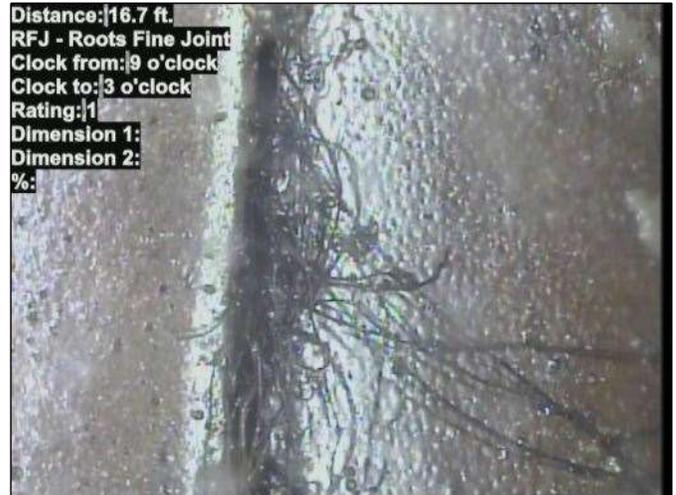
Distance: 16.7 ft.
RFJ - Roots Fine Joint
Clock from: 9 o'clock
Clock to: 3 o'clock
Rating: 1
Dimension 1:
Dimension 2:
%:
Photo: SS08073-SS02704-20200624-100353-101615.JPG
At: 16.7 ft. 9/3 RFJ - Roots Fine Joint
Joint: Yes

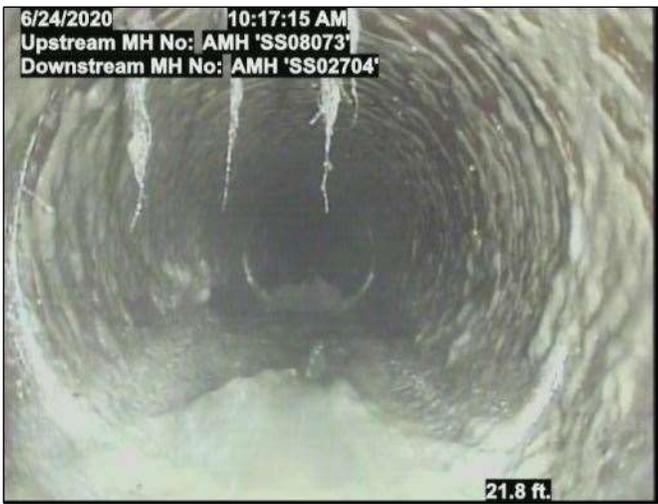
Photo: SS08073-SS02704-20200624-100353-101649_1.JPG
At: 19.8 ft. 9/3 RFJ - Roots Fine Joint
Joint: Yes
