APPENDIX A
TELEVISION INSPECTION LOGS

Main Inspections Pipe Run with Images

Project name: WEST05-65	Mainline ID: SM00768	City: WORCESTER MA	Street: ASH ST
Start date/time: 20190510-121424	Direction: D	Weather: 1	Location code:
Shape: C	Material: VCP	Height: 12 in.	Width:

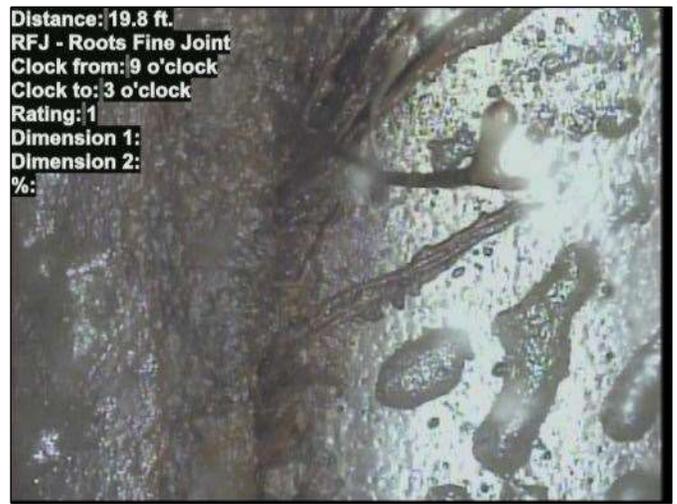
Photo: SS08073-SS02704-20200624-100353-101649.JPG
At: 19.8 ft. 9/3 RFJ - Roots Fine Joint
Joint: Yes

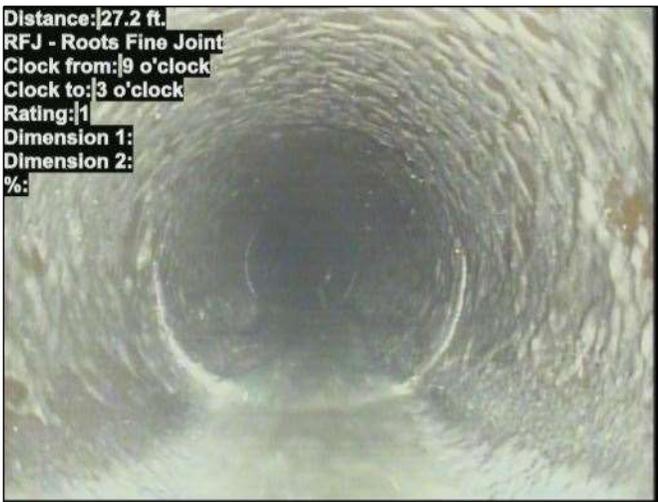
Photo: SS08073-SS02704-20200624-100353-101747.JPG
At: 27.2 ft. 9/3 RFJ - Roots Fine Joint
Joint: Yes

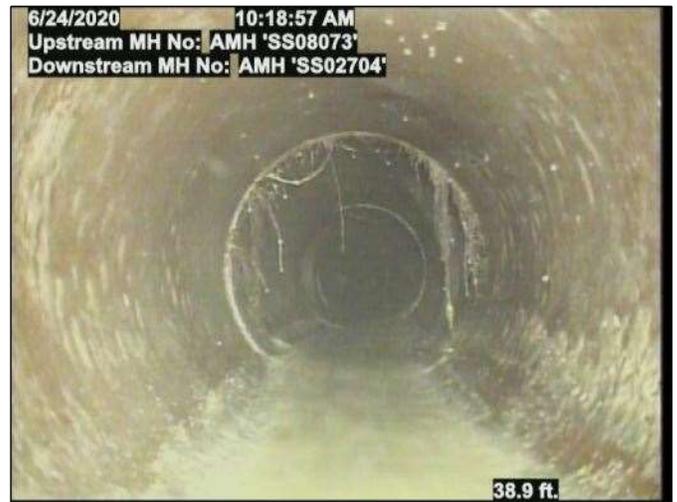
Photo: SS08073-SS02704-20200624-100353-101828_2.JPG
At: 34.9 ft. 8/4 RFJ - Roots Fine Joint
Joint: Yes

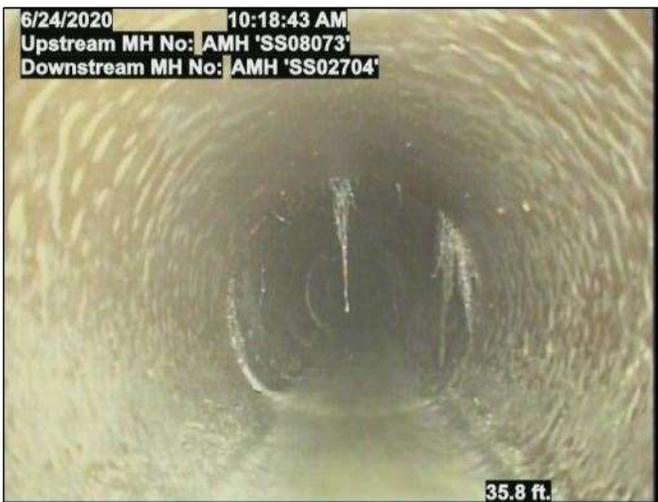
Photo: SS08073-SS02704-20200624-100353-101828_1.JPG
At: 34.9 ft. 8/4 RFJ - Roots Fine Joint
Joint: Yes

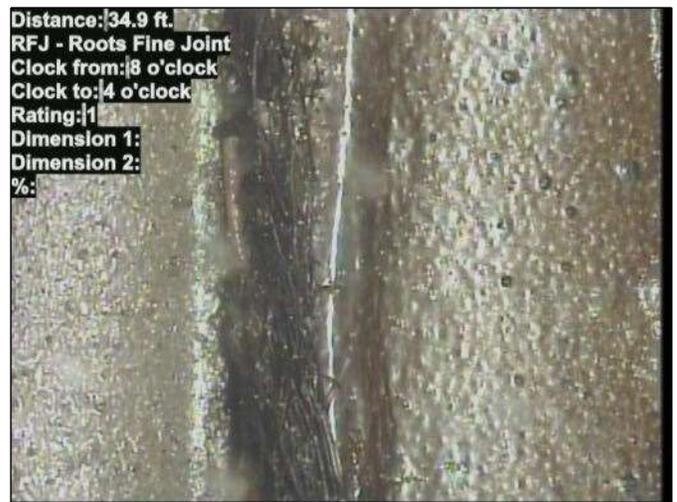
Photo: SS08073-SS02704-20200624-100353-101828.JPG
At: 34.9 ft. 8/4 RFJ - Roots Fine Joint
Joint: Yes

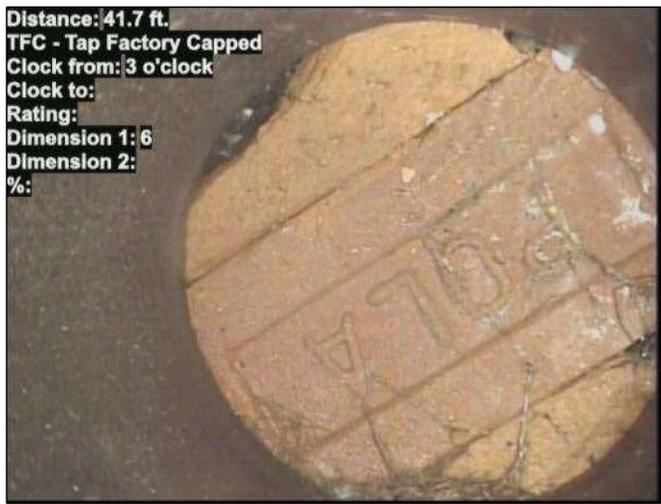
Distance: 41.7 ft.
TFC - Tap Factory Capped
Clock from: 3 o'clock
Clock to:
Rating:
Dimension 1: 6
Dimension 2:
%:

Photo: SS08073-SS02704-20200624-100353-101911.JPG
At: 41.7 ft. 3/. TFC - Tap Factory Capped
Joint: Yes

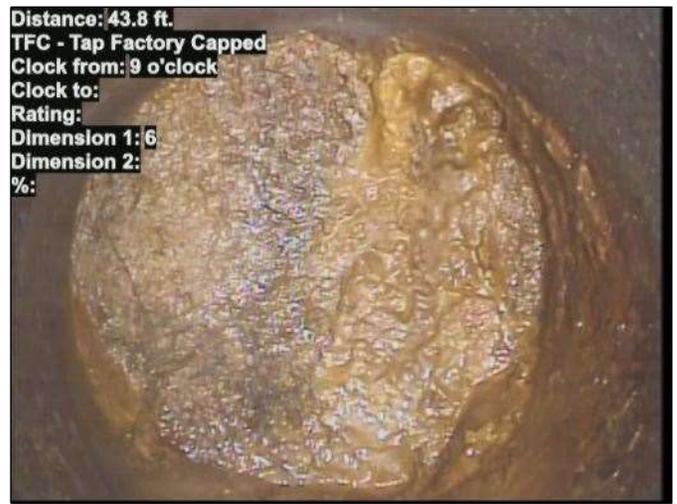
Distance: 43.8 ft.
TFC - Tap Factory Capped
Clock from: 9 o'clock
Clock to:
Rating:
Dimension 1: 6
Dimension 2:
%:

Photo: SS08073-SS02704-20200624-100353-101933.JPG
At: 43.8 ft. 9/. TFC - Tap Factory Capped
Joint: Yes

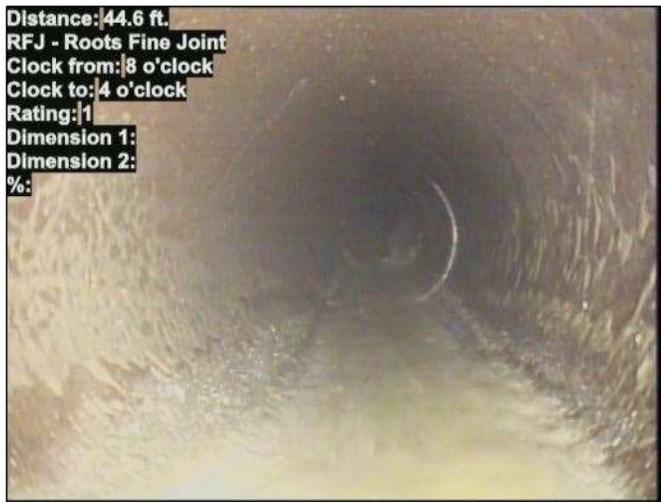
Distance: 44.6 ft.
RFJ - Roots Fine Joint
Clock from: 8 o'clock
Clock to: 4 o'clock
Rating: 1
Dimension 1:
Dimension 2:
%:

Photo: SS08073-SS02704-20200624-100353-101950.JPG
At: 44.6 ft. 8/4 RFJ - Roots Fine Joint
Joint: Yes

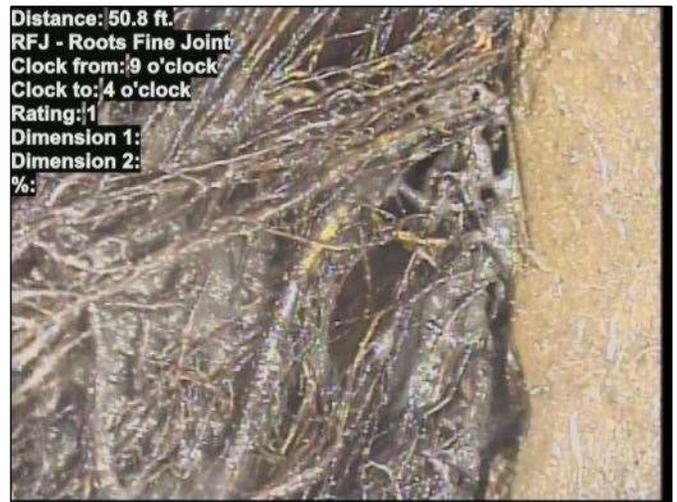
Distance: 50.8 ft.
RFJ - Roots Fine Joint
Clock from: 9 o'clock
Clock to: 4 o'clock
Rating: 1
Dimension 1:
Dimension 2:
%:

Photo: SS08073-SS02704-20200624-100353-102027.JPG
At: 50.8 ft. 9/4 RFJ - Roots Fine Joint
Joint: Yes

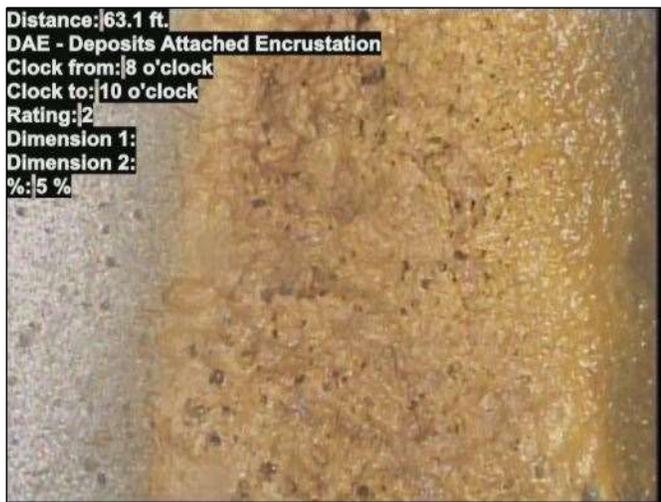
Distance: 63.1 ft.
DAE - Deposits Attached Encrustation
Clock from: 8 o'clock
Clock to: 10 o'clock
Rating: 2
Dimension 1:
Dimension 2:
%: 5 %

Photo: SS08073-SS02704-20200624-100353-102138.JPG
At: 63.1 ft. 8/10 DAE - Deposits Attached Encrustation
Joint: Yes 5 %

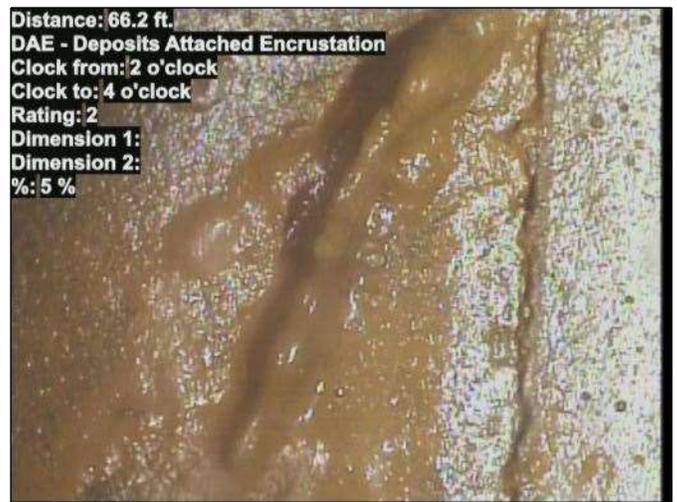
Distance: 66.2 ft.
DAE - Deposits Attached Encrustation
Clock from: 2 o'clock
Clock to: 4 o'clock
Rating: 2
Dimension 1:
Dimension 2:
%: 5 %

Photo: SS08073-SS02704-20200624-100353-102233.JPG
At: 66.2 ft. 2/4 DAE - Deposits Attached Encrustation
Joint: Yes 5 %

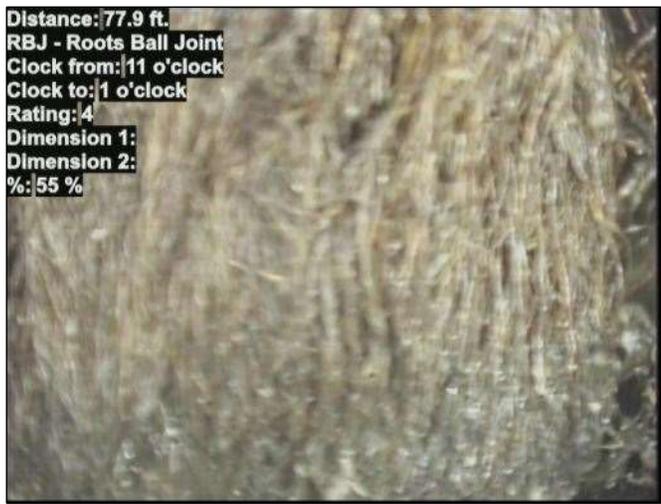
Distance: 77.9 ft.
RBJ - Roots Ball Joint
Clock from: 11 o'clock
Clock to: 1 o'clock
Rating: 4
Dimension 1:
Dimension 2:
%: 55 %

Photo: SS08073-SS02704-20200624-100353-102333.JPG
At: 77.9 ft. 11/1 RBJ - Roots Ball Joint
Joint: Yes 55 %

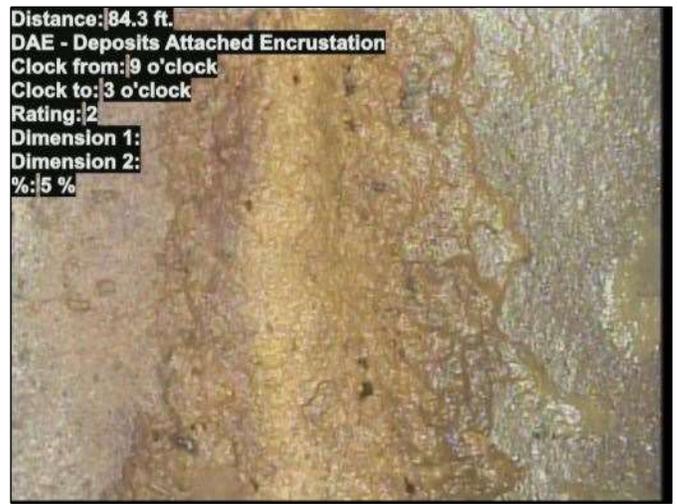
Distance: 84.3 ft.
DAE - Deposits Attached Encrustation
Clock from: 9 o'clock
Clock to: 3 o'clock
Rating: 2
Dimension 1:
Dimension 2:
%: 5 %

Photo: SS08073-SS02704-20200624-100353-102449.JPG
At: 84.3 ft. 9/3 DAE - Deposits Attached Encrustation
Joint: Yes 5 %

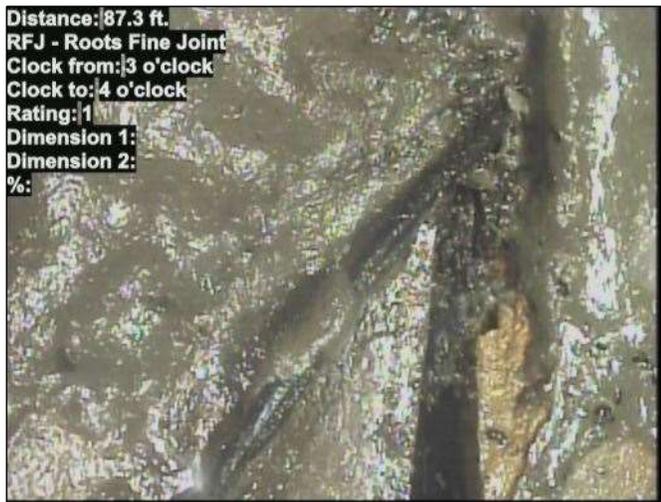
Distance: 87.3 ft.
RFJ - Roots Fine Joint
Clock from: 3 o'clock
Clock to: 4 o'clock
Rating: 1
Dimension 1:
Dimension 2:
%:

Photo: SS08073-SS02704-20200624-100353-102516.JPG
At: 87.3 ft. 3/4 RFJ - Roots Fine Joint
Joint: Yes

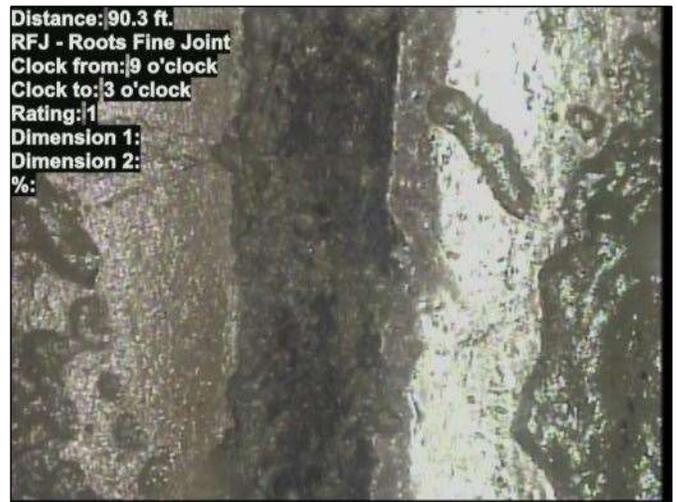
Distance: 90.3 ft.
RFJ - Roots Fine Joint
Clock from: 9 o'clock
Clock to: 3 o'clock
Rating: 1
Dimension 1:
Dimension 2:
%:

Photo: SS08073-SS02704-20200624-100353-102542.JPG
At: 90.3 ft. 9/3 RFJ - Roots Fine Joint
Joint: Yes

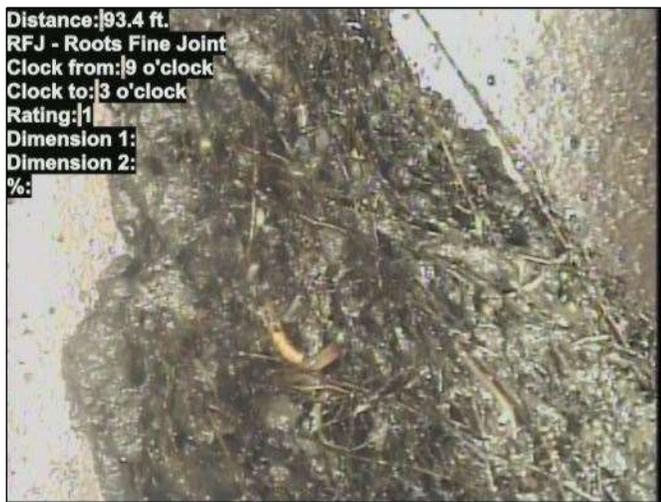
Distance: 93.4 ft.
RFJ - Roots Fine Joint
Clock from: 9 o'clock
Clock to: 3 o'clock
Rating: 1
Dimension 1:
Dimension 2:
%:

Photo: SS08073-SS02704-20200624-100353-102606.JPG
At: 93.4 ft. 9/3 RFJ - Roots Fine Joint
Joint: Yes

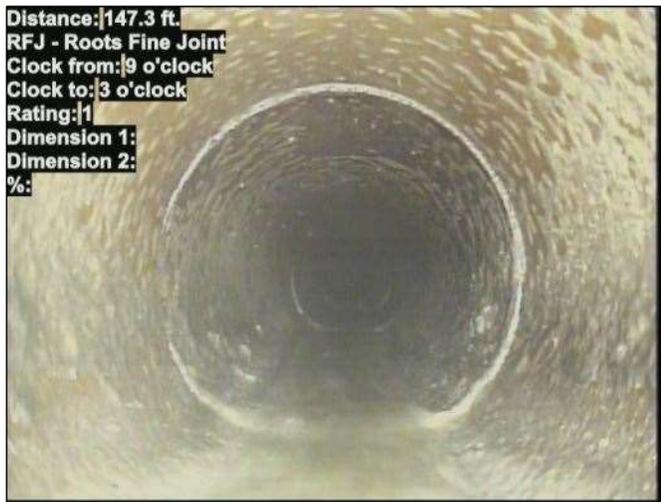
Distance: 147.3 ft.
RFJ - Roots Fine Joint
Clock from: 9 o'clock
Clock to: 3 o'clock
Rating: 1
Dimension 1:
Dimension 2:
%:

Photo: SS08073-SS02704-20200624-100353-103120.JPG
At: 147.3 ft. 9/3 RFJ - Roots Fine Joint
Joint: Yes

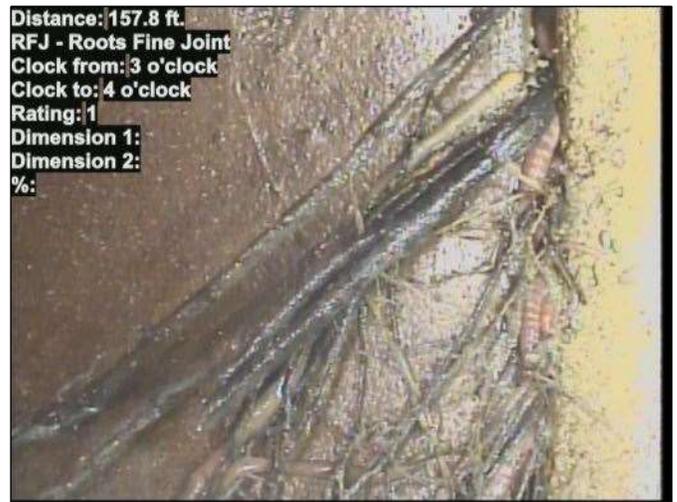
Distance: 157.8 ft.
RFJ - Roots Fine Joint
Clock from: 3 o'clock
Clock to: 4 o'clock
Rating: 1
Dimension 1:
Dimension 2:
%:

Photo: SS08073-SS02704-20200624-100353-103210.JPG
At: 157.8 ft. 3/4 RFJ - Roots Fine Joint
Joint: Yes

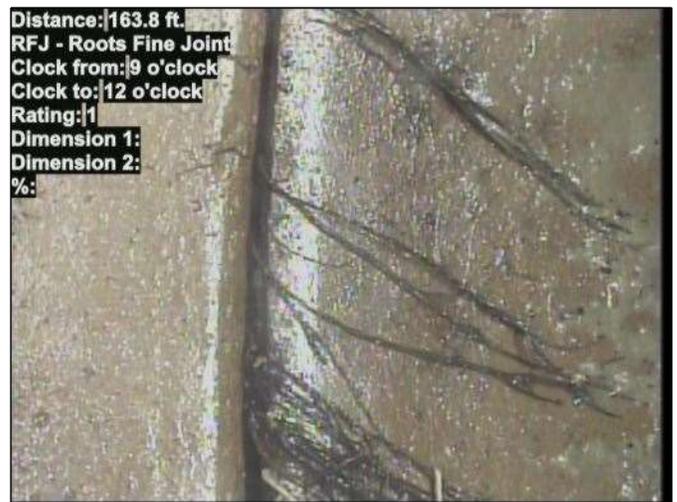
Distance: 163.8 ft.
RFJ - Roots Fine Joint
Clock from: 9 o'clock
Clock to: 12 o'clock
Rating: 1
Dimension 1:
Dimension 2:
%:

Photo: SS08073-SS02704-20200624-100353-103302.JPG
At: 163.8 ft. RFJ - Roots Fine Joint
9/12
Joint: Yes

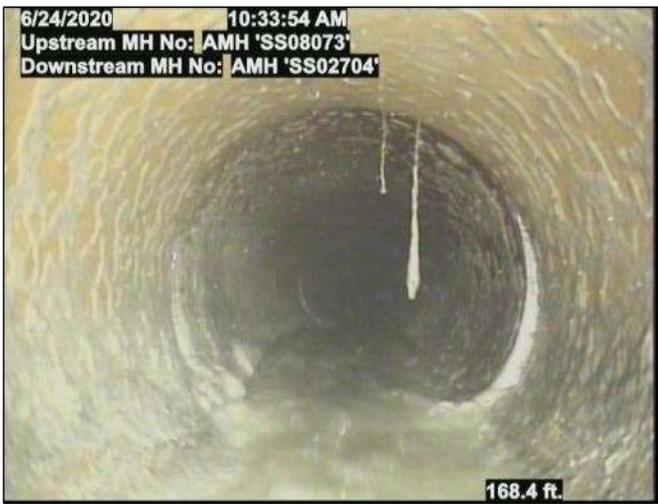
6/24/2020 10:33:54 AM
Upstream MH No: AMH 'SS08073'
Downstream MH No: AMH 'SS02704'
Photo: SS08073-SS02704-20200624-100353-103328_2.JPG
At: 166.4 ft. 9/1 RFJ - Roots Fine Joint
Joint: Yes

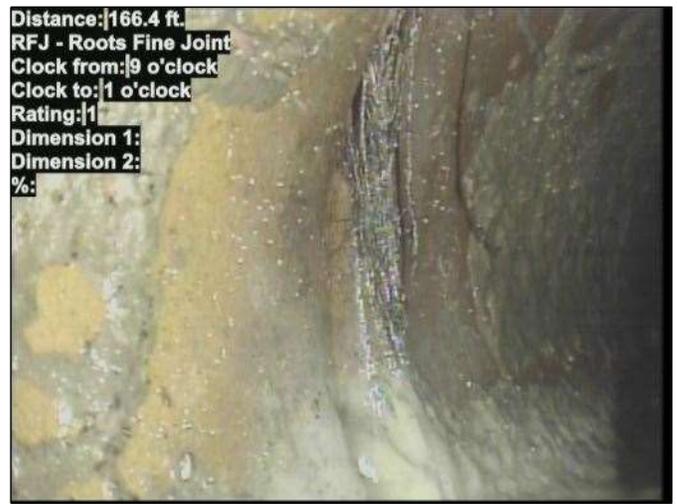
Distance: 166.4 ft.
RFJ - Roots Fine Joint
Clock from: 9 o'clock
Clock to: 1 o'clock
Rating: 1
Dimension 1:
Dimension 2:
%:
Photo: SS08073-SS02704-20200624-100353-103328_1.JPG
At: 166.4 ft. 9/1 RFJ - Roots Fine Joint
Joint: Yes

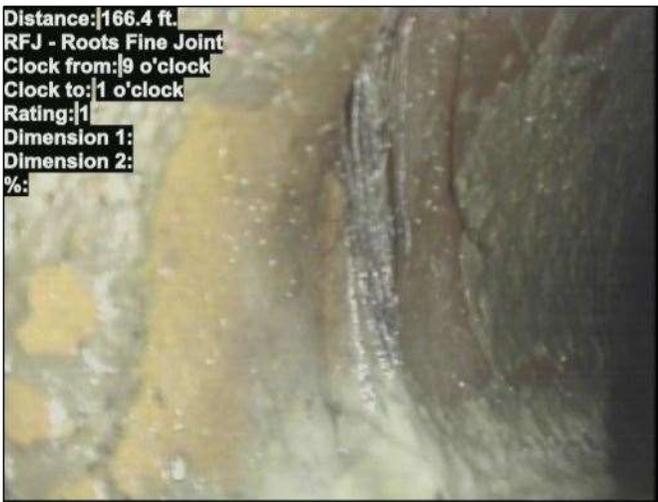
Distance: 166.4 ft.
RFJ - Roots Fine Joint
Clock from: 9 o'clock
Clock to: 1 o'clock
Rating: 1
Dimension 1:
Dimension 2:
%:
Photo: SS08073-SS02704-20200624-100353-103328.JPG
At: 166.4 ft. 9/1 RFJ - Roots Fine Joint
Joint: Yes

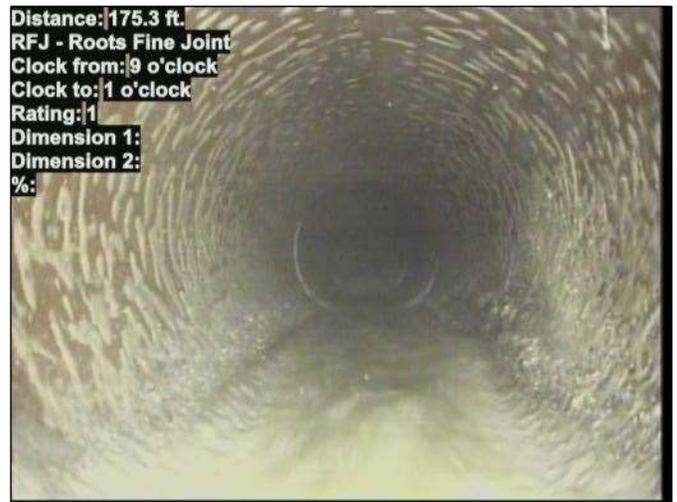
Distance: 175.3 ft.
RFJ - Roots Fine Joint
Clock from: 9 o'clock
Clock to: 1 o'clock
Rating: 1
Dimension 1:
Dimension 2:
%:
Photo: SS08073-SS02704-20200624-100353-103427.JPG
At: 175.3 ft. 9/1 RFJ - Roots Fine Joint
Joint: Yes

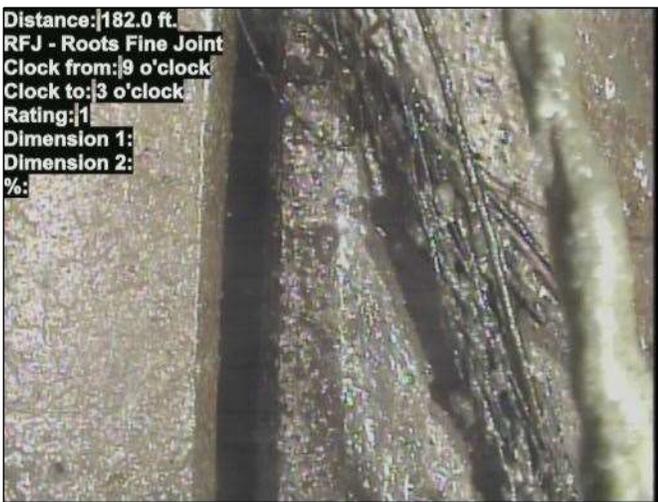
Distance: 182.0 ft.
RFJ - Roots Fine Joint
Clock from: 9 o'clock
Clock to: 3 o'clock
Rating: 1
Dimension 1:
Dimension 2:
%:
Photo: SS08073-SS02704-20200624-100353-103500.JPG
At: 182 ft. 9/3 RFJ - Roots Fine Joint
Joint: Yes

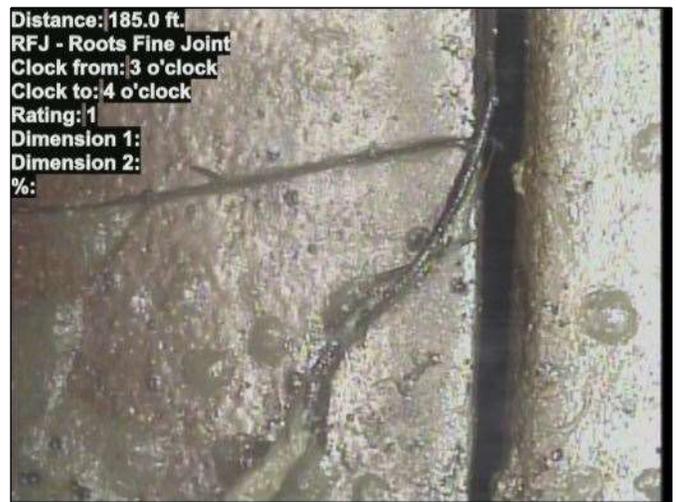
Distance: 185.0 ft.
RFJ - Roots Fine Joint
Clock from: 3 o'clock
Clock to: 4 o'clock
Rating: 1
Dimension 1:
Dimension 2:
%:
Photo: SS08073-SS02704-20200624-100353-103527.JPG
At: 185 ft. 3/4 RFJ - Roots Fine Joint
Joint: Yes

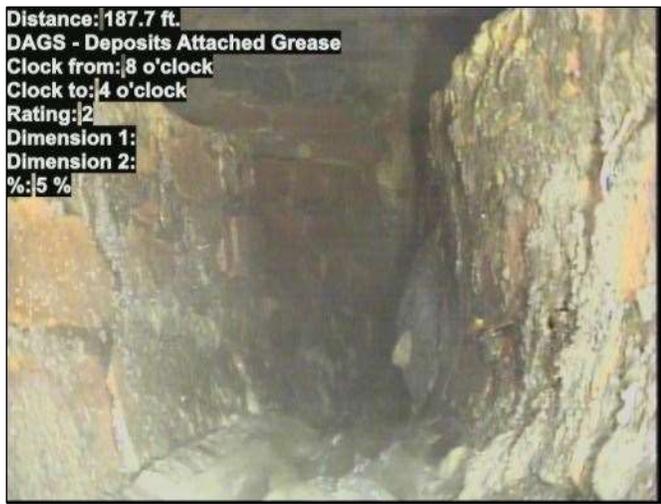
Distance: 187.7 ft.
DAGS - Deposits Attached Grease
Clock from: 8 o'clock
Clock to: 4 o'clock
Rating: 2
Dimension 1:
Dimension 2:
%: 5 %

Photo: SS08073-SS02704-20200624-100353-103551.JPG
At: 187.7 ft. 8/4 DAGS - Deposits Attached Grease
Joint: No 5 %

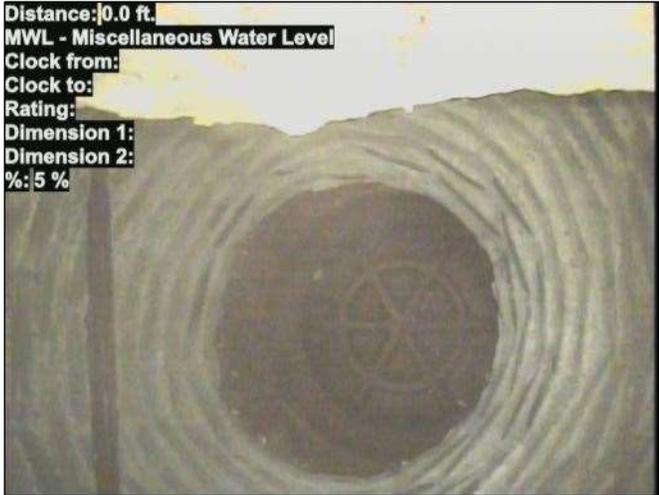
Photo: SS02704-SS02705-20200624-103910-103911.JPG
At: 0 ft. MWL - Miscellaneous Water Level
Joint: No 5 %

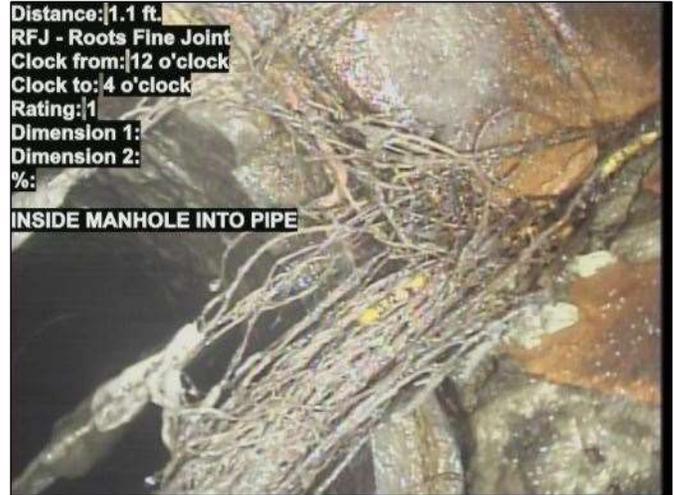
Photo: SS02704-SS02705-20200624-103910-104018.JPG
At: 1.1 ft. 12/4 RFJ - Roots Fine Joint
Joint: Yes INSIDE MANHOLE INTO PIPE

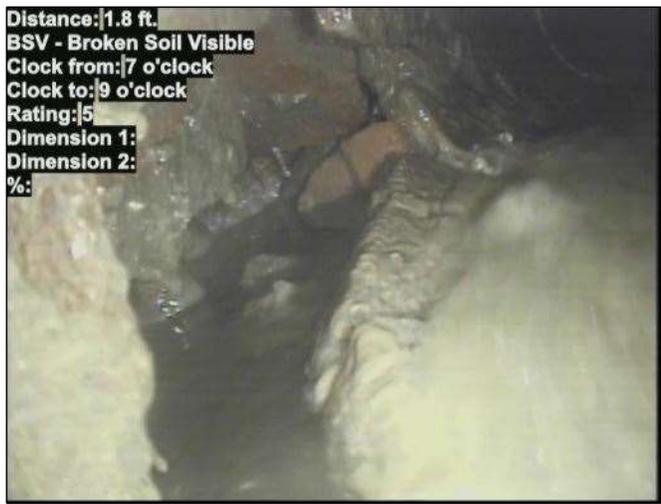
Distance:|1.8 ft.
BSV - Broken Soil Visible
Clock from:|7 o'clock
Clock to:|9 o'clock
Rating:|5
Dimension 1:
Dimension 2:
%:

Photo: SS02704-SS02705-20200624-103910-104041_1.JPG
At: 1.8 ft. 7/9 BSV - Broken Soil Visible
Joint: Yes

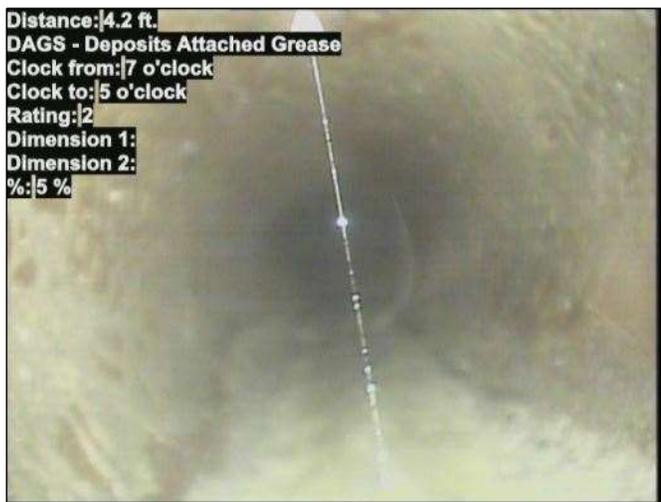
Distance:|4.2 ft.
DAGS - Deposits Attached Grease
Clock from:|7 o'clock
Clock to:|5 o'clock
Rating:|2
Dimension 1:
Dimension 2:
%:|5 %

Photo: SS02704-SS02705-20200624-103910-104201.JPG
At: 4.2 ft. 7/5 DAGS - Deposits Attached Grease
Joint: No 5 %

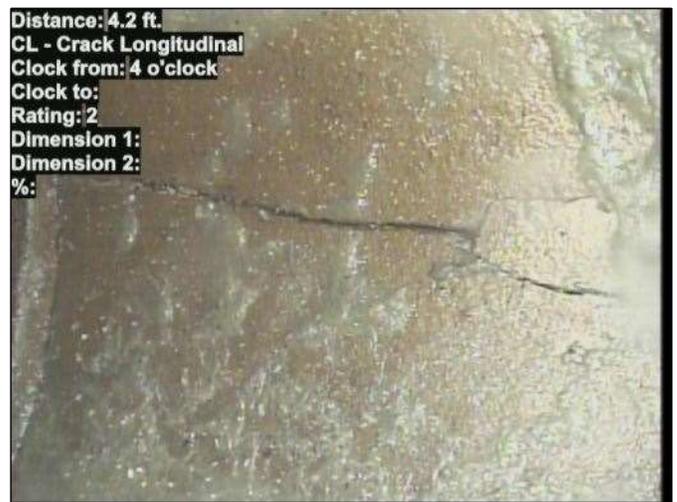
Distance:|4.2 ft.
CL - Crack Longitudinal
Clock from:|4 o'clock
Clock to:
Rating:|2
Dimension 1:
Dimension 2:
%:

Photo: SS02704-SS02705-20200624-103910-104152.JPG
At: 4.2 ft. 4/. CL - Crack Longitudinal
Joint: Yes

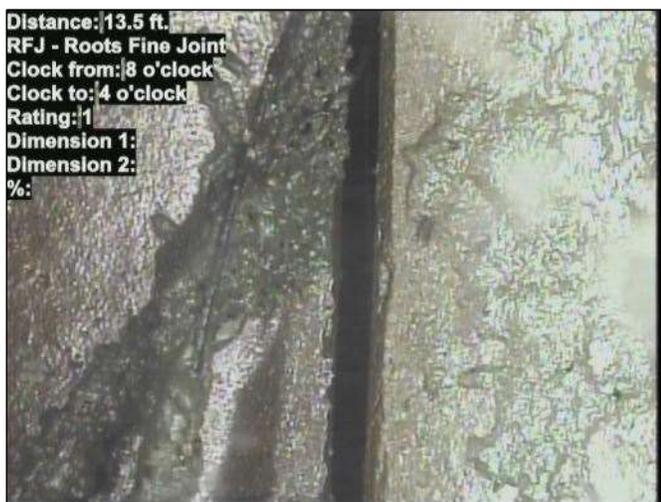
Distance:|13.5 ft.
RFJ - Roots Fine Joint
Clock from:|8 o'clock
Clock to:|4 o'clock
Rating:|1
Dimension 1:
Dimension 2:
%:

Photo: SS02704-SS02705-20200624-103910-104313.JPG
At: 13.5 ft. 8/4 RFJ - Roots Fine Joint
Joint: Yes

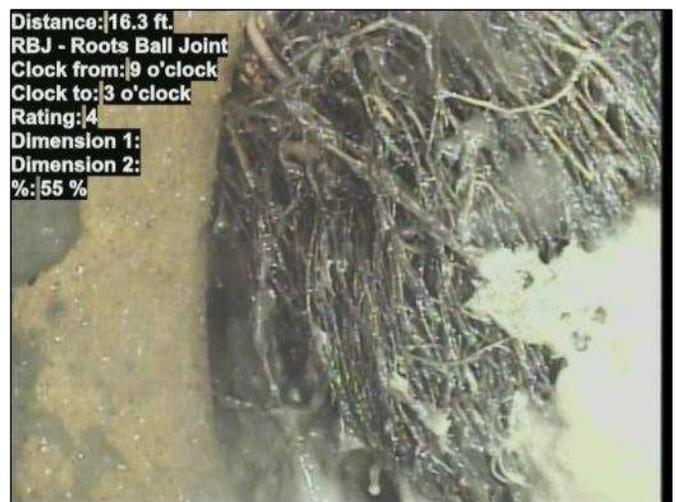
Distance:|16.3 ft.
RBJ - Roots Ball Joint
Clock from:|9 o'clock
Clock to:|3 o'clock
Rating:|4
Dimension 1:
Dimension 2:
%:|55 %

Photo: SS02704-SS02705-20200624-103910-104339.JPG
At: 16.3 ft. 9/3 RBJ - Roots Ball Joint
Joint: Yes 55 %

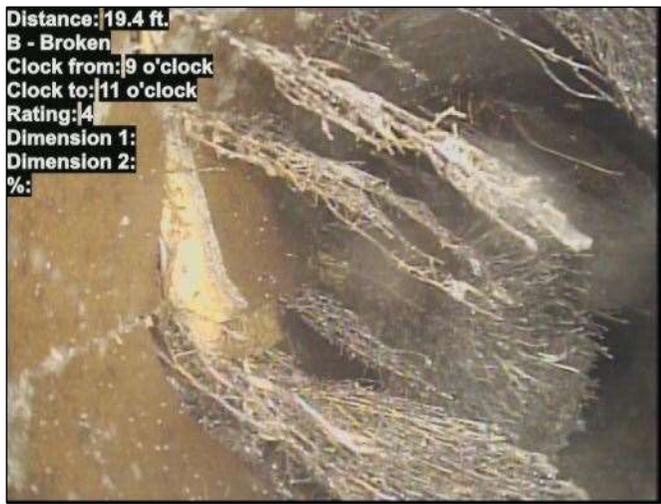
Photo: SS02704-SS02705-20200624-103910-104422_1.JPG
At: 19.4 ft. 9/11 B - Broken
Joint: Yes

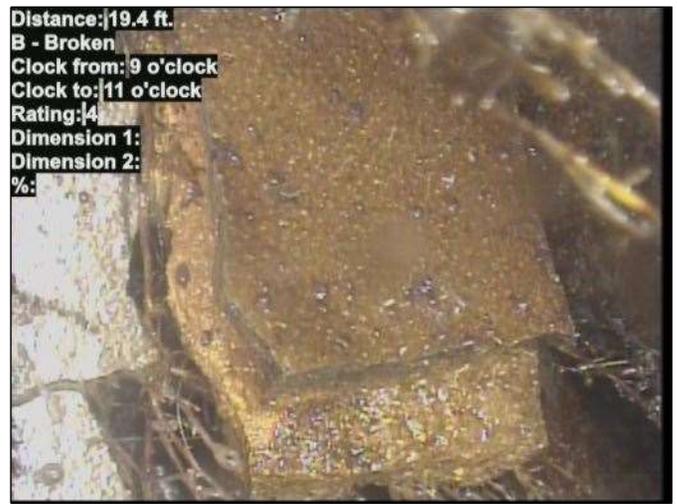
Photo: SS02704-SS02705-20200624-103910-104422.JPG
At: 19.4 ft. 9/11 B - Broken
Joint: Yes

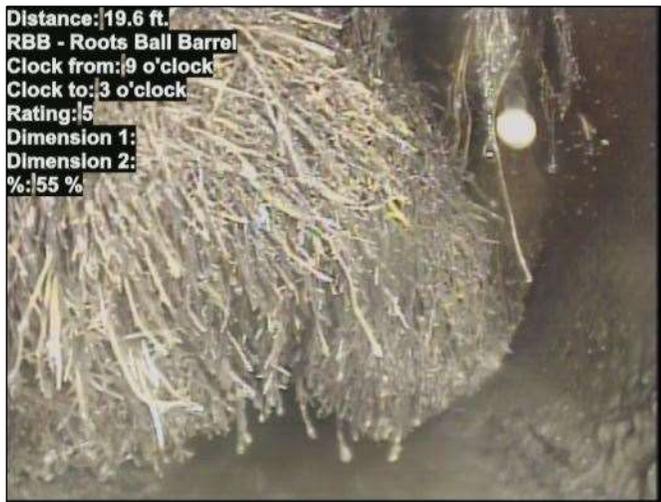
Photo: SS02704-SS02705-20200624-103910-104452.JPG
At: 19.6 ft. 9/3 RBB - Roots Ball Barrel
Joint: No 55 %

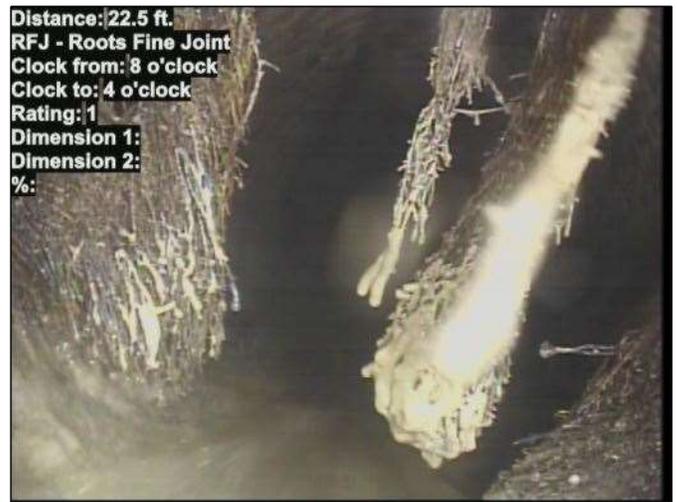
Photo: SS02704-SS02705-20200624-103910-104534_1.JPG
At: 22.5 ft. 8/4 RFJ - Roots Fine Joint
Joint: Yes

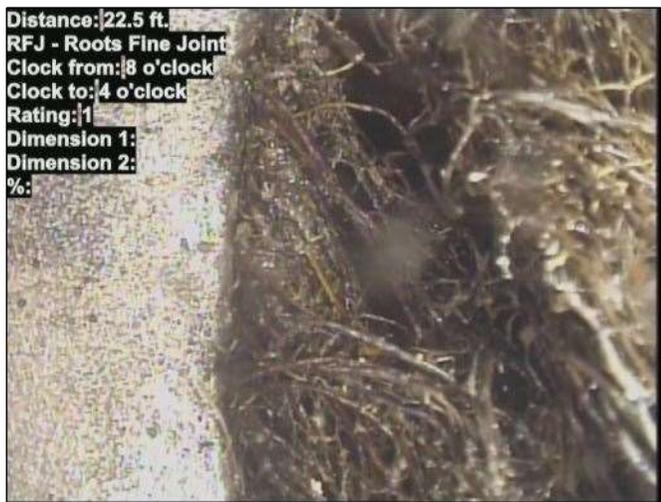
Photo: SS02704-SS02705-20200624-103910-104534.JPG
At: 22.5 ft. 8/4 RFJ - Roots Fine Joint
Joint: Yes

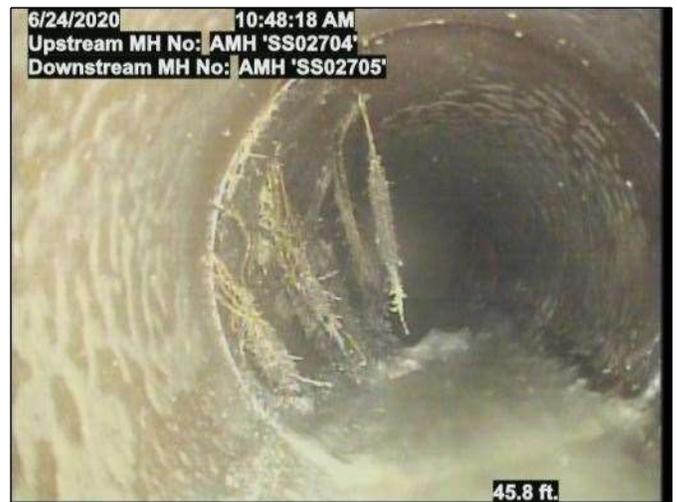
Photo: SS02704-SS02705-20200624-103910-104700_3.JPG
At: 34.9 ft. 8/4 RFJ - Roots Fine Joint
Joint: Yes

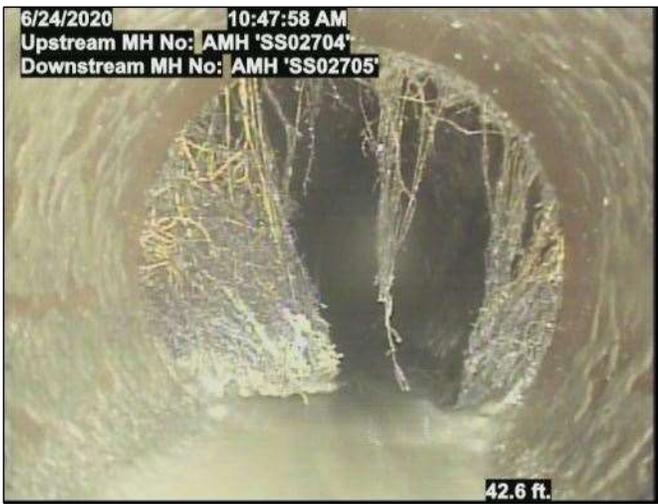
Photo: SS02704-SS02705-20200624-103910-104700_2.JPG
At: 34.9 ft. 8/4 RFJ - Roots Fine Joint
Joint: Yes

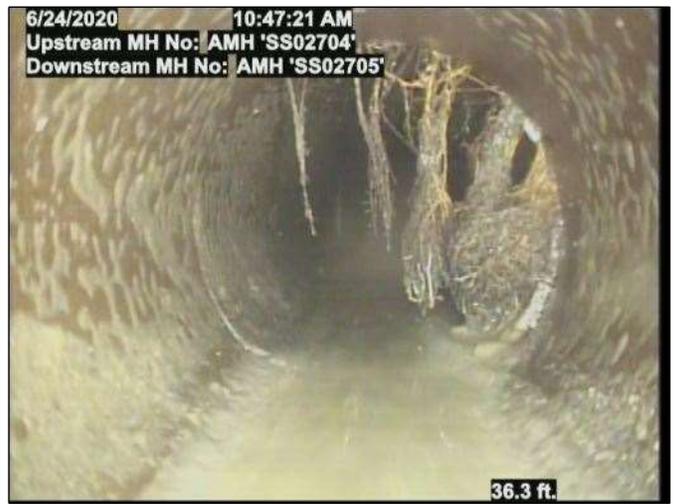
Photo: SS02704-SS02705-20200624-103910-104700_1.JPG
At: 34.9 ft. 8/4 RFJ - Roots Fine Joint
Joint: Yes

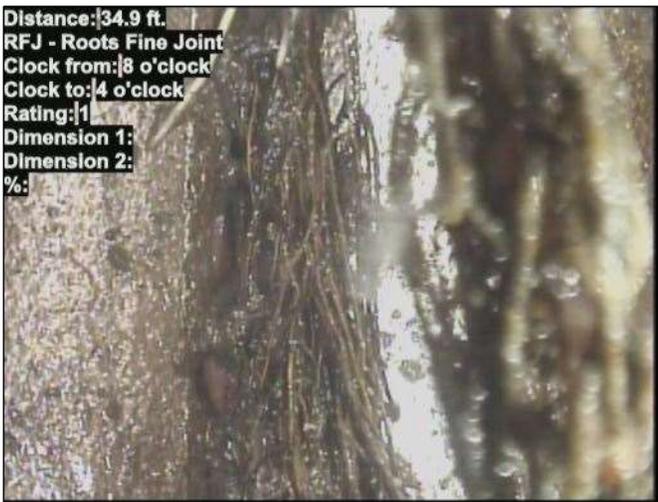
Photo: SS02704-SS02705-20200624-103910-104700.JPG
At: 34.9 ft. 8/4 RFJ - Roots Fine Joint
Joint: Yes

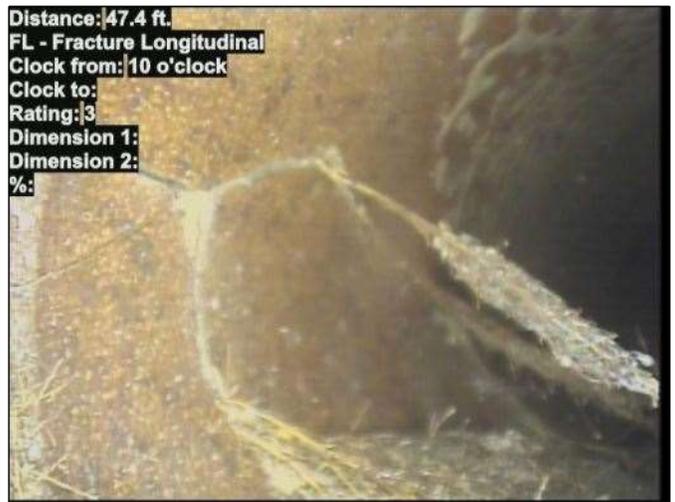
Photo: SS02704-SS02705-20200624-103910-104841_1.JPG
At: 47.4 ft. 10/. FL - Fracture Longitudinal
Joint: Yes

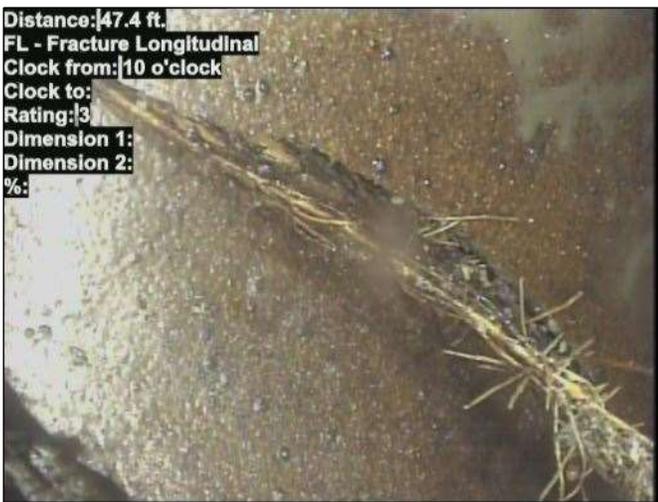
Photo: SS02704-SS02705-20200624-103910-104841.JPG
At: 47.4 ft. 10/. FL - Fracture Longitudinal
Joint: Yes

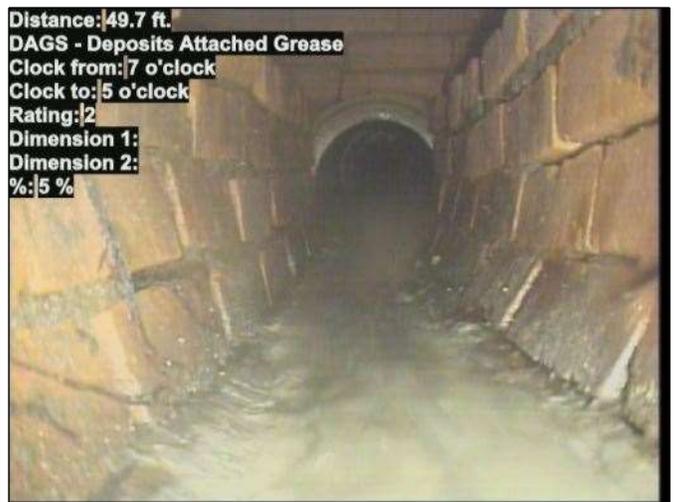
Photo: SS02704-SS02705-20200624-103910-104910.JPG
At: 49.7 ft. 7/5 DAGS - Deposits Attached Grease
Joint: No 5 %

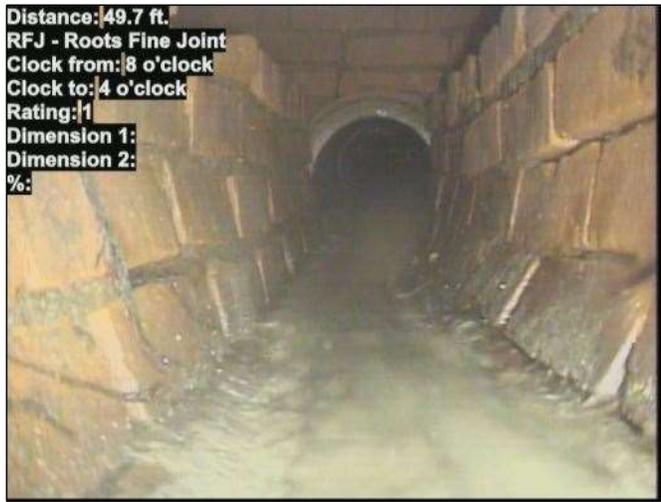
Distance: 49.7 ft.
RFJ - Roots Fine Joint
Clock from: 8 o'clock
Clock to: 4 o'clock
Rating: 1
Dimension 1:
Dimension 2:
%:

Photo: SS02704-SS02705-20200624-103910-104916.JPG
At: 49.7 ft. 8/4 RFJ - Roots Fine Joint
Joint: Yes

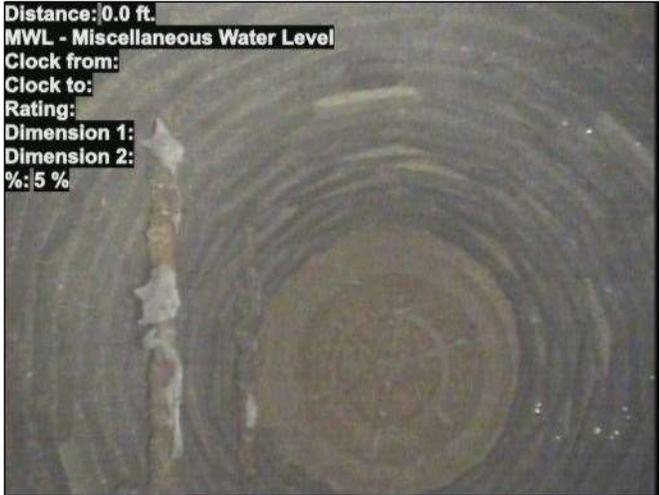
Photo: SS02705-SS02707-20200624-105315-105316.JPG
At: 0 ft. MWL - Miscellaneous Water Level
Joint: No 5 %

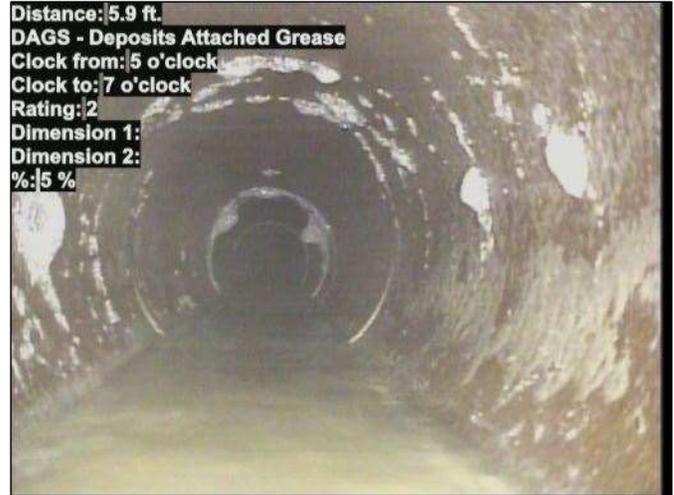
Photo: SS02705-SS02707-20200624-105315-105803.JPG
At: 5.9 ft. 5/7 DAGS - Deposits Attached Grease
Joint: No 5 %

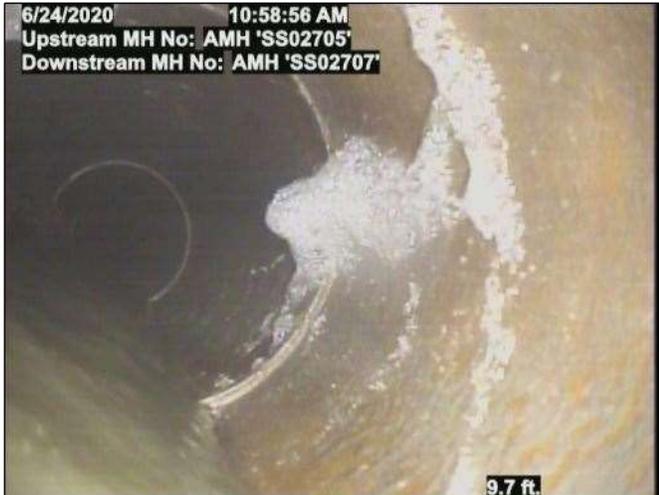
Photo: SS02705-SS02707-20200624-105315-105815_1.JPG
At: 6 ft. 9/3 DSC - Deposits Settled Hard/Compacted
Joint: No 5 % SMALL AMOUNTS OF HARD DEPOSITS STUCK TO PIPE

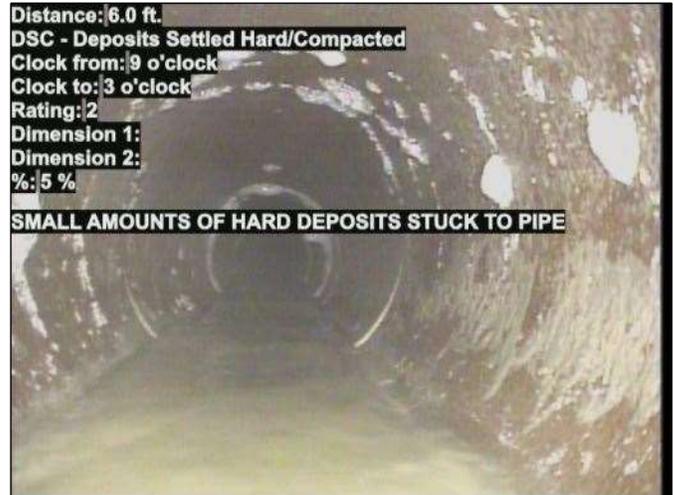
Photo: SS02705-SS02707-20200624-105315-105815.JPG
At: 6 ft. 9/3 DSC - Deposits Settled Hard/Compacted
Joint: No 5 % SMALL AMOUNTS OF HARD DEPOSITS STUCK TO PIPE

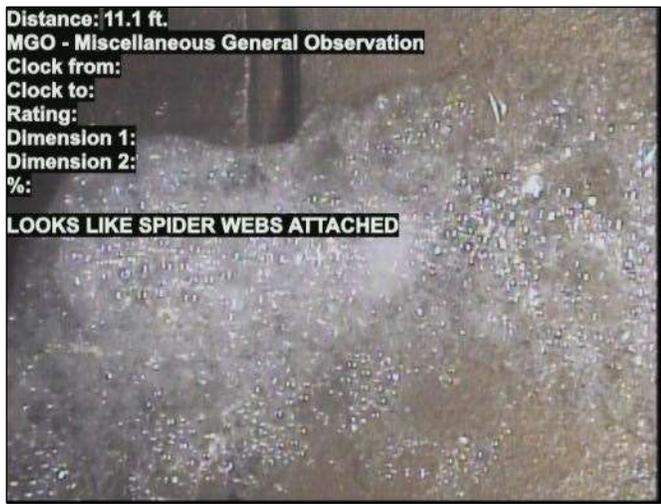
Distance: 11.1 ft.
MGO - Miscellaneous General Observation
Clock from:
Clock to:
Rating:
Dimension 1:
Dimension 2:
%:

LOOKS LIKE SPIDER WEBS ATTACHED

Photo: SS02705-SS02707-20200624-105315-105912.JPG
At: 11.1 ft. MGO - Miscellaneous General Observation
Joint: No LOOKS LIKE SPIDER WEBS ATTACHED

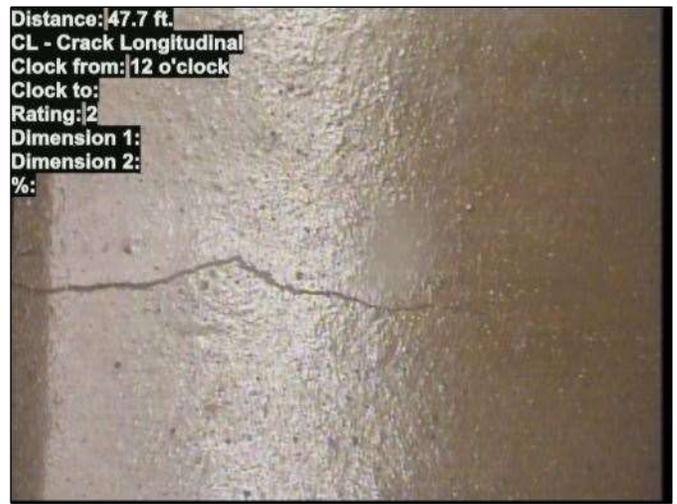
Distance: 47.7 ft.
CL - Crack Longitudinal
Clock from: 12 o'clock
Clock to:
Rating: 2
Dimension 1:
Dimension 2:
%:

Photo: SS02705-SS02707-20200624-105315-110215.JPG
At: 47.7 ft. 12/ CL - Crack Longitudinal
Joint: Yes

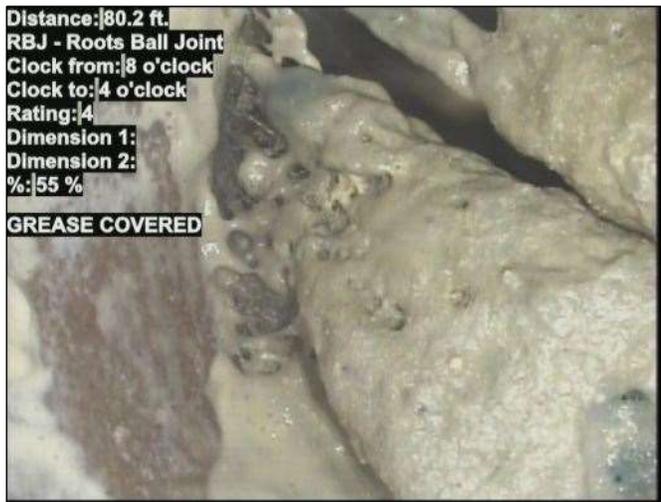
Distance: 80.2 ft.
RBJ - Roots Ball Joint
Clock from: 8 o'clock
Clock to: 4 o'clock
Rating: 4
Dimension 1:
Dimension 2:
%: 55 %

GREASE COVERED

Photo: SS02705-SS02707-20200624-105315-110609.JPG
At: 80.2 ft. 8/4 RBJ - Roots Ball Joint
Joint: Yes 55 % GREASE COVERED

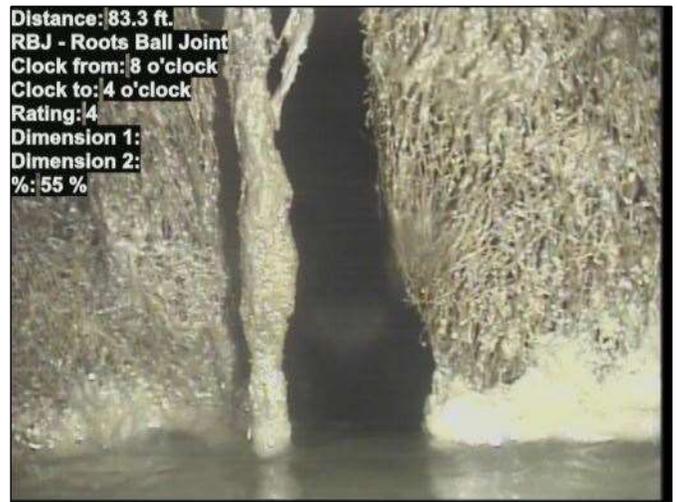
Distance: 83.3 ft.
RBJ - Roots Ball Joint
Clock from: 8 o'clock
Clock to: 4 o'clock
Rating: 4
Dimension 1:
Dimension 2:
%: 55 %

Photo: SS02705-SS02707-20200624-105315-110700.JPG
At: 83.3 ft. 8/4 RBJ - Roots Ball Joint
Joint: Yes 55 %

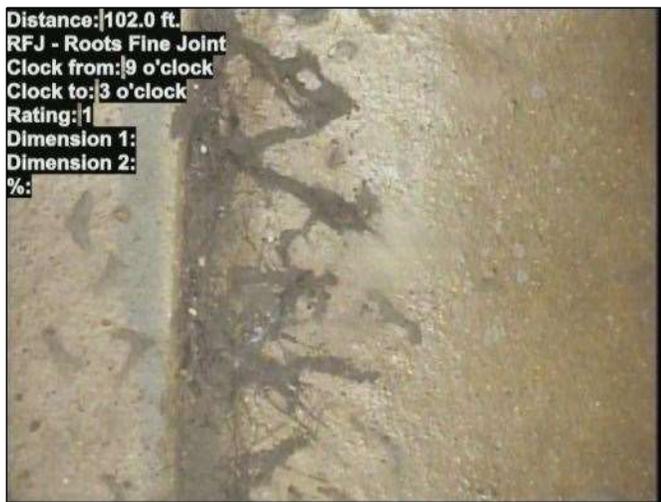
Distance: 102.0 ft.
RFJ - Roots Fine Joint
Clock from: 9 o'clock
Clock to: 3 o'clock
Rating: 1
Dimension 1:
Dimension 2:
%:

Photo: SS02705-SS02707-20200624-105315-110856.JPG
At: 102 ft. 9/3 RFJ - Roots Fine Joint
Joint: Yes

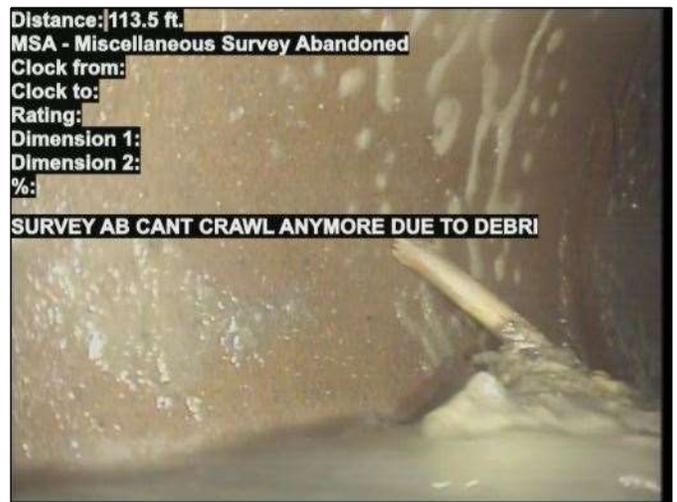
Distance: 113.5 ft.
MSA - Miscellaneous Survey Abandoned
Clock from:
Clock to:
Rating:
Dimension 1:
Dimension 2:
%:

SURVEY AB CANT CRAWL ANYMORE DUE TO DEBRI

Photo: SS02705-SS02707-20200624-105315-111915.JPG
At: 113.5 ft. MSA - Miscellaneous Survey Abandoned
Joint: No SURVEY AB CANT CRAWL ANYMORE DUE TO DEBRI

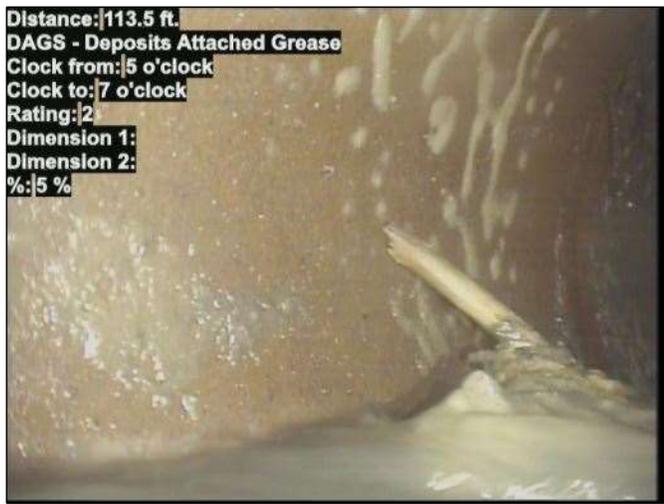
Photo: SS02705-SS02707-20200624-105315-111851.JPG

At: 113.5 ft. 5/7 DAGS - Deposits Attached Grease

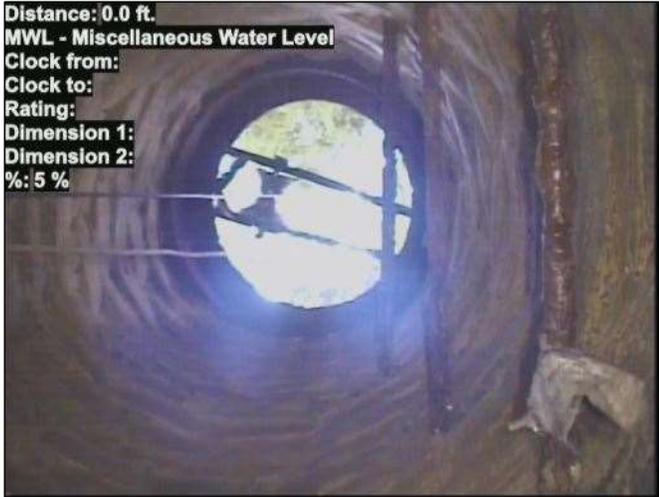
Distance: 0.0 ft.
MWL - Miscellaneous Water Level
Clock from:
Clock to:
Rating:
Dimension 1:
Dimension 2:
%: 5 %

Photo: SS08071-SS08072-20200624-083859-083901.JPG
At: 0 ft. MWL - Miscellaneous Water Level
Joint: No 5 %

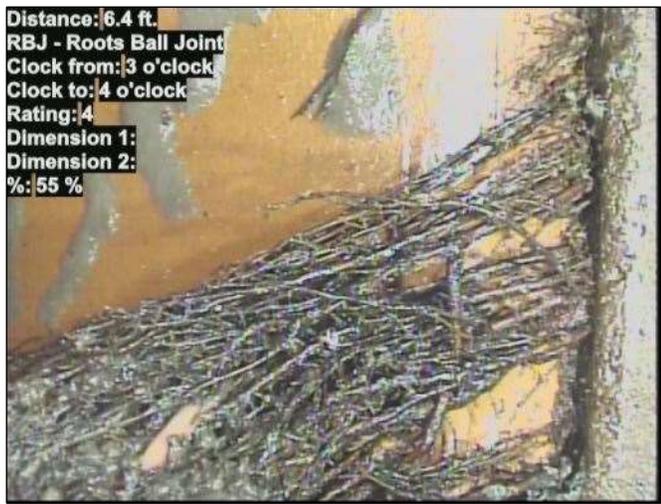
Distance: 6.4 ft.
RBJ - Roots Ball Joint
Clock from: 3 o'clock
Clock to: 4 o'clock
Rating: 4
Dimension 1:
Dimension 2:
%: 55 %

Photo: SS08071-SS08072-20200624-083859-084103_1.JPG
At: 6.4 ft. 3/4 RBJ - Roots Ball Joint
Joint: Yes 55 %
