APPENDIX A
TELEVISION INSPECTION LOGS

Main Inspections Pipe Run with Images

Project name: WEST05-65	Mainline ID: SM00768	City: WORCESTER MA	Street: ASH ST
Start date/time: 20190510-121424	Direction: D	Weather: 1	Location code:
Shape: C	Material: VCP	Height: 12 in.	Width:

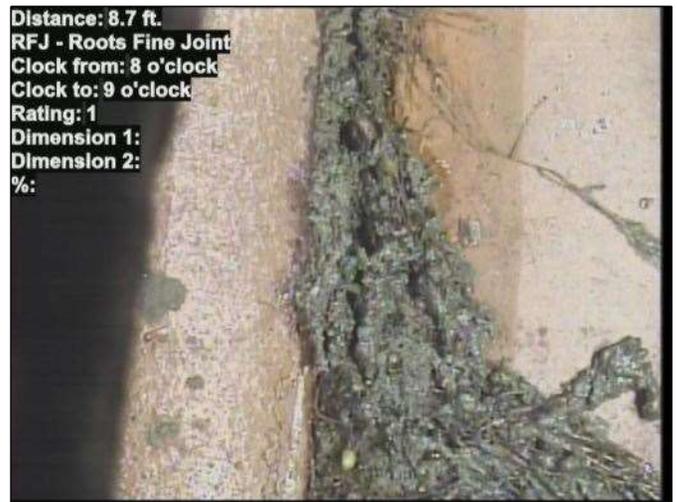
Distance: 8.7 ft.
RFJ - Roots Fine Joint
Clock from: 8 o'clock
Clock to: 9 o'clock
Rating: 1
Dimension 1:
Dimension 2:
%:

Photo: SS08071-SS08072-20200624-083859-084209_1.JPG
At: 8.7 ft. 8/9 RFJ - Roots Fine Joint
Joint: Yes

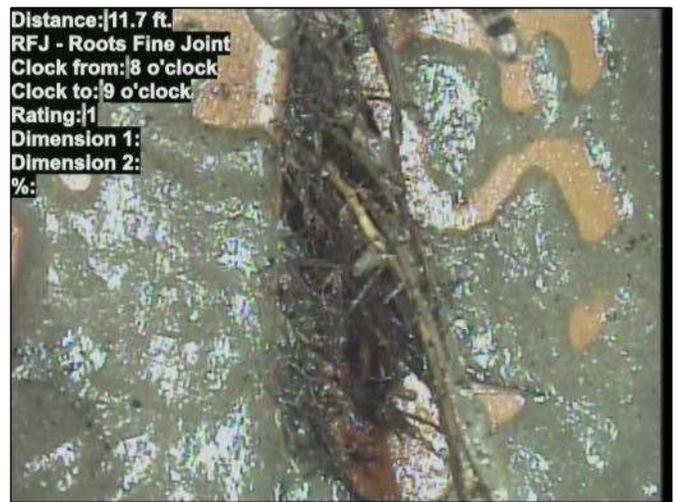
Distance: 11.7 ft.
RFJ - Roots Fine Joint
Clock from: 8 o'clock
Clock to: 9 o'clock
Rating: 1
Dimension 1:
Dimension 2:
%:

Photo: SS08071-SS08072-20200624-083859-084253_1.JPG
At: 11.7 ft. 8/9 RFJ - Roots Fine Joint
Joint: Yes

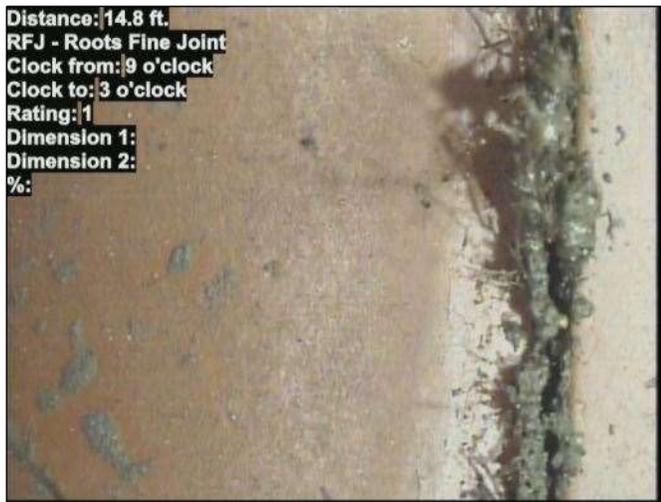
Distance: 14.8 ft.
RFJ - Roots Fine Joint
Clock from: 9 o'clock
Clock to: 3 o'clock
Rating: 1
Dimension 1:
Dimension 2:
%:

Photo: SS08071-SS08072-20200624-083859-084337_1.JPG
At: 14.8 ft. 9/3 RFJ - Roots Fine Joint
Joint: Yes

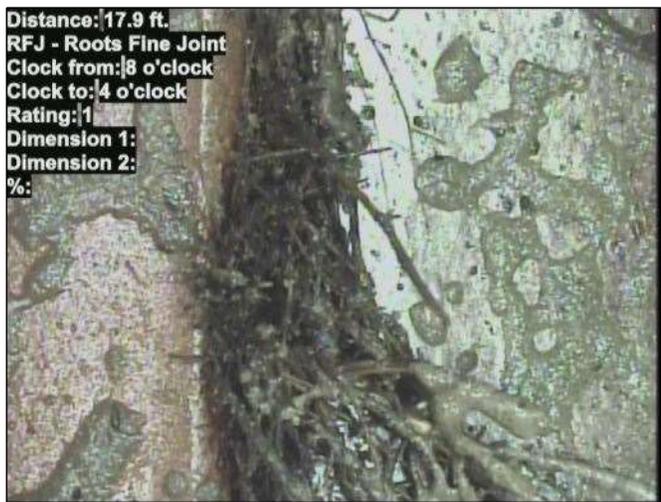
Distance: 17.9 ft.
RFJ - Roots Fine Joint
Clock from: 8 o'clock
Clock to: 4 o'clock
Rating: 1
Dimension 1:
Dimension 2:
%:

Photo: SS08071-SS08072-20200624-083859-084411_1.JPG
At: 17.9 ft. 8/4 RFJ - Roots Fine Joint
Joint: Yes

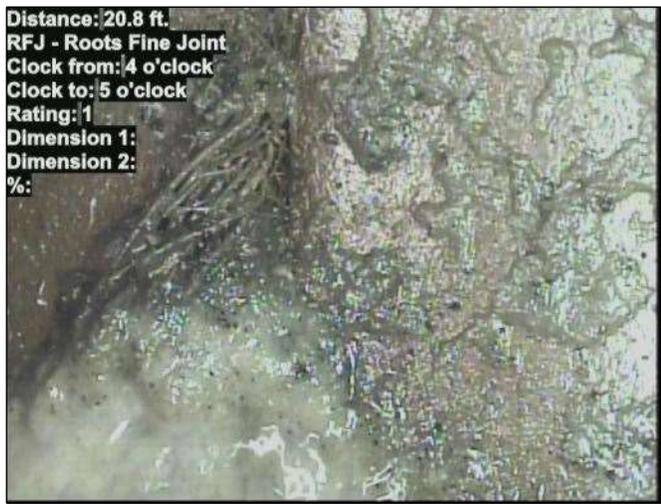
Photo: SS08071-SS08072-20200624-083859-084442_1.JPG
At: 20.8 ft. 4/5 RFJ - Roots Fine Joint
Joint: Yes

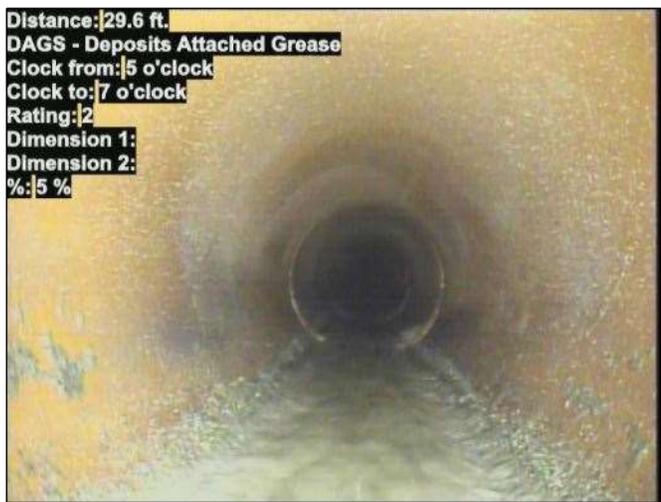
Photo: SS08071-SS08072-20200624-083859-084558_1.JPG
At: 29.6 ft. 5/7 DAGS - Deposits Attached Grease
Joint: No 5%

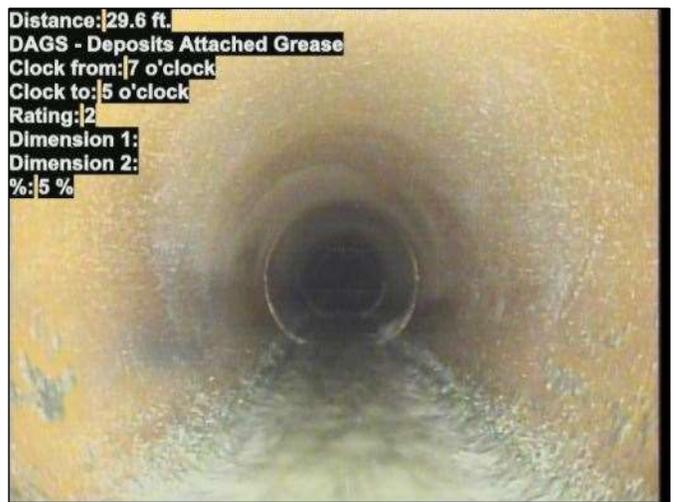
Photo: SS08071-SS08072-20200624-083859-084558.JPG
At: 29.6 ft. 5/7 DAGS - Deposits Attached Grease
Joint: No 5%

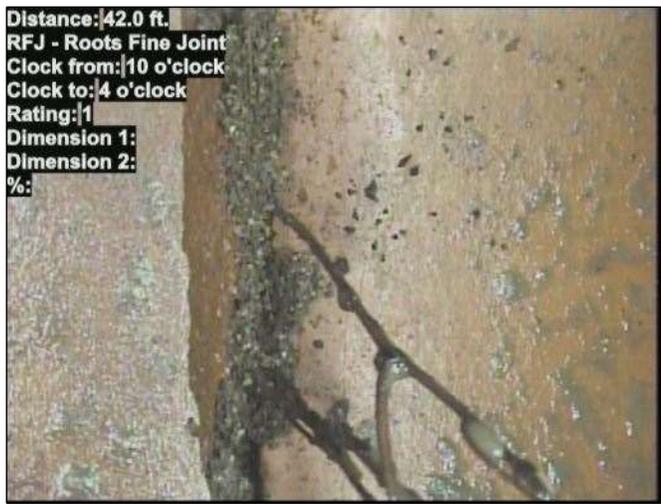
Photo: SS08071-SS08072-20200624-083859-084714_1.JPG
At: 42 ft. 10/4 RFJ - Roots Fine Joint
Joint: Yes

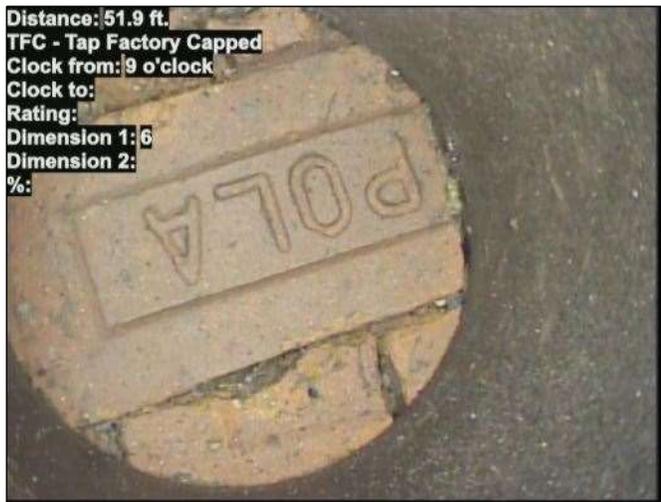
Photo: SS08071-SS08072-20200624-083859-084814_1.JPG
At: 51.9 ft. 9/ TFC - Tap Factory Capped
Joint: Yes

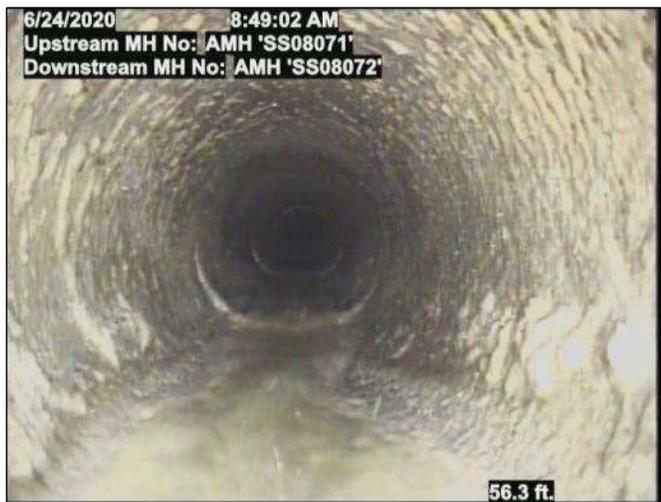
Photo: SS08071-SS08072-20200624-083859-084838_3.JPG
At: 53 ft. 9/ RFJ - Roots Fine Joint
Joint: Yes

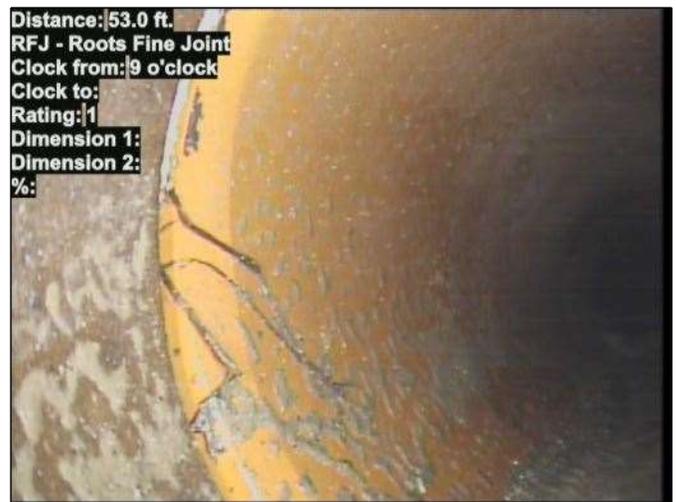
Photo: SS08071-SS08072-20200624-083859-084838_2.JPG
At: 53 ft. 9/ RFJ - Roots Fine Joint
Joint: Yes

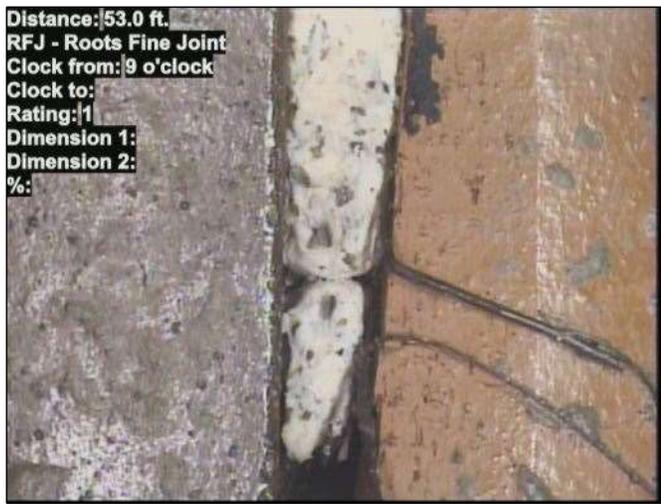
Photo: SS08071-SS08072-20200624-083859-084838_1.JPG
At: 53 ft. 9/ RFJ - Roots Fine Joint
Joint: Yes

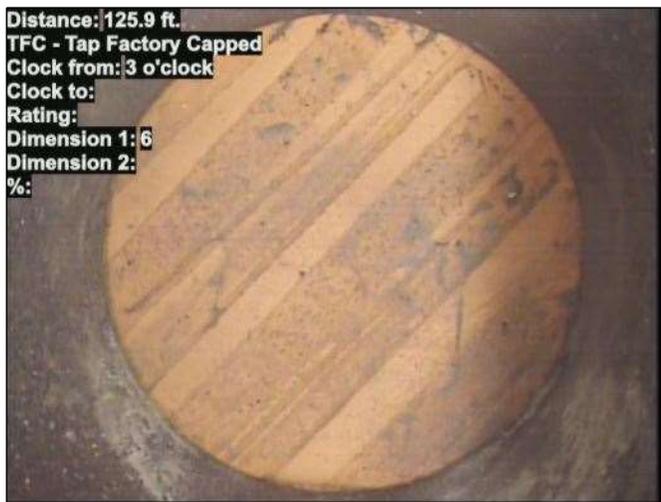
Distance: 125.9 ft.
TFC - Tap Factory Capped
Clock from: 3 o'clock
Clock to:
Rating:
Dimension 1: 6
Dimension 2:
%:

Photo: SS08071-SS08072-20200624-083859-091031_1.JPG
At: 125.9 ft. 3/. TFC - Tap Factory Capped
Joint: Yes

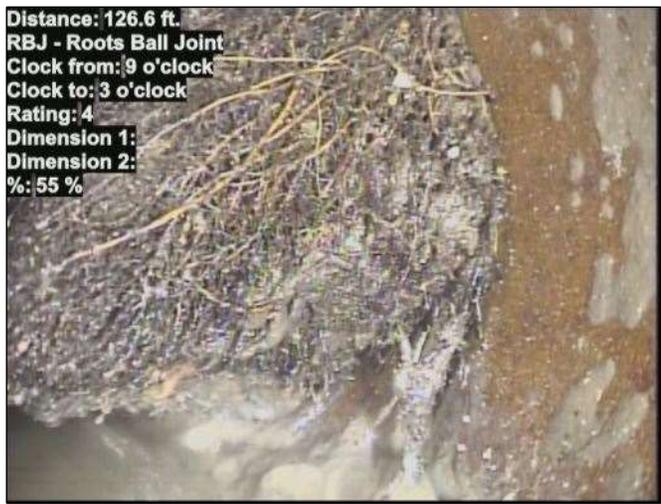
Distance: 126.6 ft.
RBJ - Roots Ball Joint
Clock from: 9 o'clock
Clock to: 3 o'clock
Rating: 4
Dimension 1:
Dimension 2:
%: 55 %

Photo: SS08071-SS08072-20200624-083859-091053_1.JPG
At: 126.6 ft. 9/3 RBJ - Roots Ball Joint
Joint: Yes 55 %

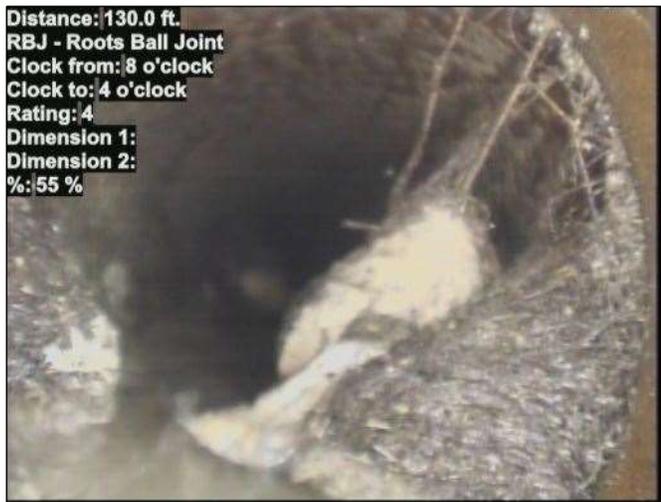
Distance: 130.0 ft.
RBJ - Roots Ball Joint
Clock from: 8 o'clock
Clock to: 4 o'clock
Rating: 4
Dimension 1:
Dimension 2:
%: 55 %

Photo: SS08071-SS08072-20200624-083859-091148_1.JPG
At: 130 ft. 8/4 RBJ - Roots Ball Joint
Joint: Yes 55 %

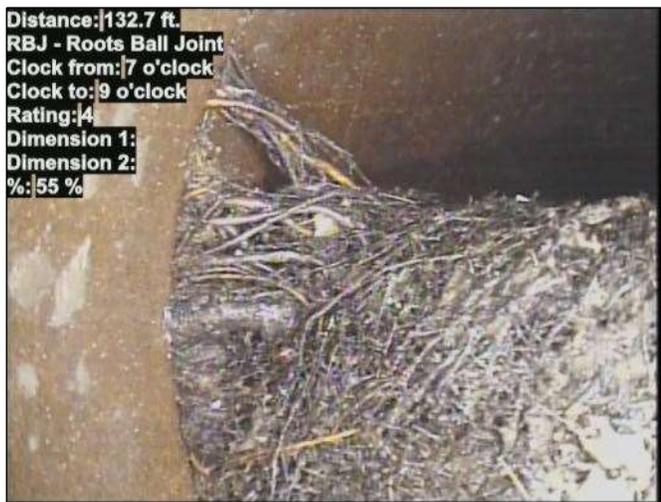
Distance: 132.7 ft.
RBJ - Roots Ball Joint
Clock from: 7 o'clock
Clock to: 9 o'clock
Rating: 4
Dimension 1:
Dimension 2:
%: 55 %

Photo: SS08071-SS08072-20200624-083859-091245_1.JPG
At: 132.7 ft. 7/9 RBJ - Roots Ball Joint
Joint: Yes 55 %

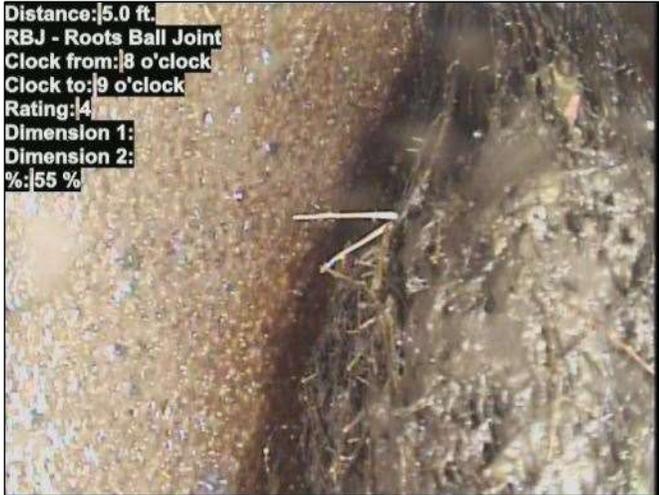
Photo: SS08071-SS08072-20200624-093144-093247.JPG
At: 5 ft. 8/9 RBJ - Roots Ball Joint
Joint: Yes 55 %

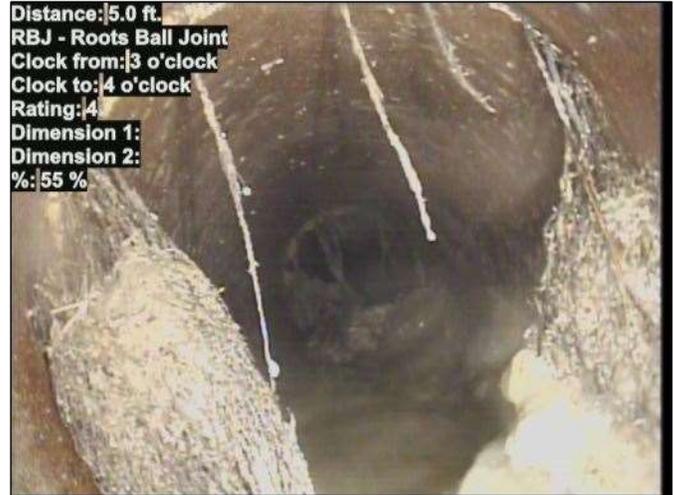
Photo: SS08071-SS08072-20200624-093144-093301_1.JPG
At: 5 ft. 3/4 RBJ - Roots Ball Joint
Joint: Yes 55 %

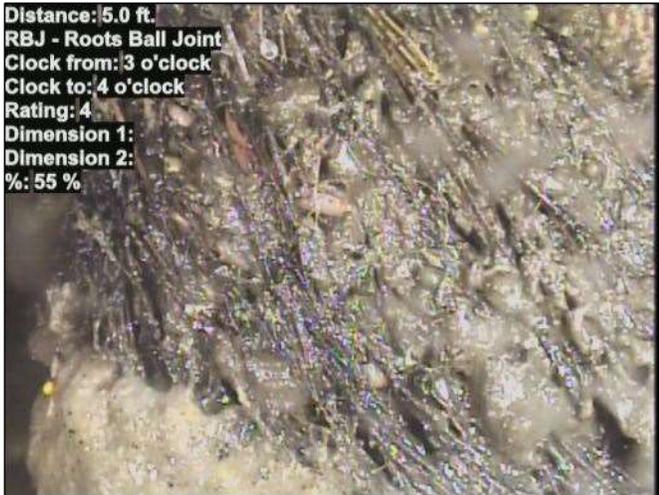
Photo: SS08071-SS08072-20200624-093144-093301.JPG
At: 5 ft. 3/4 RBJ - Roots Ball Joint
Joint: Yes 55 %

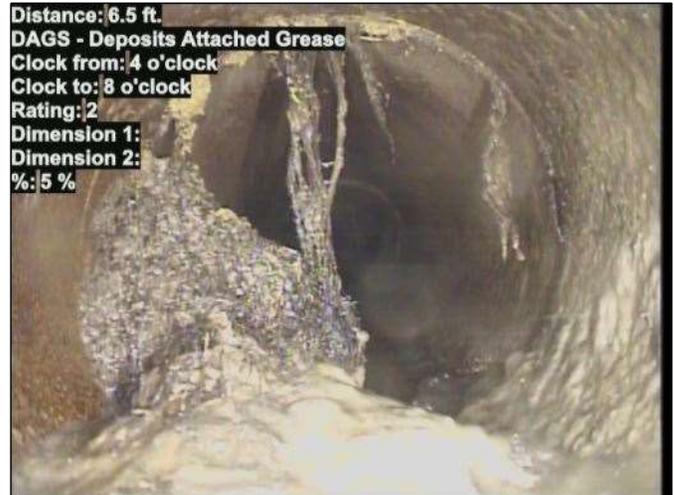
Photo: SS08071-SS08072-20200624-093144-093436.JPG
At: 6.5 ft. 4/8 DAGS - Deposits Attached Grease
Joint: No 5 %

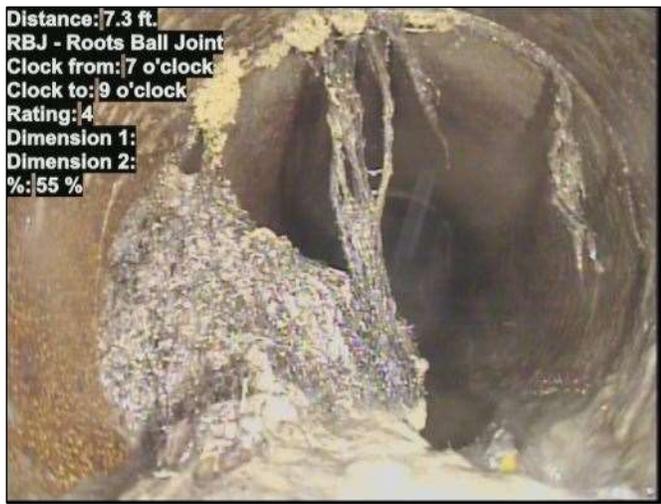
Photo: SS08071-SS08072-20200624-093144-093455_1.JPG
At: 7.3 ft. 7/9 RBJ - Roots Ball Joint
Joint: Yes 55 %

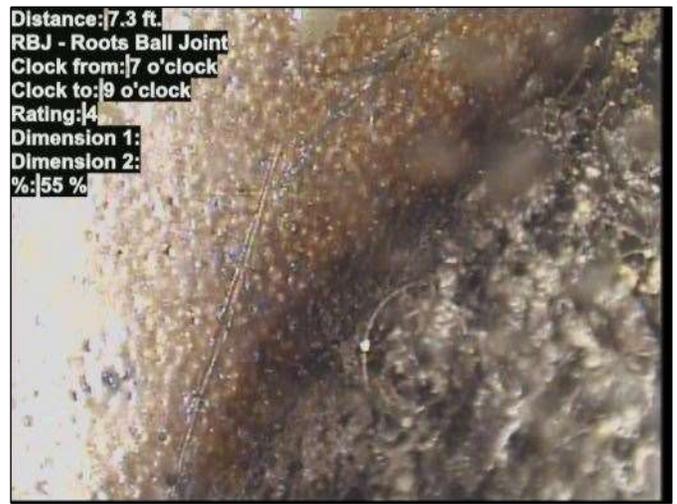
Photo: SS08071-SS08072-20200624-093144-093455.JPG
At: 7.3 ft. 7/9 RBJ - Roots Ball Joint
Joint: Yes 55 %

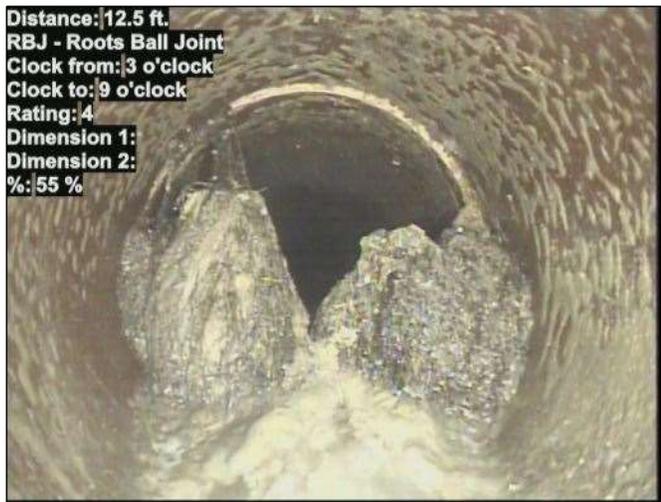
Photo: SS08071-SS08072-20200624-093144-093914_1.JPG
At: 12.5 ft. 3/9 RBJ - Roots Ball Joint
Joint: Yes 55 %

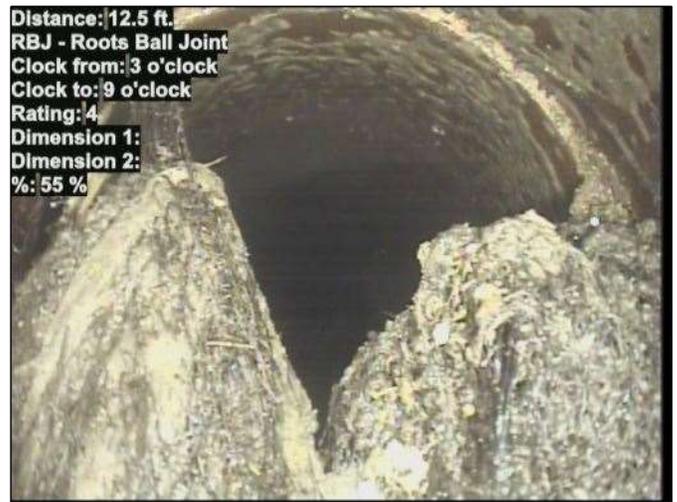
Photo: SS08071-SS08072-20200624-093144-093914.JPG
At: 12.5 ft. 3/9 RBJ - Roots Ball Joint
Joint: Yes 55 %

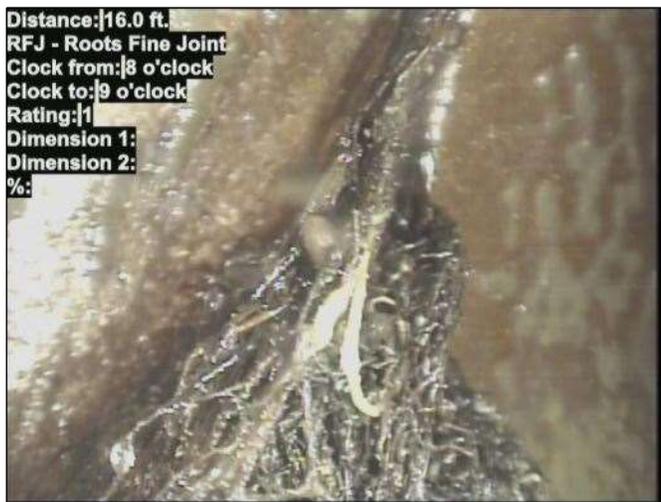
Photo: SS08071-SS08072-20200624-093144-093957.JPG
At: 16 ft. 8/9 RFJ - Roots Fine Joint
Joint: Yes

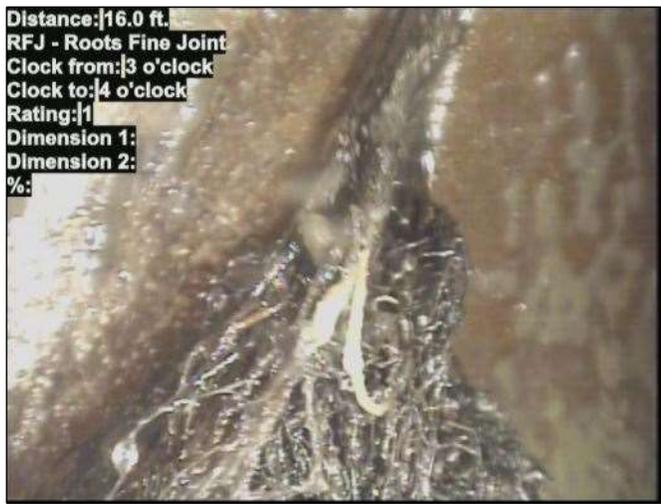
Distance: 16.0 ft.
RFJ - Roots Fine Joint
Clock from: 3 o'clock
Clock to: 4 o'clock
Rating: 1
Dimension 1:
Dimension 2:
%:

Photo: SS08071-SS08072-20200624-093144-094003.JPG
At: 16 ft. 3/4 RFJ - Roots Fine Joint
Joint: Yes

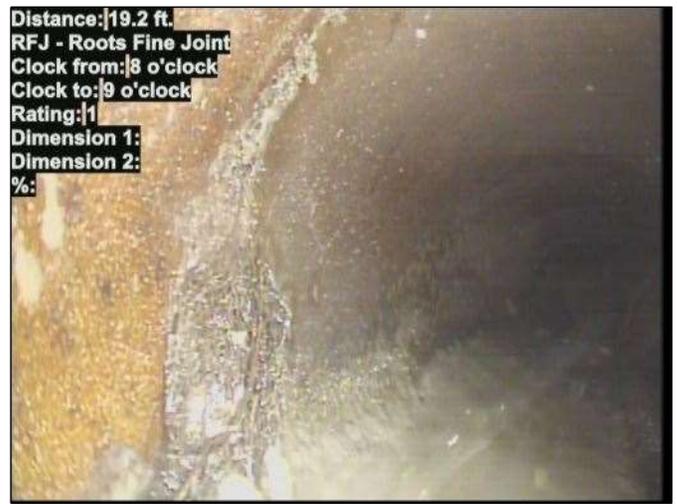
Distance: 19.2 ft.
RFJ - Roots Fine Joint
Clock from: 8 o'clock
Clock to: 9 o'clock
Rating: 1
Dimension 1:
Dimension 2:
%:

Photo: SS08071-SS08072-20200624-093144-094042_1.JPG
At: 19.2 ft. 8/9 RFJ - Roots Fine Joint
Joint: Yes

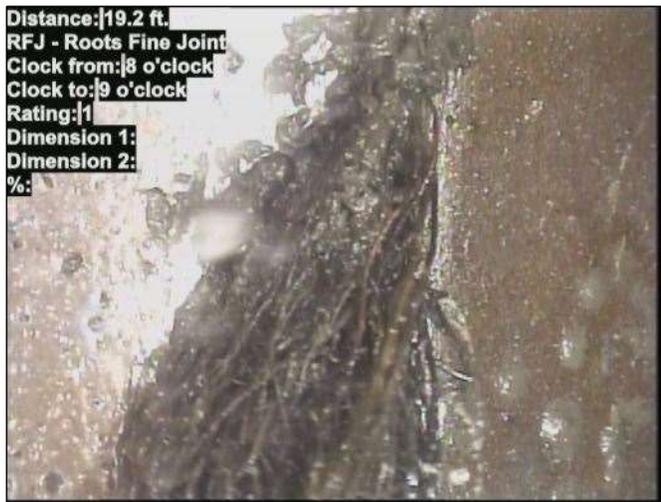
Distance: 19.2 ft.
RFJ - Roots Fine Joint
Clock from: 8 o'clock
Clock to: 9 o'clock
Rating: 1
Dimension 1:
Dimension 2:
%:

Photo: SS08071-SS08072-20200624-093144-094042.JPG
At: 19.2 ft. 8/9 RFJ - Roots Fine Joint
Joint: Yes

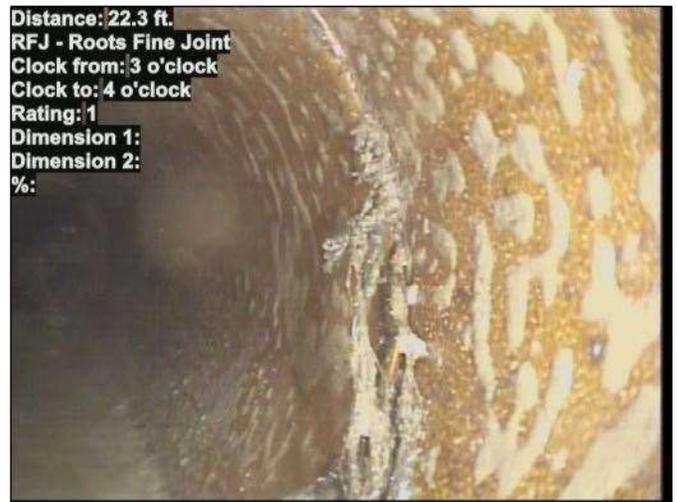
Distance: 22.3 ft.
RFJ - Roots Fine Joint
Clock from: 3 o'clock
Clock to: 4 o'clock
Rating: 1
Dimension 1:
Dimension 2:
%:

Photo: SS08071-SS08072-20200624-093144-094110_1.JPG
At: 22.3 ft. 3/4 RFJ - Roots Fine Joint
Joint: Yes

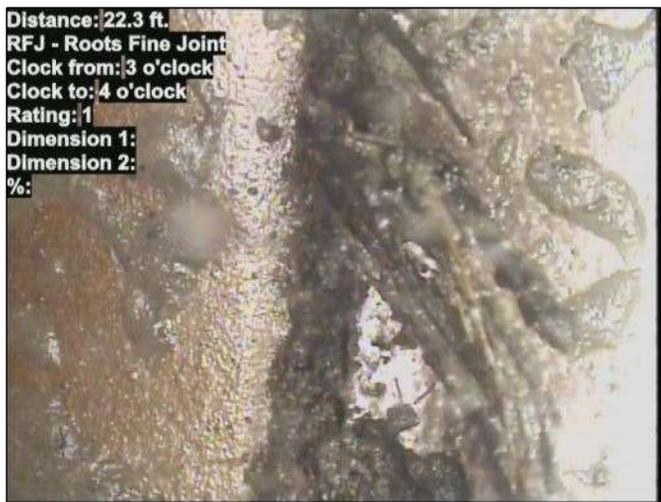
Distance: 22.3 ft.
RFJ - Roots Fine Joint
Clock from: 3 o'clock
Clock to: 4 o'clock
Rating: 1
Dimension 1:
Dimension 2:
%:

Photo: SS08071-SS08072-20200624-093144-094110.JPG
At: 22.3 ft. 3/4 RFJ - Roots Fine Joint
Joint: Yes

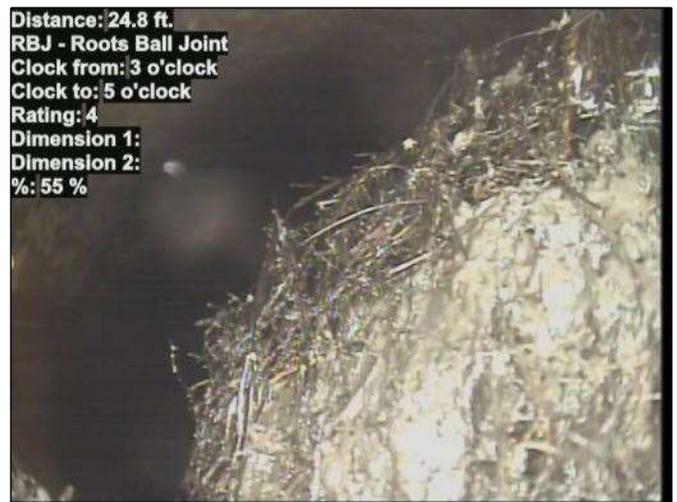
Distance: 24.8 ft.
RBJ - Roots Ball Joint
Clock from: 3 o'clock
Clock to: 5 o'clock
Rating: 4
Dimension 1:
Dimension 2:
%: 55 %

Photo: SS08071-SS08072-20200624-093144-094134.JPG
At: 24.8 ft. 3/5 RBJ - Roots Ball Joint
Joint: Yes 55 %

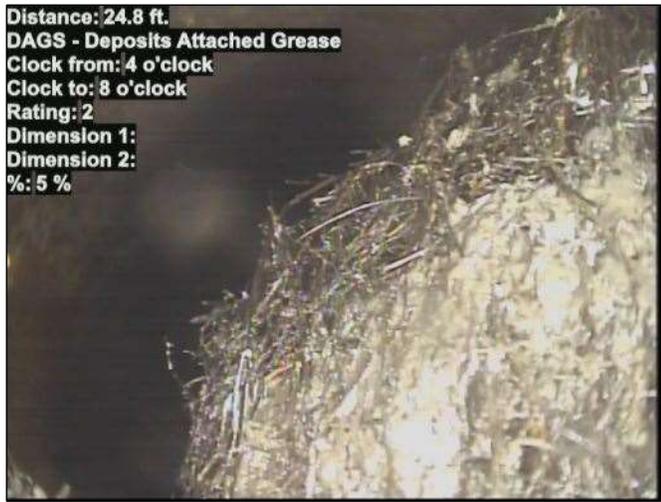
Photo: SS08071-SS08072-20200624-093144-094143.JPG
At: 24.8 ft. 4/8 DAGS - Deposits Attached Grease
Joint: No 5 %

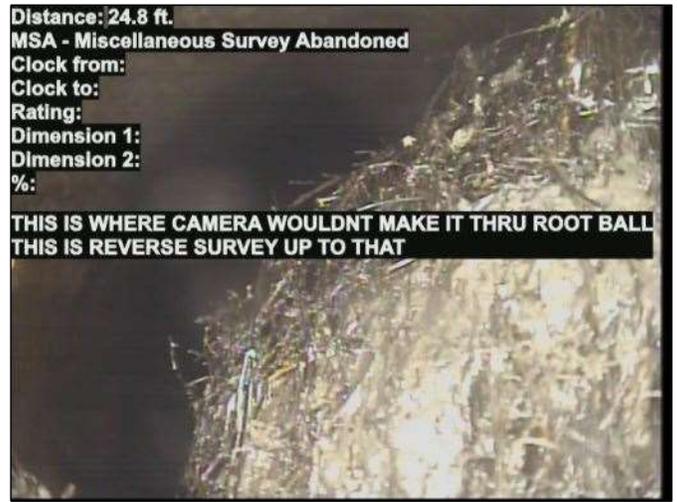
Photo: SS08071-SS08072-20200624-093144-094149.JPG
At: 24.8 ft. MSA - Miscellaneous Survey Abandoned
Joint: No THIS IS WHERE CAMERA WOULDNT MAKE IT THRU ROOT BALL THIS IS REVERSE SURVEY UP TO THAT

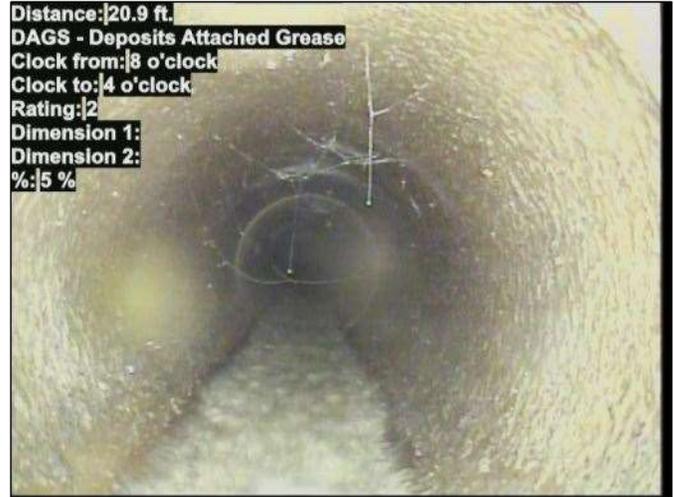
Distance: 20.9 ft.
DAGS - Deposits Attached Grease
Clock from: 8 o'clock
Clock to: 4 o'clock
Rating: 2
Dimension 1:
Dimension 2:
%: 5 %
Photo: SS06393-SS06394-20200624-125306-130349.JPG
At: 20.9 ft. 8/4 DAGS - Deposits Attached Grease
Joint: No 5 %

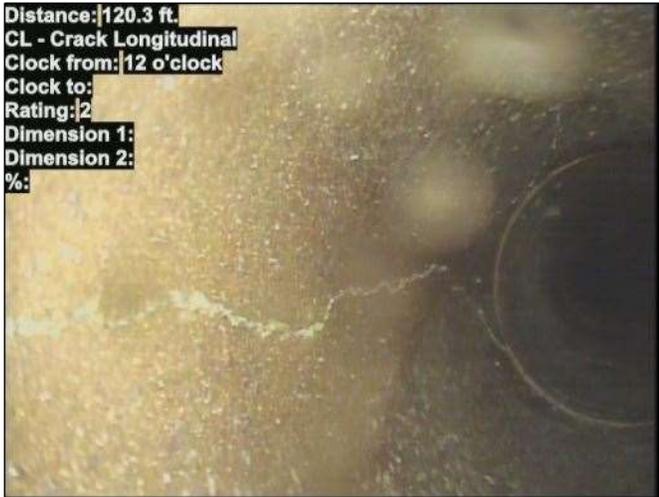
Distance: 120.3 ft.
CL - Crack Longitudinal
Clock from: 12 o'clock
Clock to:
Rating: 2
Dimension 1:
Dimension 2:
%:
Photo: SS06393-SS06394-20200624-125306-131305_3.JPG
At: 120.3 ft. 12/. CL - Crack Longitudinal
Joint: Yes

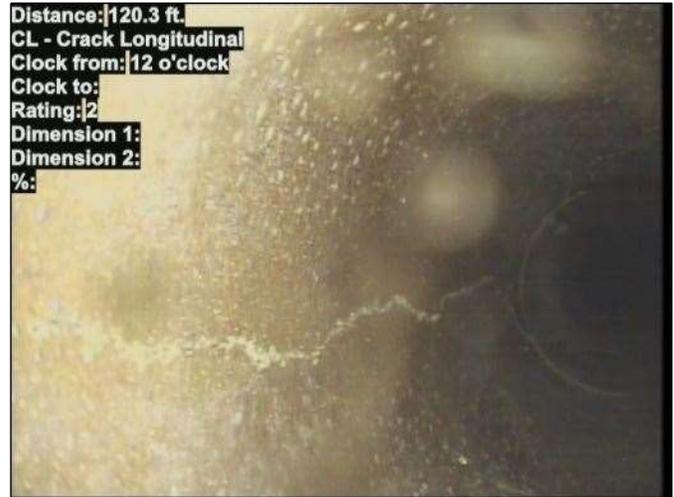
Distance: 120.3 ft.
CL - Crack Longitudinal
Clock from: 12 o'clock
Clock to:
Rating: 2
Dimension 1:
Dimension 2:
%:
Photo: SS06393-SS06394-20200624-125306-131305_2.JPG
At: 120.3 ft. 12/. CL - Crack Longitudinal
Joint: Yes

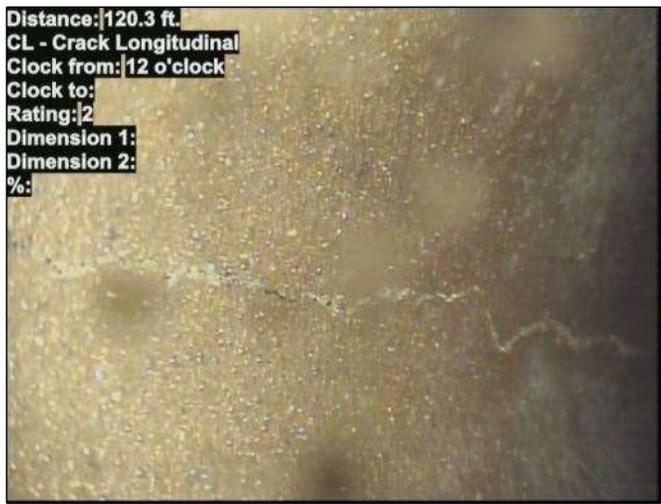
Distance: 120.3 ft.
CL - Crack Longitudinal
Clock from: 12 o'clock
Clock to:
Rating: 2
Dimension 1:
Dimension 2:
%:

Photo: SS06393-SS06394-20200624-125306-131305_1.JPG
At: 120.3 ft. 12/. CL - Crack Longitudinal
Joint: Yes

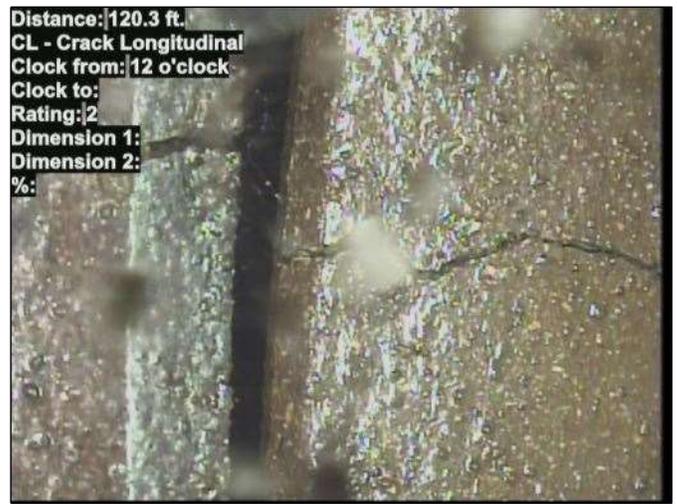
Distance: 120.3 ft.
CL - Crack Longitudinal
Clock from: 12 o'clock
Clock to:
Rating: 2
Dimension 1:
Dimension 2:
%:

Photo: SS06393-SS06394-20200624-125306-131305.JPG
At: 120.3 ft. 12/. CL - Crack Longitudinal
Joint: Yes

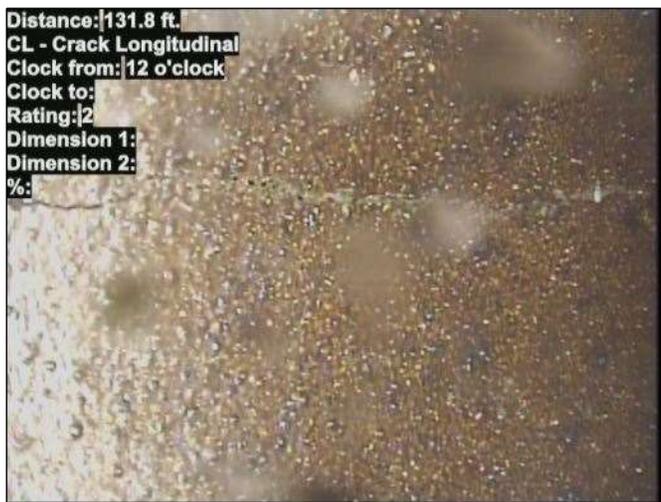
Distance: 131.8 ft.
CL - Crack Longitudinal
Clock from: 12 o'clock
Clock to:
Rating: 2
Dimension 1:
Dimension 2:
%:

Photo: SS06393-SS06394-20200624-125306-131426.JPG
At: 131.8 ft. 12/. CL - Crack Longitudinal
Joint: Yes

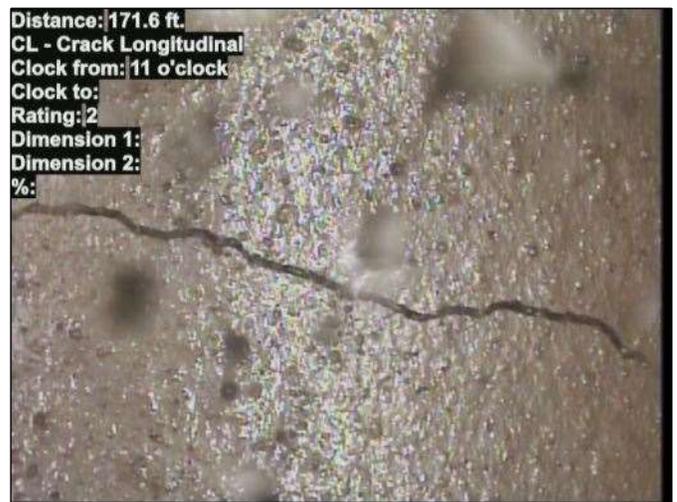
Distance: 171.6 ft.
CL - Crack Longitudinal
Clock from: 11 o'clock
Clock to:
Rating: 2
Dimension 1:
Dimension 2:
%:

Photo: SS06393-SS06394-20200624-125306-131800.JPG
At: 171.6 ft. 11/. CL - Crack Longitudinal
Joint: Yes

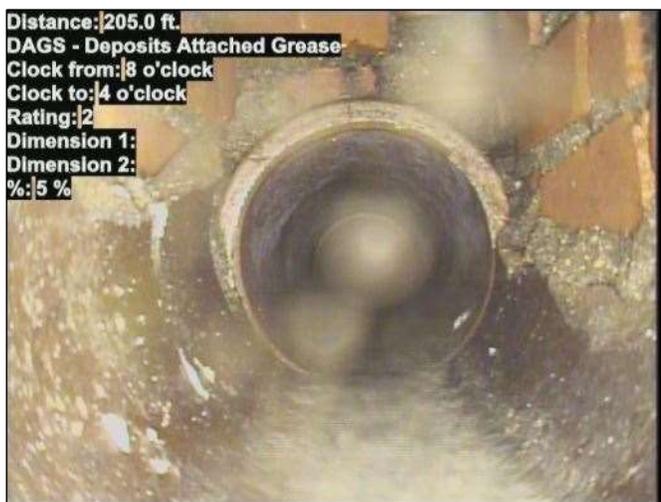
Distance: 205.0 ft.
DAGS - Deposits Attached Grease
Clock from: 8 o'clock
Clock to: 4 o'clock
Rating: 2
Dimension 1:
Dimension 2:
%: 5 %

Photo: SS06393-SS06394-20200624-125306-132146.JPG
At: 205 ft. 8/4 DAGS - Deposits Attached Grease
Joint: No 5 %

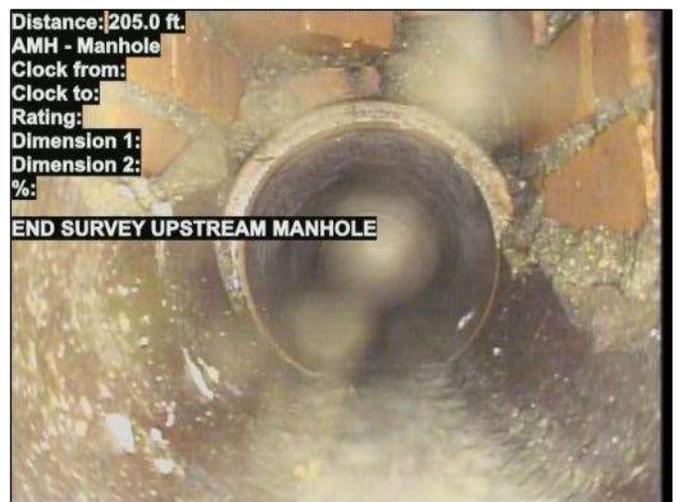
Distance: 205.0 ft.
AMH - Manhole
Clock from:
Clock to:
Rating:
Dimension 1:
Dimension 2:
%:

END SURVEY UPSTREAM MANHOLE
