WORCESTER CONSERVATION COMMISSION

# Fitzgerald Brook

Conservation Property Baseline Assessment

July 2024

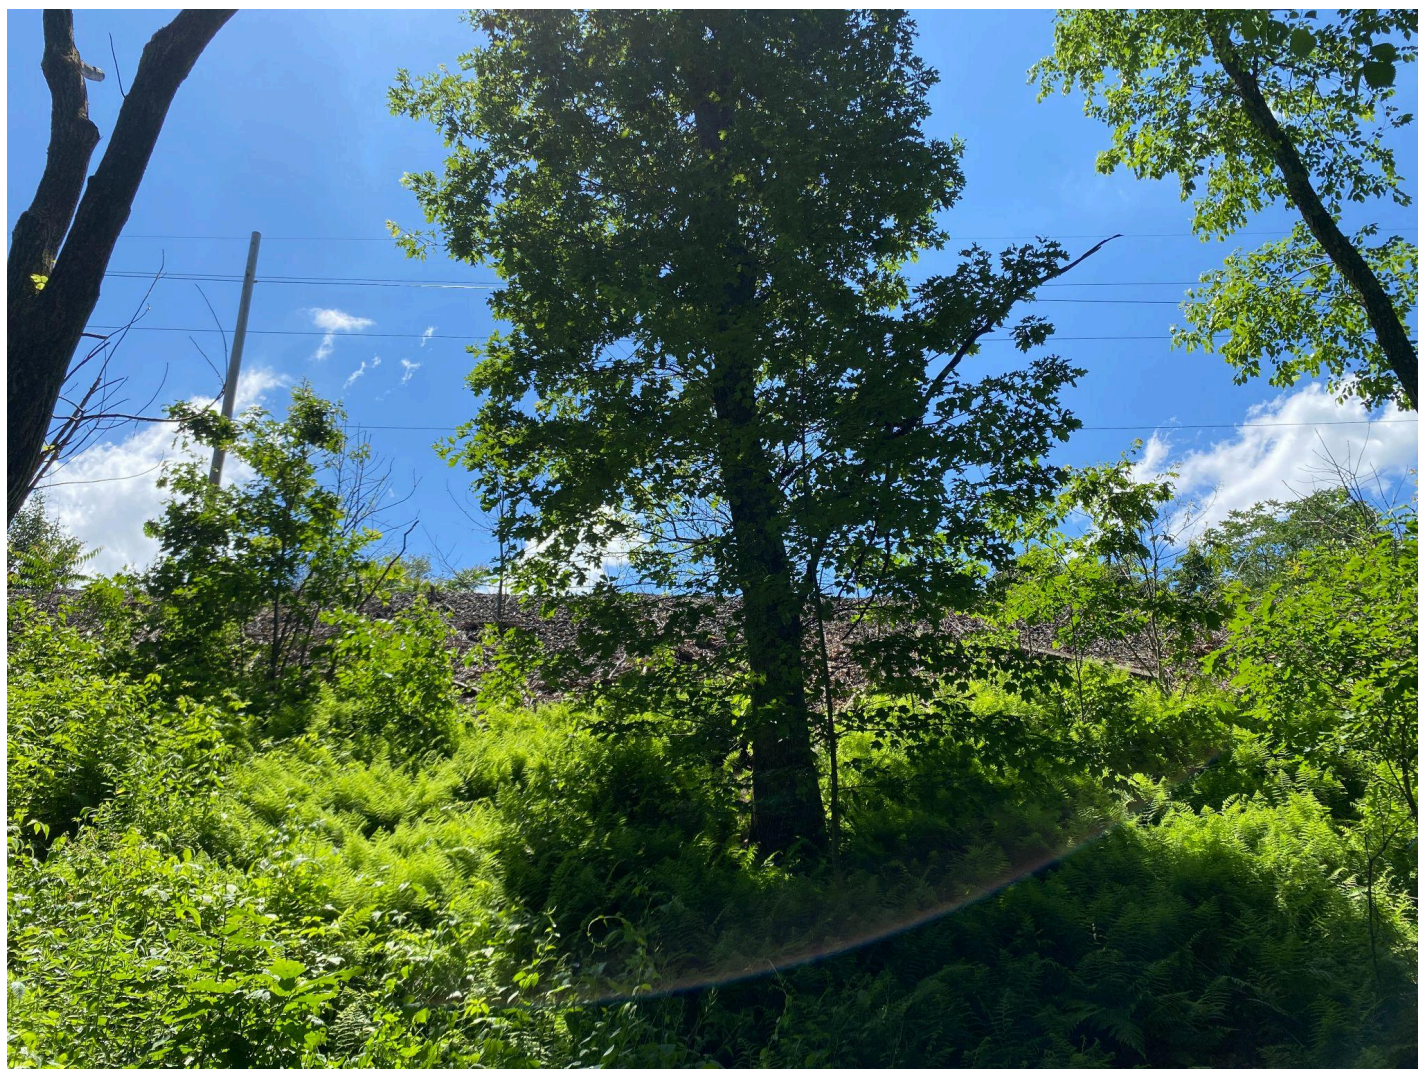
**Photo 36**

**Type:** Invasive Species

**Comments:** Japanese knotweed along the boundary with 94 Locust Avenue. A shed may be partially on conservation property.
