# *CONDOMINIUM RESERVE STUDY*

## **Denholm Building**

**484 Main Street  
Worcester, Massachusetts**

**Subject: Condominium Reserve Study & MEP/LS Report  
Denholm Building  
484 Main Street, Worcester, Massachusetts  
EBI Project #1319000663**

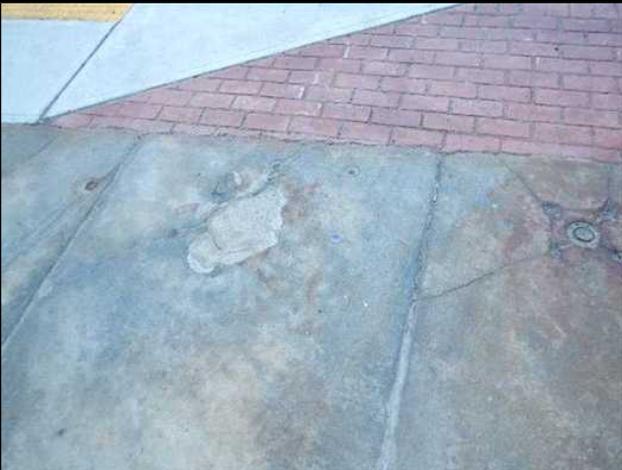
Minor moisture infiltration through the sidewalk paver and stone slabs was observed and reported. Critical Repairs are recommended to reseal the stone slab joints and/or stone paver mortar joints. Based on the observed condition and expected useful life, Capital Needs are recommended for sidewalk repairs during the analysis term.

Washed out mortar at granite pavers	Cracked stone sidewalk at front of building

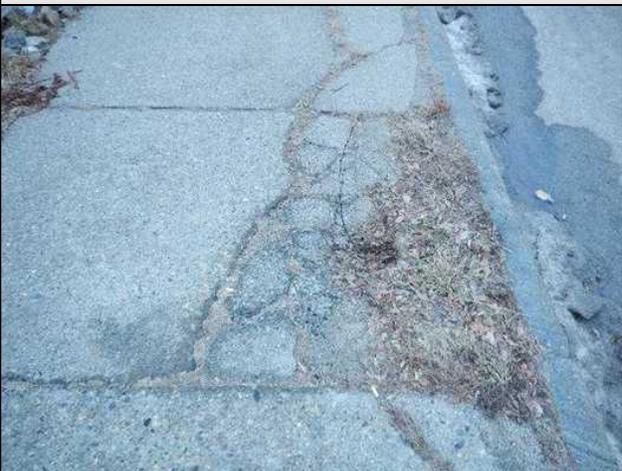
2.3	Pavement/ Parking	Localized full-depth asphalt repairs (> 1,000 SF)	4,103	\$3.97	20.0%	\$4.76	per square foot	\$19,530.53			The remote parking lot is in generally fair condition with the northeastern entrance drive in poor condition. Remote parking lot asphalt paving repairs.

Sidewalk along remote parking lot	Deteriorated sidewalk at remote parking lot

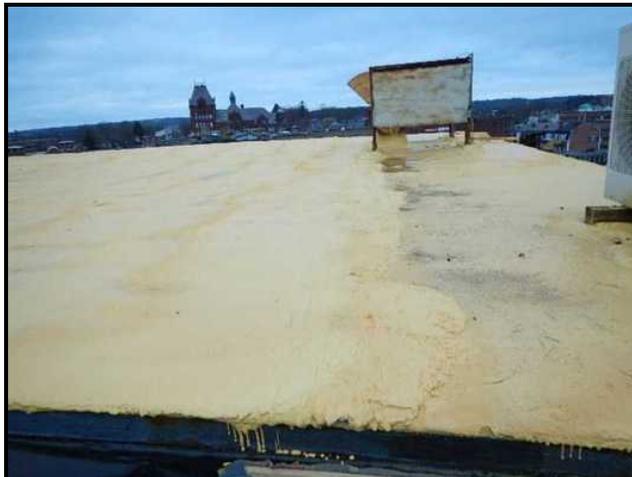
Unfinished polyurethane foam roof section E

4.1	Roof	Complete roofing installation Section E	1		20.0%		action item				Complete roofing installation delayed due to weather.
4.1	Roof	Rework parapet walls and flashings	1	\$5,000.00	20.0%	\$6,000.00	lump sum				Repair worn parapet walls and flashings.

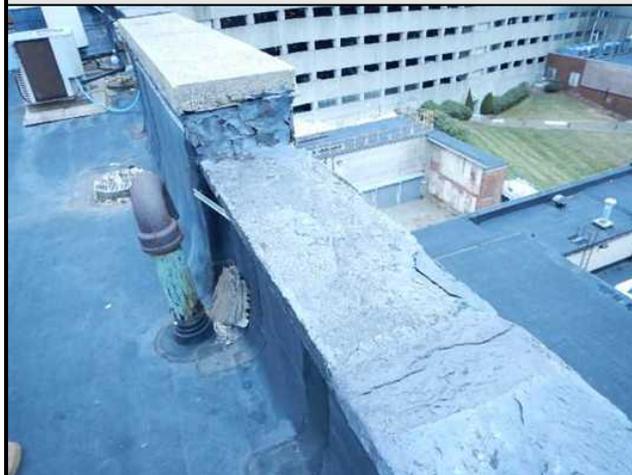
Roof section A/B parapet wall

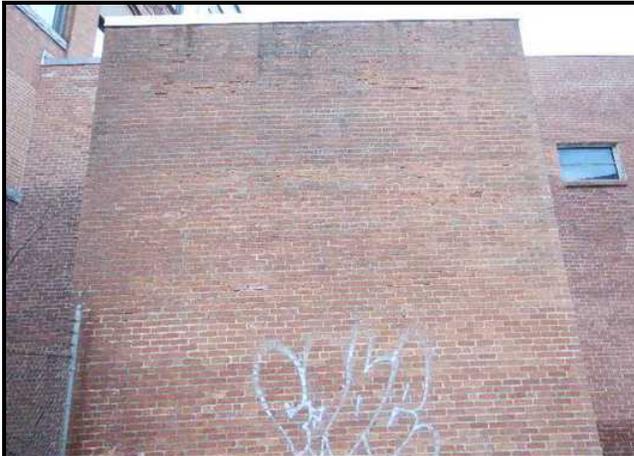
Northern façade brick mortar joint deterioration

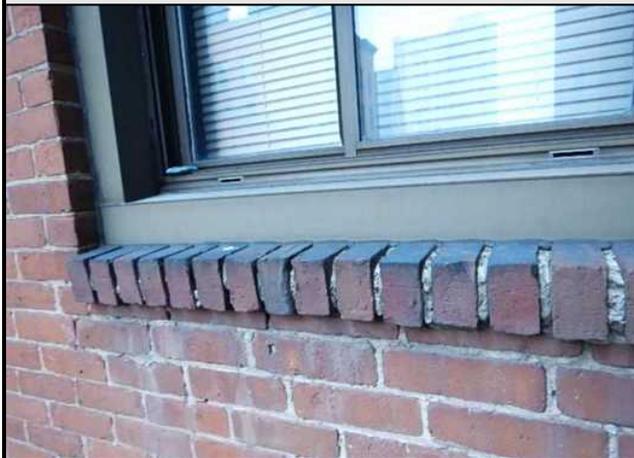
Washed out mortar joints at window sill along northern side

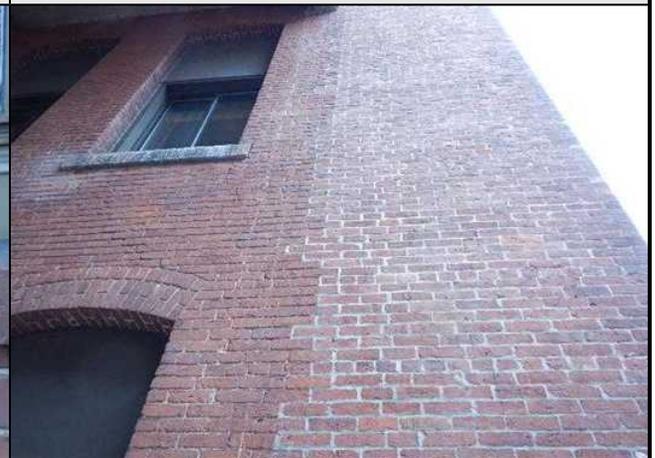
Previous mortar repointing along northern side of building

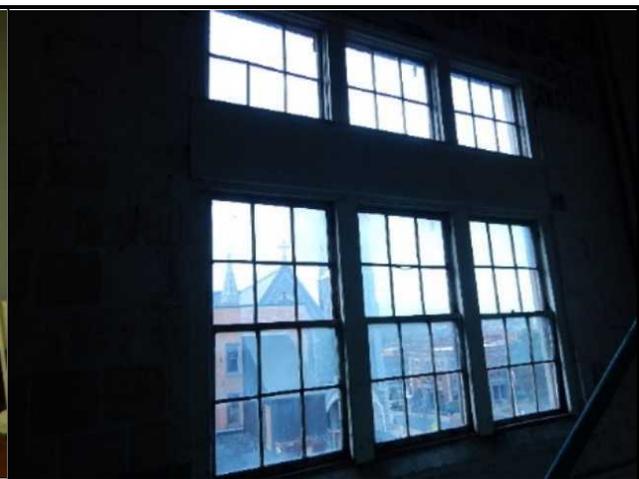
Single-pane stairwell original windows

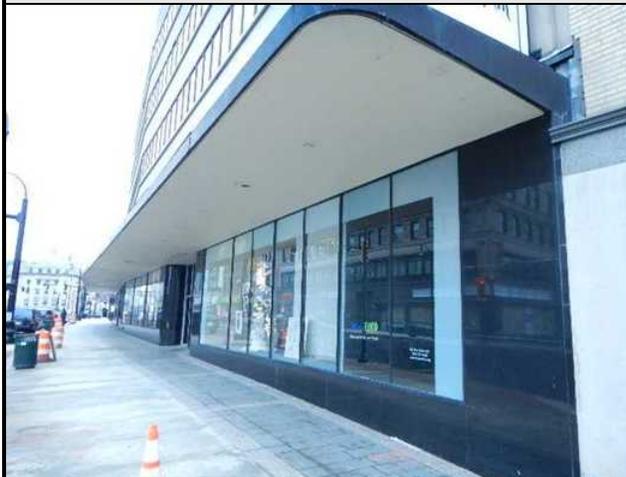
Front of building storefront assembly with canopy overhang

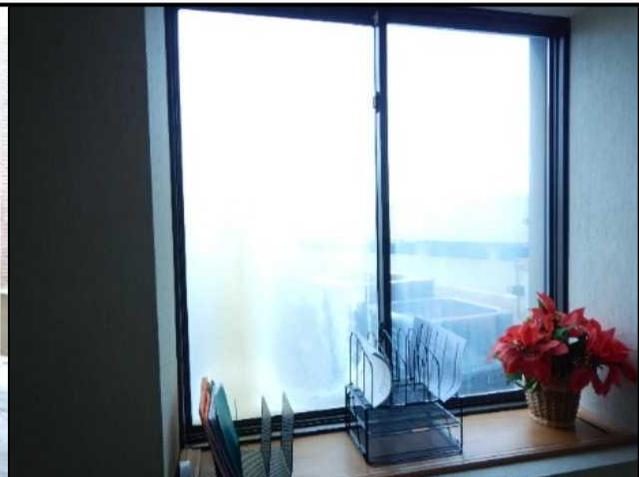
The exterior aluminum insulated windows appear to be in generally good condition and are reportedly weathertight. Ten fogged windows and four cracked insulated panes were observed. Based on observed conditions, Non-Critical Repairs are recommended to replace the fogged and cracked panes throughout the building. Additional fogged and broken windows likely are present at the subject building and a thorough review of every window is recommended before the windows are replaced. Through wear and tear, and occasional misuse, doors are expected to require minor repairs, limited replacement, and adjustments over their life, and Capital Needs are recommended accordingly.

Fogged window pane in office space

- **Replace broken pane and/or fogged window panes**

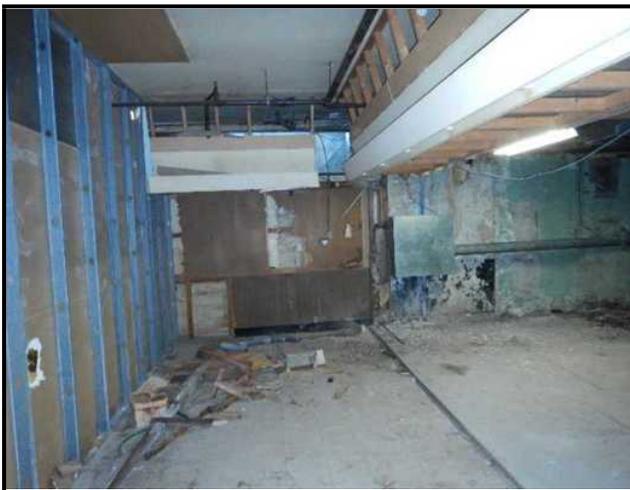
Stripped basement finishes

The basement was reportedly utilized during the time when the building was a department store and furniture was sold at the basement level. Currently, the basement is in generally poor condition with recent flooding damage observed due to a malfunctioning sump pump. Moisture infiltration appears to be a common issue along several perimeter walls where ground water is constantly seeping in and needs to be pumped out. Based on the observed condition, Non-Critical Repairs are recommended for a general cleanup of the basement so that worn and water damaged finishes are removed and the basement is in an easier to maintain condition.

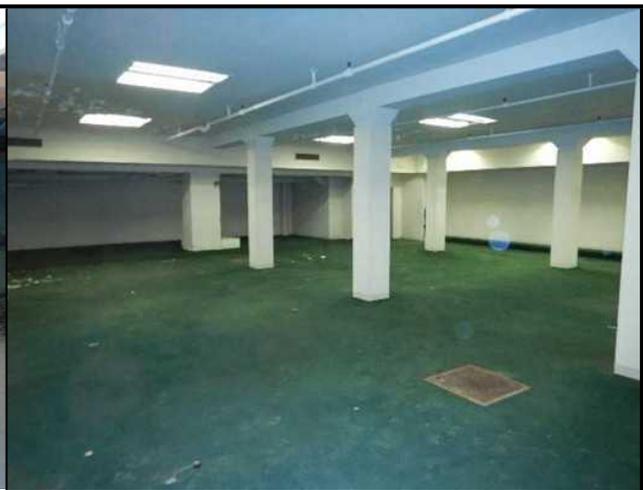
Remaining basement finishes

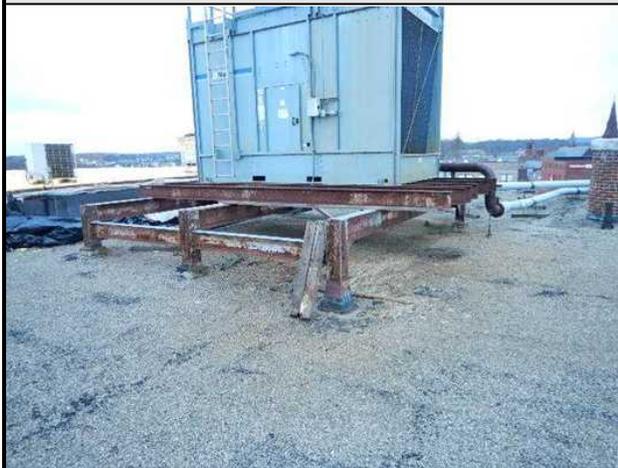
Rooftop cooling tower	Basement low pressure steam boiler

- **Replace one (1) DX condensers**
- **Replace Cooling Tower (250 Ton)**
- **Replace Two (2) Pump Motors (25 HP)**

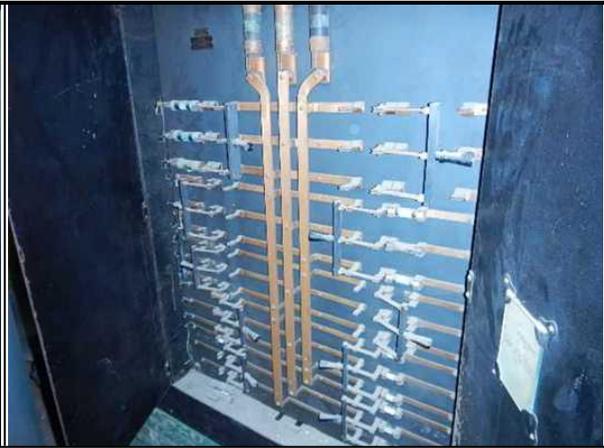
Vintage electrical knife switch panel

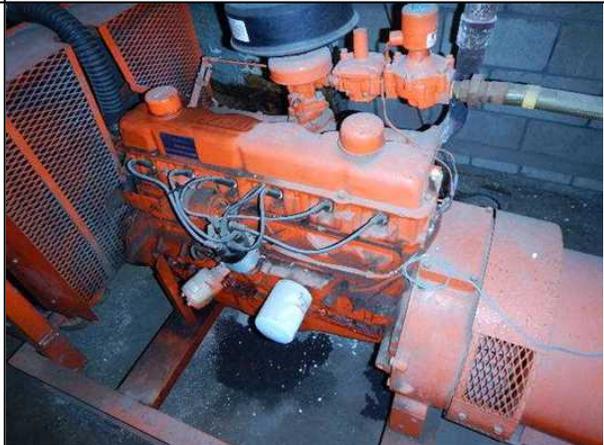
Basement mounted backup generator

- **Replace Gas-Fired Emergency Generator (60 kW)**

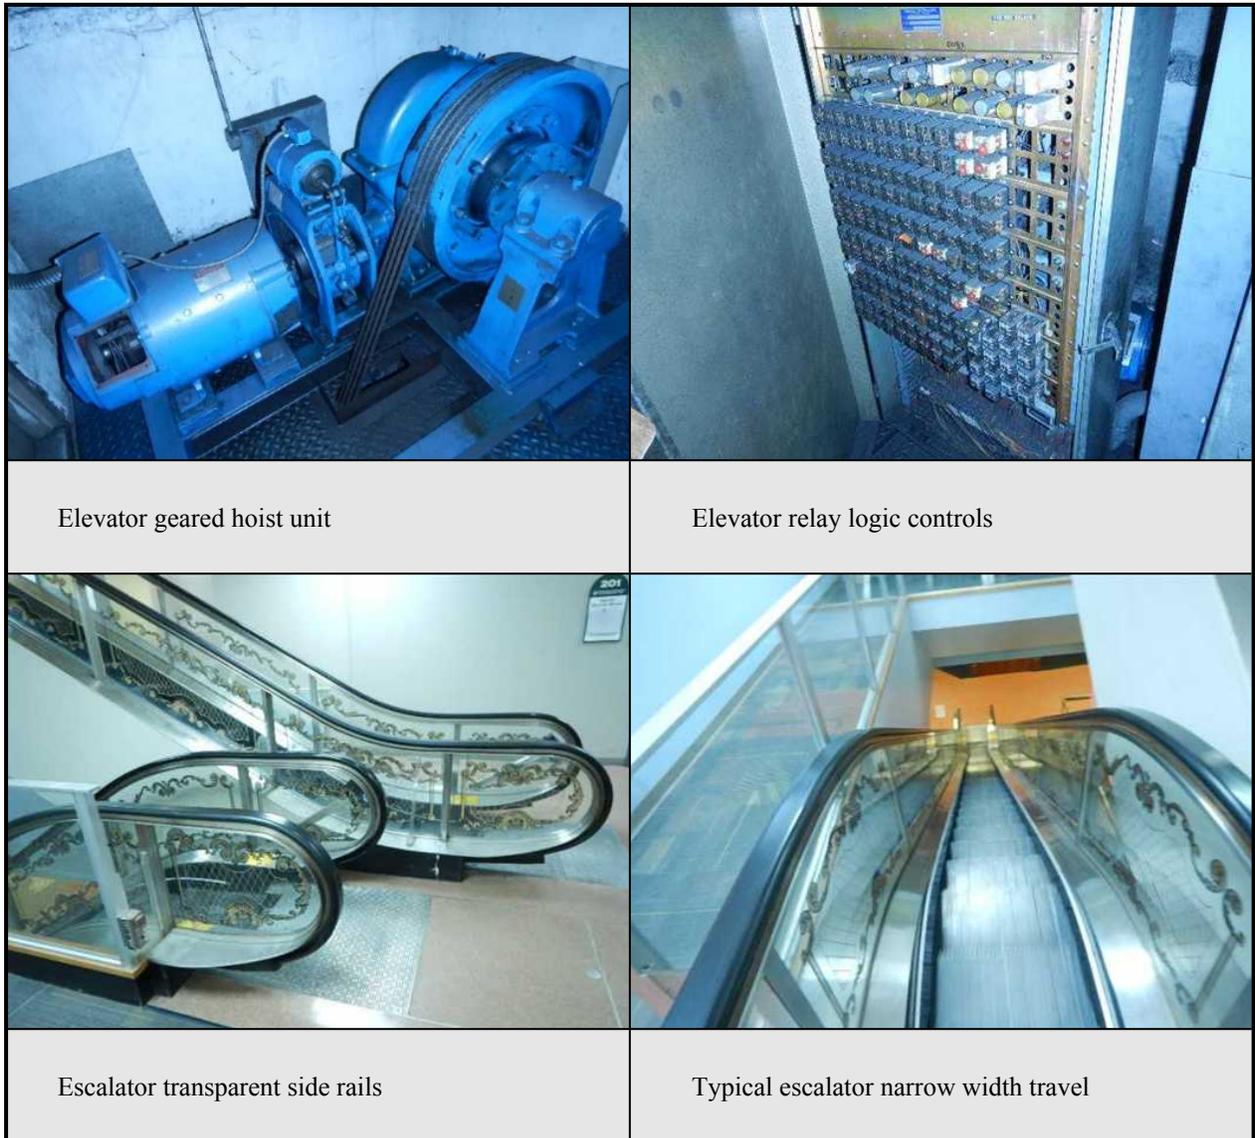
Elevator geared hoist unit

Elevator relay logic controls

The elevators appear to be in generally fair condition. The elevator controls are dated and periodic service calls are required to keep them operational and/or to free passengers when down. Based on the observed condition and expected useful life, Non-Critical Repairs are recommended for elevator modernization that could include updating the elevator controls to solid state, eliminating the need for motor-generators, door operators, and the updating of the elevator cab finishes and controls. The elevator certificates were up to date and expire on April 3, 2020.

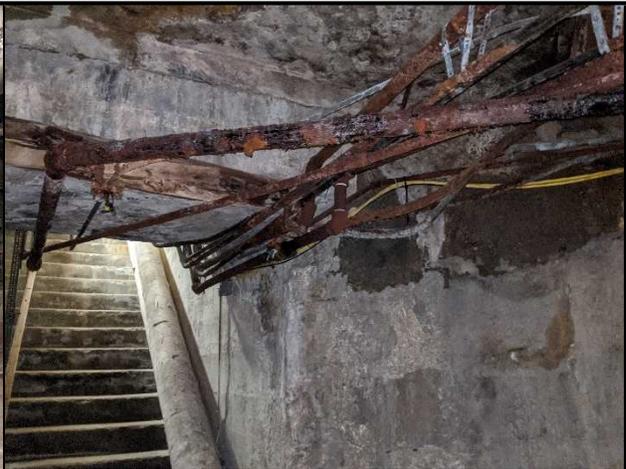
The Subject Property domestic galvanized and copper water piping on the first floor through the sixth floor appears to be in fair condition, with no reported problems noted; the water piping in the basement appears to be in fair to poor condition with visible corrosion noted. Galvanized steel piping is susceptible to internal corrosion as zinc in the piping erodes over time. This can significantly affect the water pressure and quality in plumbing supply lines. Internal pipe corrosion cannot be identified through visual observation. Therefore, based on the overall condition, use of galvanized piping and age, it is recommended that the domestic water piping be evaluated by a qualified professional to assess its current condition, identify repair needs, and provide an estimate of its remaining useful life as an Immediate Repair. Any modifications/repairs recommended by the evaluation should be completed as part of Short Term Repairs.

Water Piping

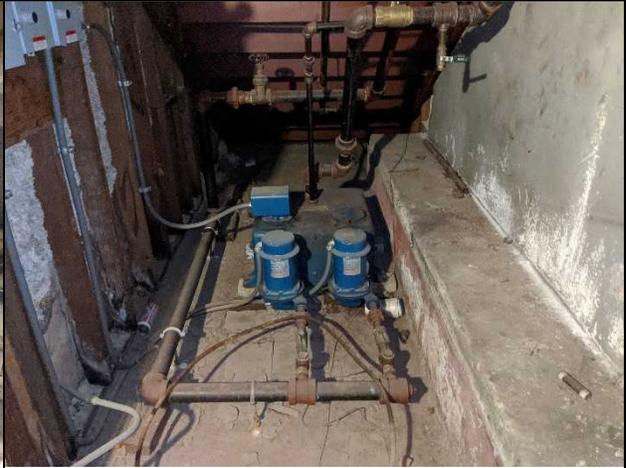
The steam piping where able to be observed, appear to be in fair to poor condition. The Subject Property is over 45 years old and the sewer pipes are starting to corrode. It is recommended that the steam piping be evaluated by a qualified professional to assess its current condition, identify repair needs, and provide an estimate of its remaining useful life as an Immediate Repair. Any modifications/repairs recommended by the evaluation should be completed as part of Short Term Repairs.

Steam System Piping

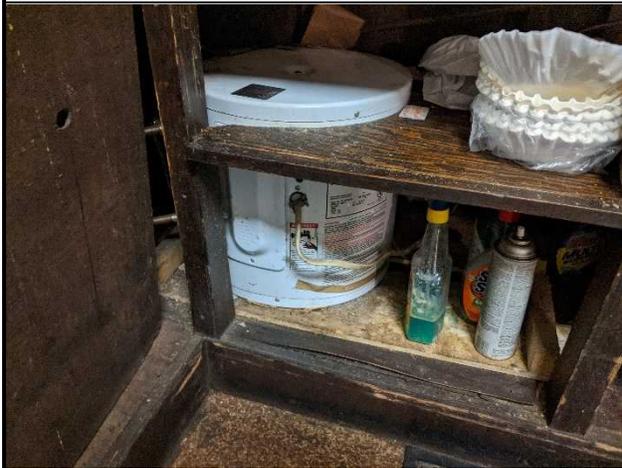
The water heater in Suite 120 does not have a catch pan underneath to assist in minimizing damage from leaking of the tank. Based on observed and reported conditions, Immediate Repairs are recommended for installation of a drain pan in Suite 120.

Water Heater Lacking Catch Pan

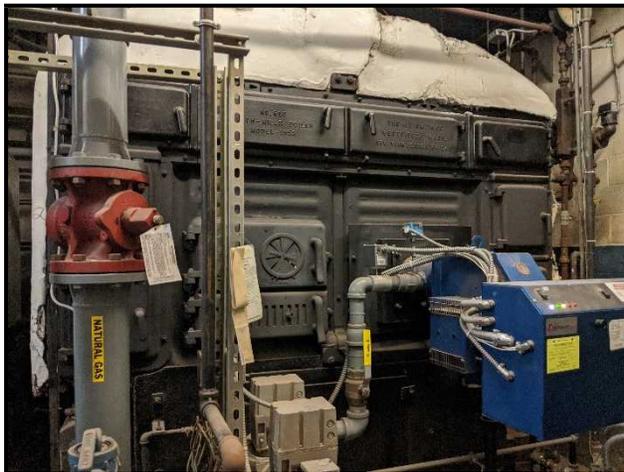
Central gas-fired steam boiler

The natural gas boiler (3770 MBH) is approximately 50 years old, appears to be in fair to poor overall condition, with a leak reported at the time of the site inspection. The average useful life of boilers of this size and type is approximately 25 to 30 years, depending upon their location, maintenance and use type. The boiler is reportedly serviced on a regular basis. An interview with the building engineer did not indicate any major problems or issues with the equipment. Based on their average effective useful life, current condition and reported maintenance program, Immediate Repairs are recommended to replace the boiler.

- **Replace Gas-Fired Steam Boiler (3770 MBH)**
- **Licensed Engineering firm to evaluate the replacement and natural gas conversion of oil-fired steam boiler (3770 MBH) and provide cost**
- **Replace six (6) DX condensers**
- **Replace eight (8) SCAHU's**
- **Replace two (2) DX AHU**
- **Replace two (2) RTU's**

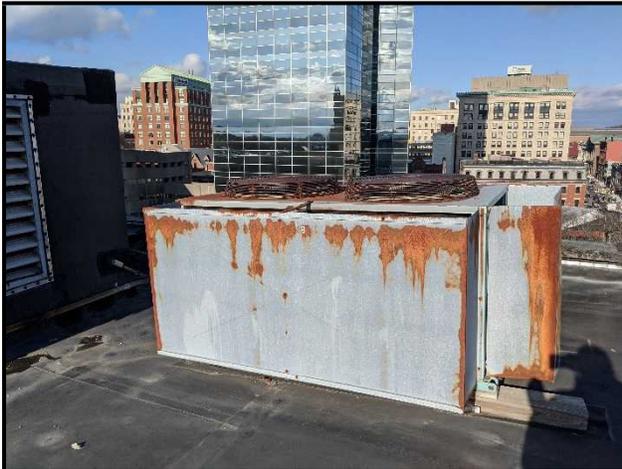
The rooftop-mounted HVAC DX condensing units appear to be in fair to poor overall condition due to their age, with no reported problems noted. The average useful life of these units of this size and type is approximately 14 to 18 years, depending upon their location, maintenance and use type. The HVAC units are reportedly serviced on an as-needed basis, and a review of the service records didn't indicate any major problems or issues with the equipment. Based on their average effective useful life, current condition, the R-22 statement above and reported maintenance program, Immediate Repairs for the replacement of six (6) DX condensers and Replacement Reserves for the replacement of one (1) DX condensers is recommended during the analysis term.

Rooftop Air-Cooled DX Condenser

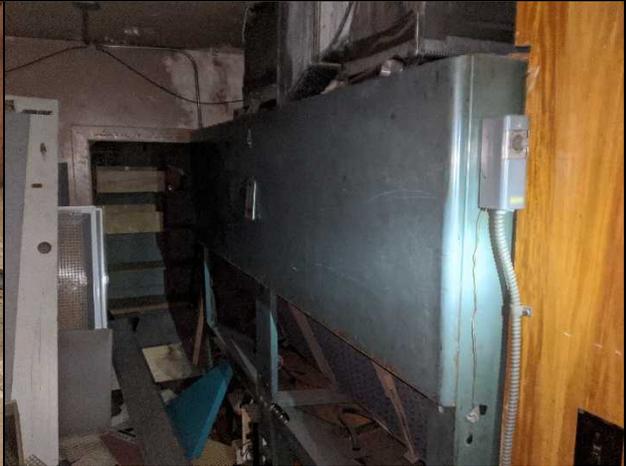
Inoperable Air Handler Unit

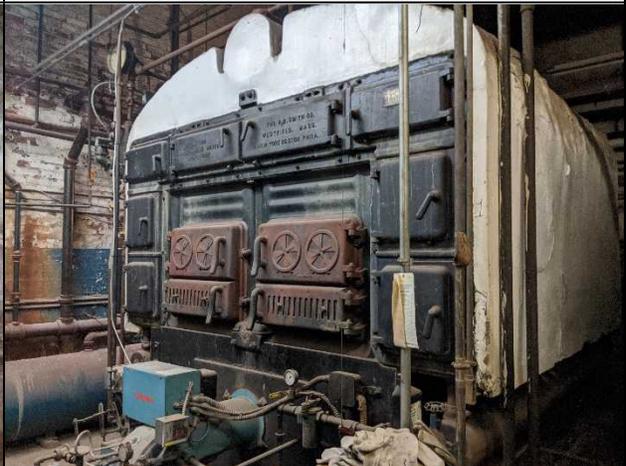
The oil-fired boiler (3770 MBH) is approximately 50 years old, appears to be in poor overall condition and has been in an inoperable condition for over 5 years. The average useful life of boilers of this size and type is approximately 25 to 30 years, depending upon their location, maintenance and use type. Based on their average effective useful life, current condition and reported maintenance program, Immediate Repairs are recommended to engage a licensed Engineering firm to evaluate the conversion of the current oil-fired steam boiler to a natural gas steam boiler and provide feasibility and cost to replace the boiler.

Inoperable Oil-fired boiler

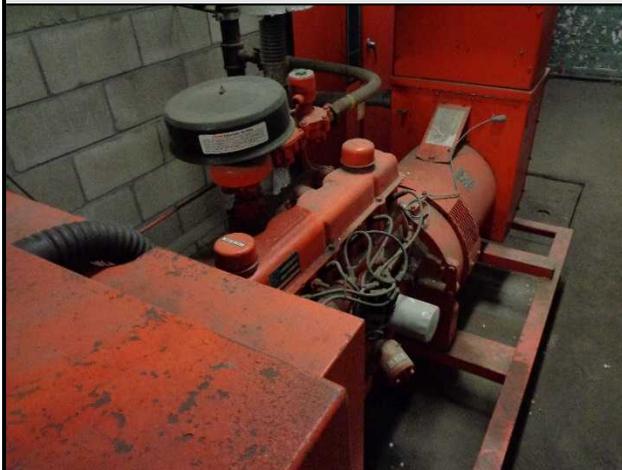
Emergency Generator

The emergency generator is approximately 40 years old and appears to be in fair to poor condition. Generators of this size and type have an average expected useful life of approximately 25 to 30 years, depending on their maintenance and amount of regular testing and usage, but can be extended with refurbishment/overhaul of the unit. The emergency generator was not operated during our on-site assessment. According to maintenance personnel, the generator is exercised at regular intervals during the year and was last tested. Based on its reported age, current condition, and expected useful life, Short Term Repairs are recommended for replacement of the emergency generator.

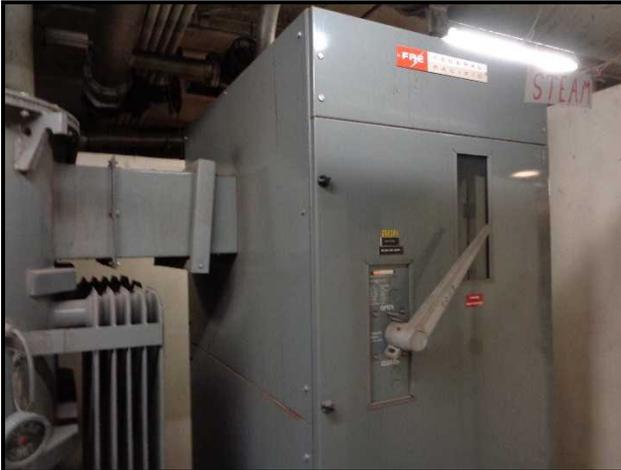
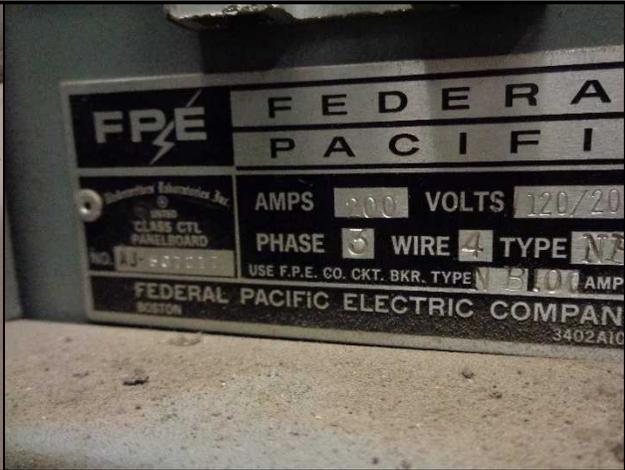
Federal Pacific Switchgear	Federal Pacific Panelboard

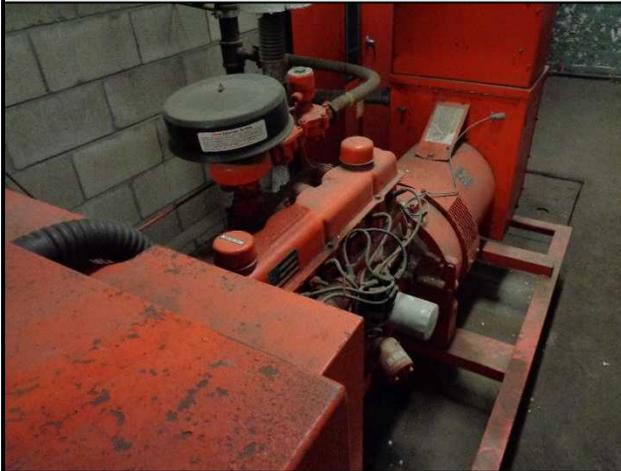
Emergency Generator	Disconnects with hot spots

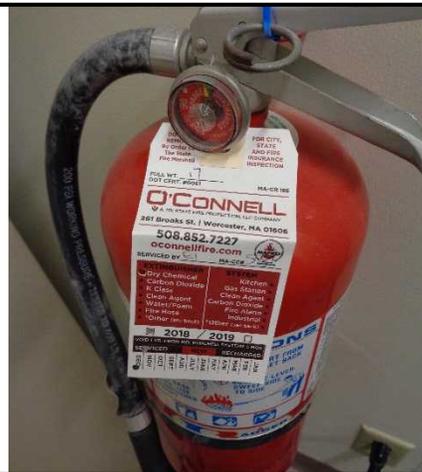
Expired Fire Extinguisher Inspection

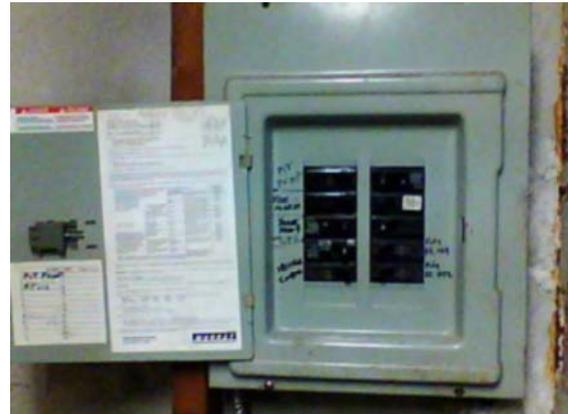
**Distribution Panel - No Tag (Basement)**

Guidelines from NETA provides guidelines which recommend that when the difference in temperature ( $\Delta T$ ) between similar components under similar loading exceeds 6-7°F, immediate repairs should be undertaken. When similar components under similar loads are not available for comparison, NETA also recommends the immediate repairs when the  $\Delta T$  between an electrical component and the ambient air exceeds 20°F.

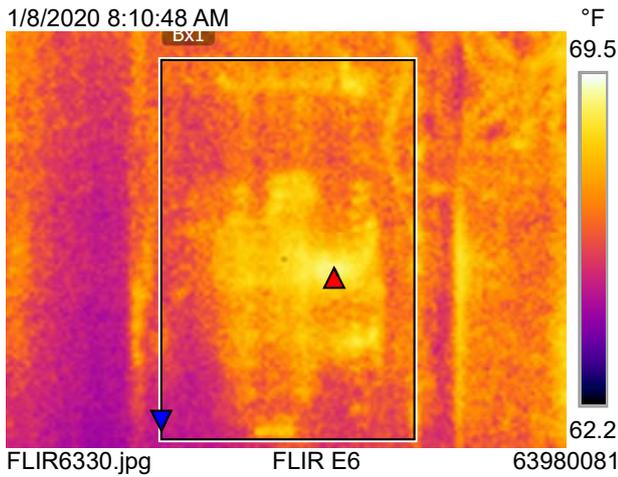
The surface temperatures recorded at the electrical panel fall within the safe temperature range defined by the InterNational Electrical Testing Association (NETA).

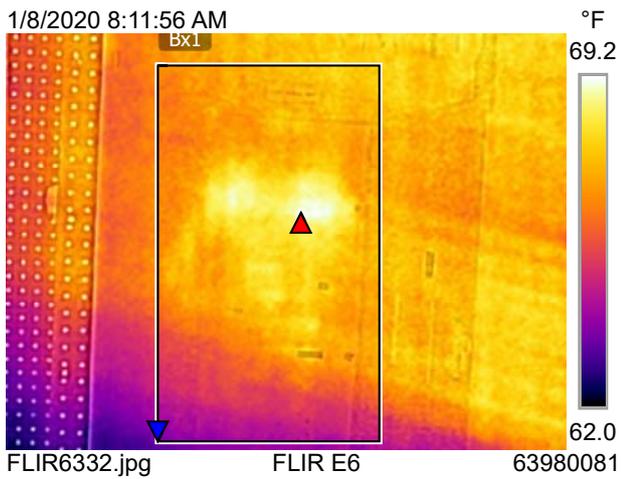
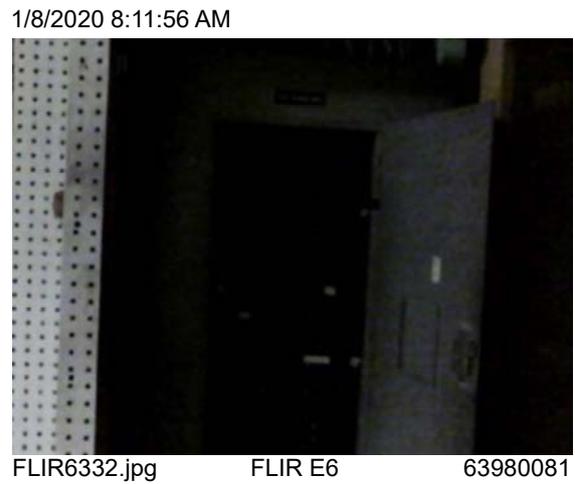
The surface temperatures recorded at the electrical panel fall within the safe temperature range defined by the InterNational Electrical Testing Association (NETA).

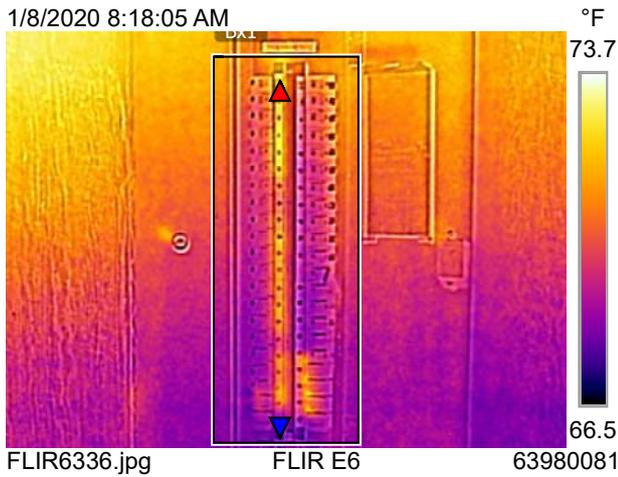
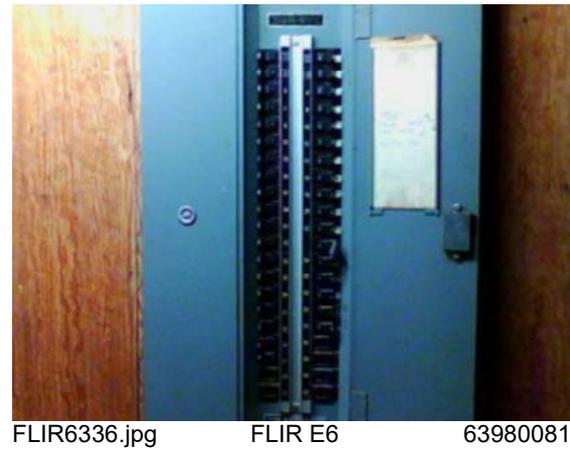
Distribution Panel - No Tag (Basement)

The surface temperatures recorded at the electrical panel fall within the safe temperature range defined by the InterNational Electrical Testing Association (NETA).

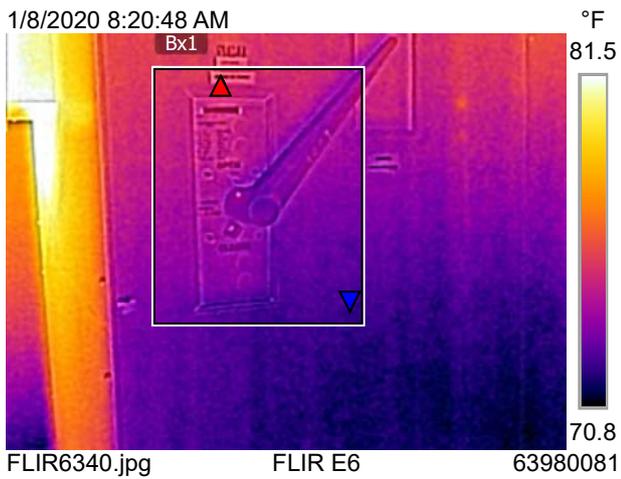
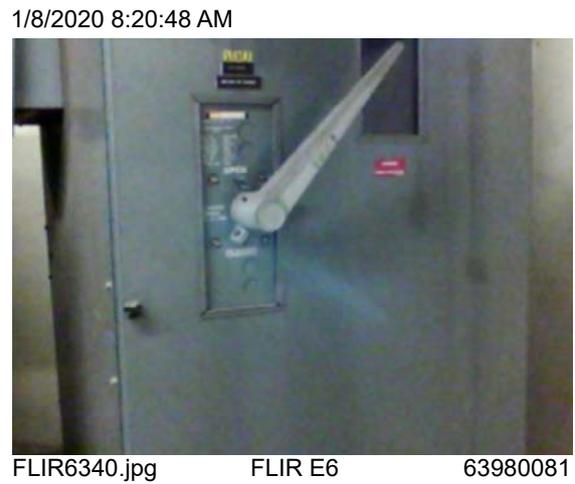
The surface temperatures recorded at the switchgear fall within the safe temperature range defined by the InterNational Electrical Testing Association (NETA).

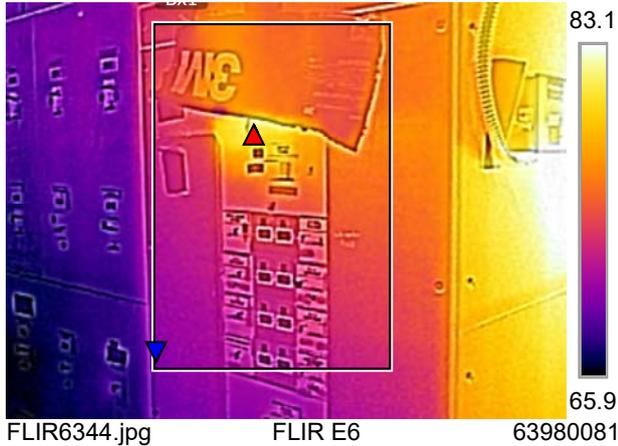
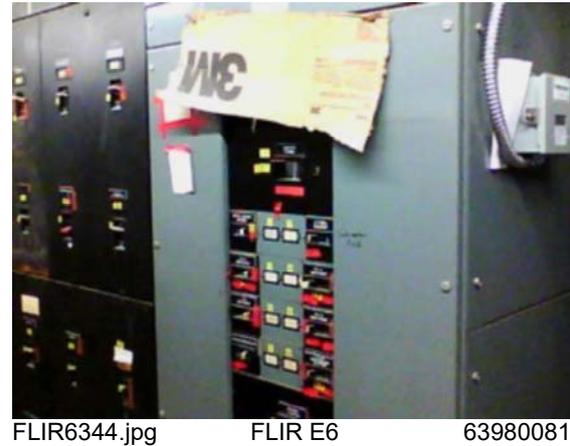
**Switchgear 1 - PE Xformer**

Transformers are typically labeled with standard temperature rises of 80°C (176°F), 115°C (239°F), or 150°C (302°F), which is the temperature rise above ambient conditions which the transformer is rated to. The transformers in the electrical room appear to be below the typical temperature range.

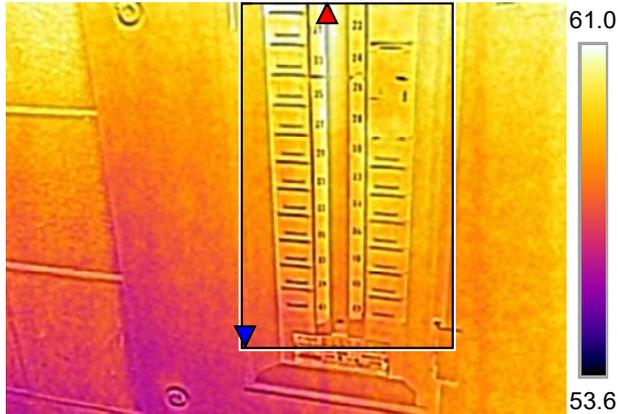
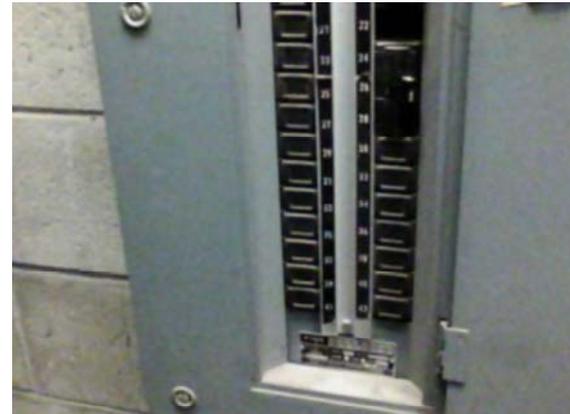
### Distribution Panel - D6

The surface temperatures recorded at the electrical panel fall within the safe temperature range defined by the InterNational Electrical Testing Association (NETA).

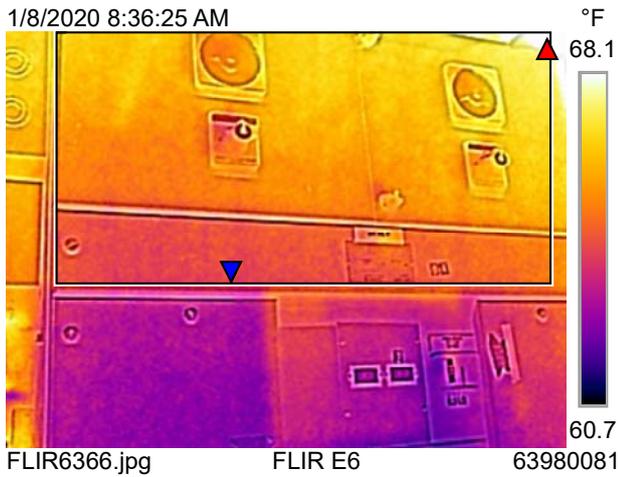
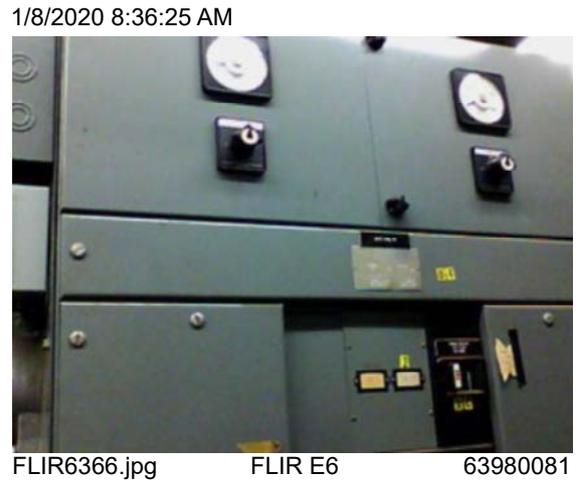
**Switchgear 2 - PE Xformer**

The surface temperatures recorded at this transformer fall within the safe temperature range.

Transformers are typically labeled with standard temperature rises of 80°C (176°F), 115°C (239°F), or 150°C (302°F), which is the temperature rise above ambient conditions which the transformer is rated to. The transformers in the electrical room appear to be below the typical temperature range.

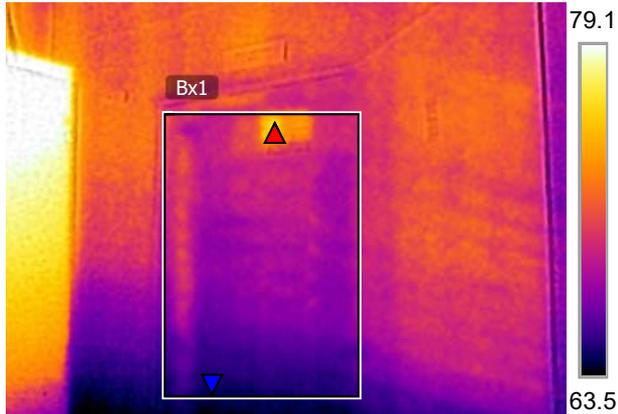
**Distribution Panel - No Tag (Basement)**

The surface temperatures recorded at the electrical panel fall within the safe temperature range defined by the InterNational Electrical Testing Association (NETA).

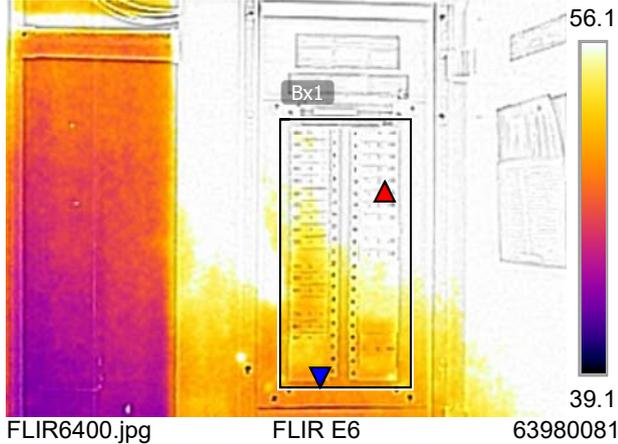
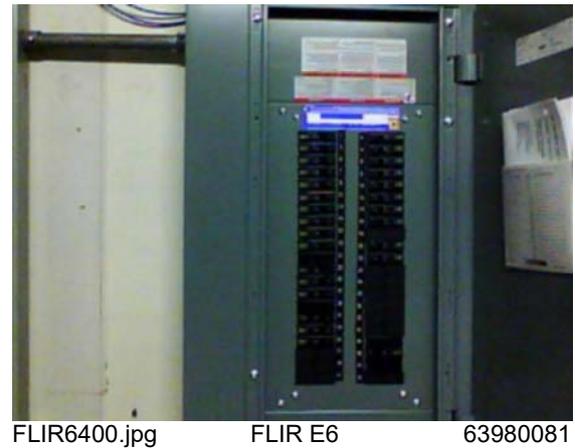
Distribution Panel - No Tag (2nd Floor)

Bx1	Max	77.5 °F
	Min	54.0 °F
	Average	56.4 °F

The surface temperatures recorded at the electrical panel DO NOT fall within the safe temperature range defined by the InterNational Electrical Testing Association (NETA).

Guidelines from NETA provides guidelines which recommend that when the difference in temperature ( $\Delta T$ ) between similar components under similar loading exceeds 6-7°F, immediate repairs should be undertaken. When similar components under similar loads are not available for comparison, NETA also recommends the immediate repairs when the  $\Delta T$  between an electrical component and the ambient air

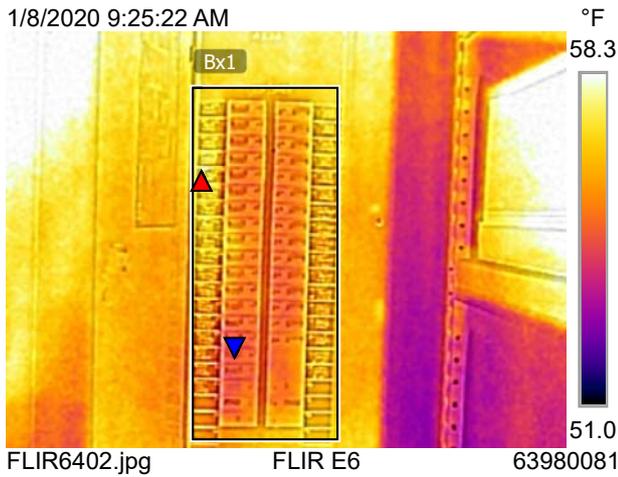
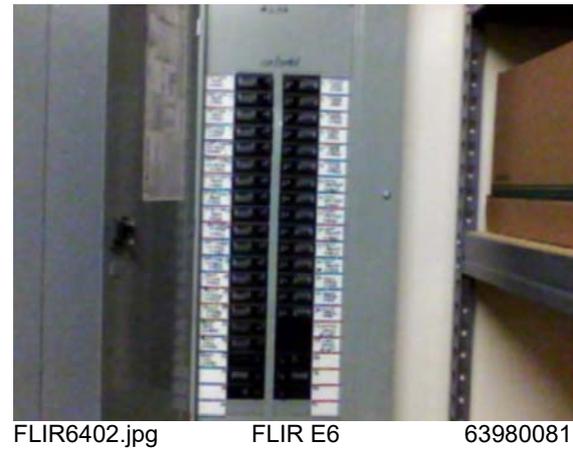
### Distribution Panel - No Tag (2nd Floor WBES)

The surface temperatures recorded at the electrical panel fall within the safe temperature range defined by the InterNational Electrical Testing Association (NETA).

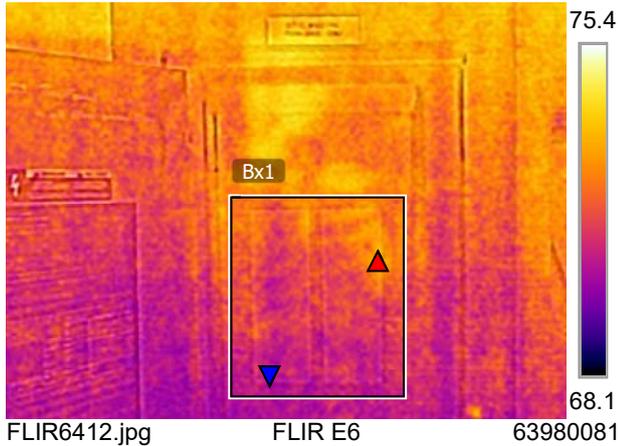
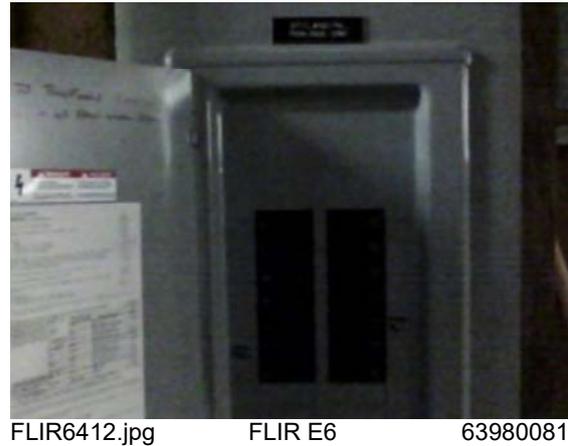
Distribution Panel - 1st Fl. Wind PNL

The surface temperatures recorded at the The surface temperatures recorded at the electrical panel fall within the safe temperature range defined by the InterNational Electrical Testing Association (NETA).

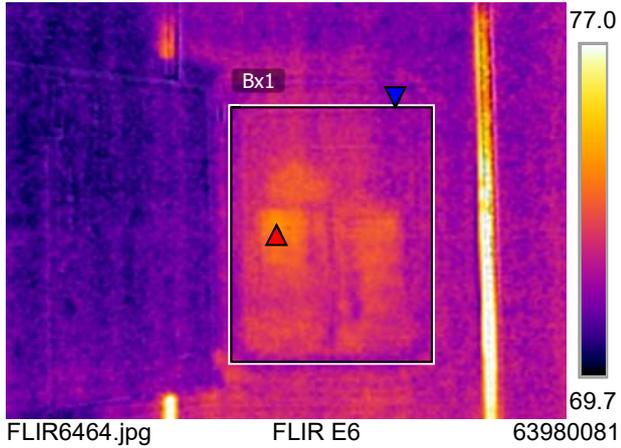
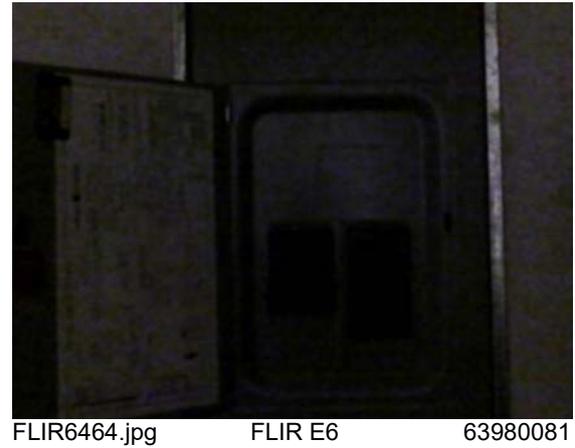
**Distribution Panel - No Tag**

The surface temperatures recorded at the electrical panel fall within the safe temperature range defined by the InterNational Electrical Testing Association (NETA).

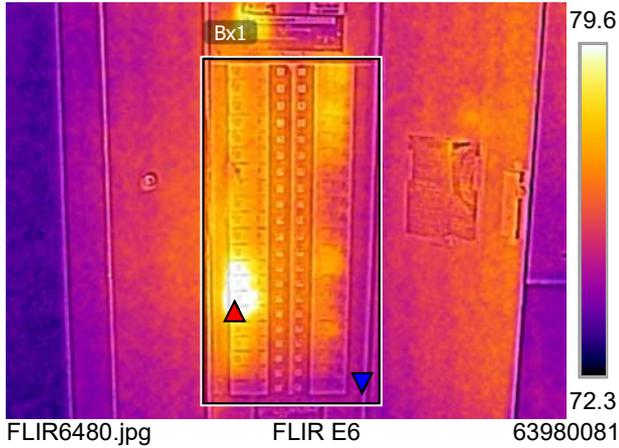
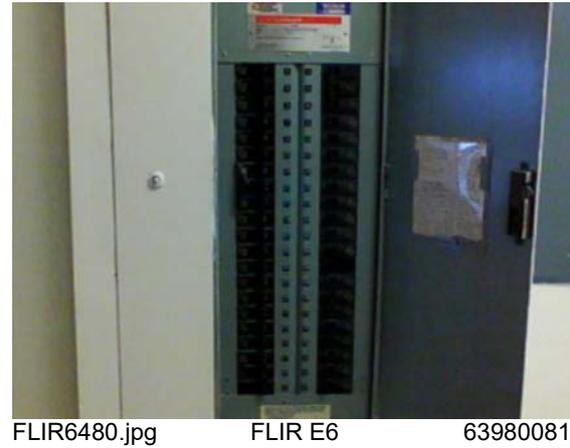
**Distribution Panel - No Tag**

The surface temperatures recorded at the electrical panel fall within the safe temperature range defined by the InterNational Electrical Testing Association (NETA).

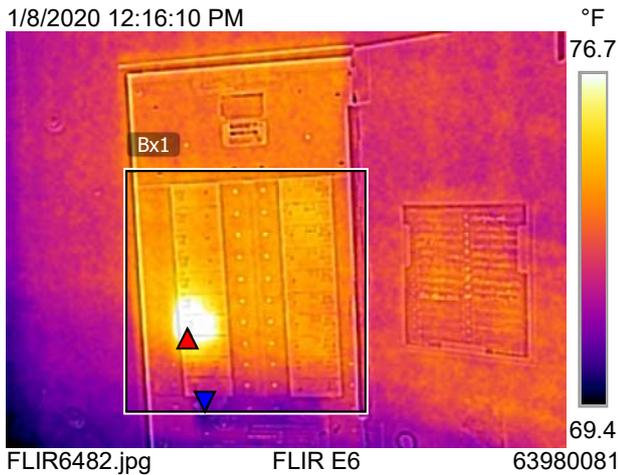
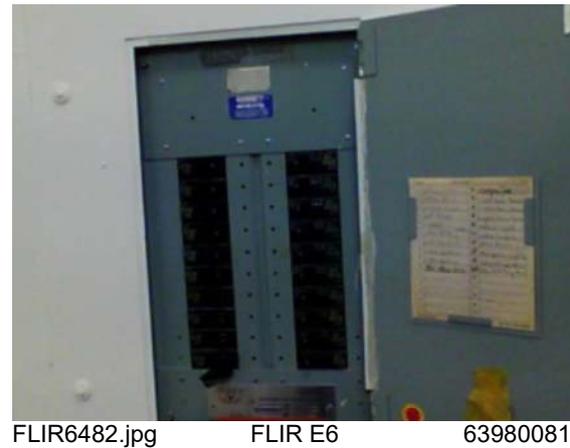
Distribution Panel - No Tag

The surface temperatures recorded at the electrical panel fall within the safe temperature range defined by the InterNational Electrical Testing Association (NETA).

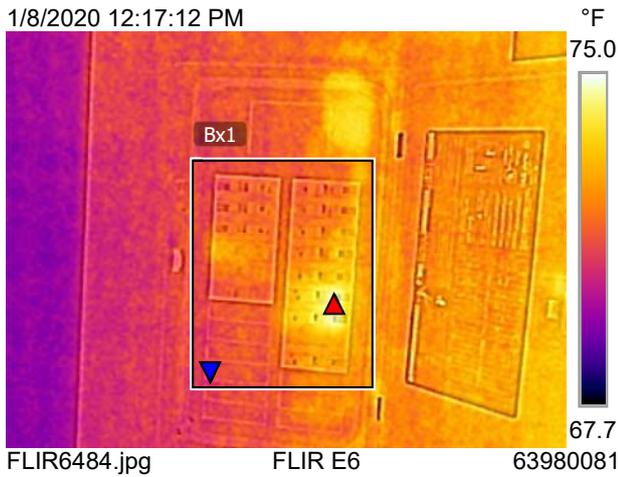
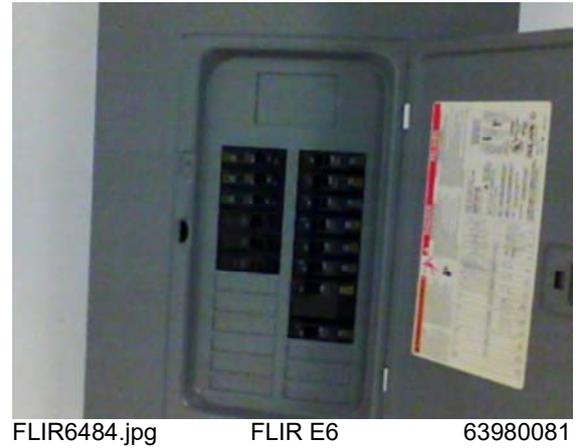
The surface temperatures recorded at the electrical panel fall within the safe temperature range defined by the InterNational Electrical Testing Association (NETA).

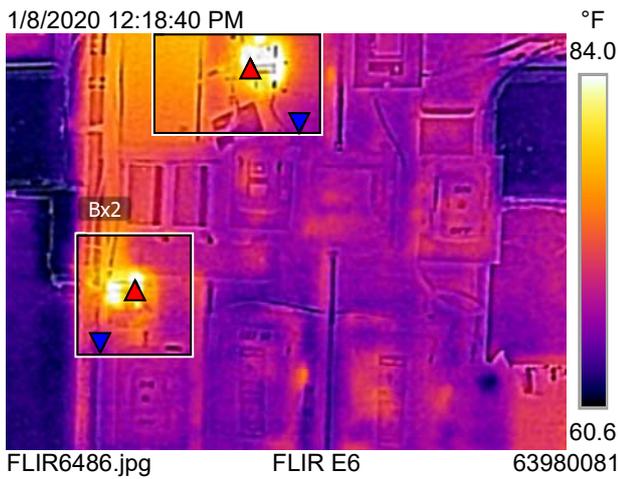
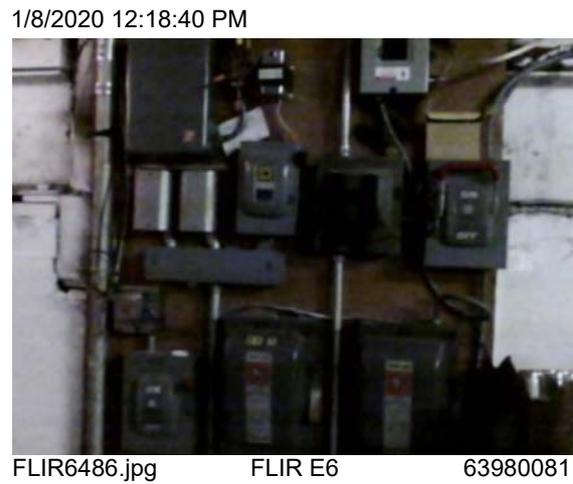
Guidelines from NETA recommend immediate repairs when the temperature difference ( $\Delta T$ ) between a component and the ambient air exceeds 20°F and 7° between similar components adjacent to one another.

Bx1	Max	112.1 °F
	Min	63.4 °F
	Average	69.6 °F
Bx2	Max	99.7 °F
	Min	63.5 °F
	Average	67.0 °F
