PINE HILL RESERVOIR DAM
PHASE I
INSPECTION / EVALUATION REPORT

Dam Name: Pine Hill Reservoir Dam
State Dam ID#: 3-14-134-6
NID ID#: MA 00623
Owner: City of Worcester
Owner Type: Municipal
Town: Holden, Massachusetts
Consultant: CDM Smith Inc.
Date of Inspection: September 24, 2015

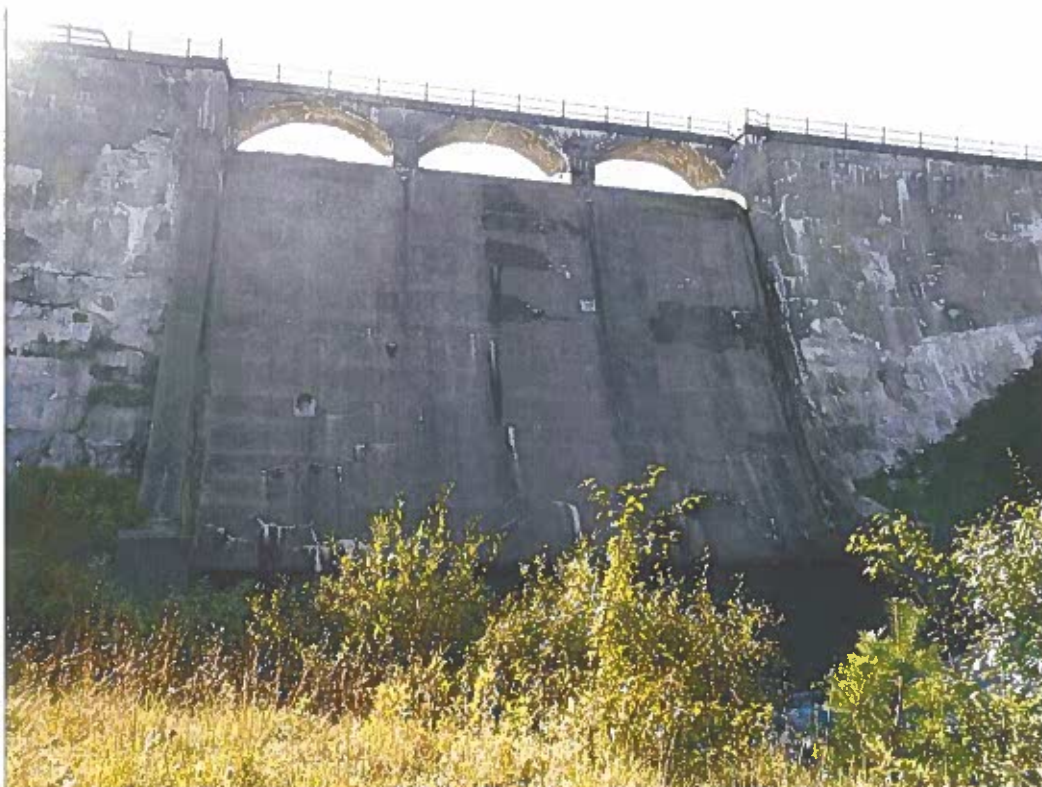
Photo No. 2: Overview of dam and downstream face from discharge channel.

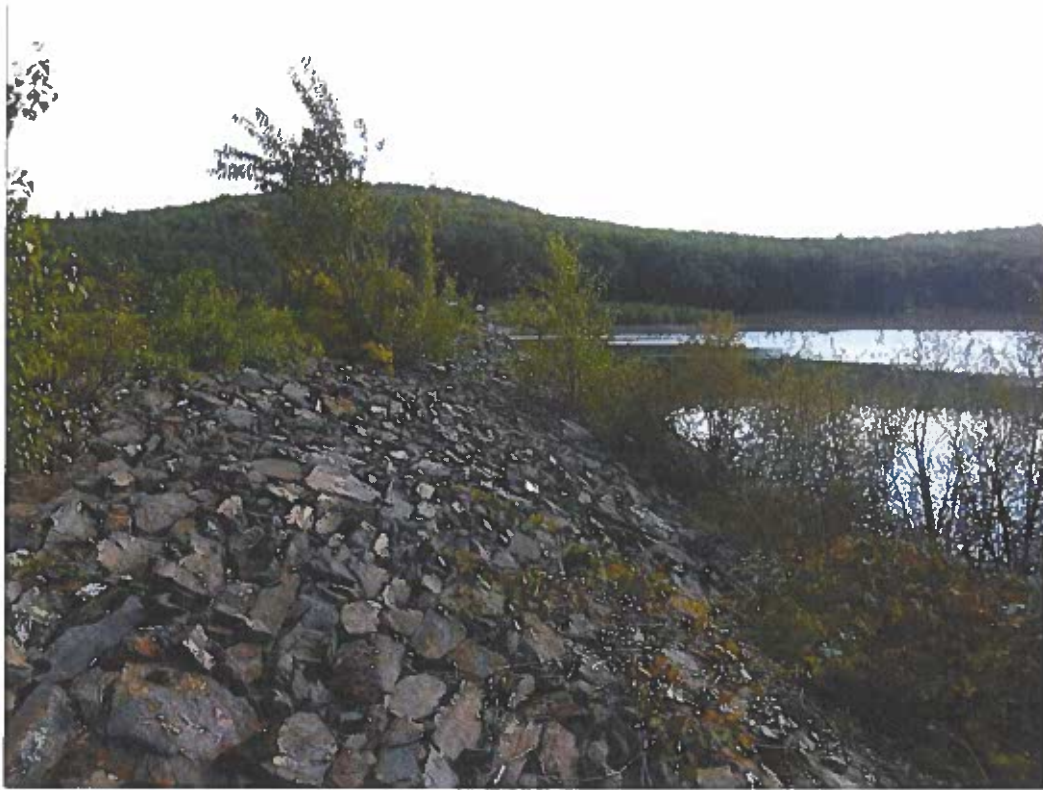
Photo No. 3: Overview of upstream face and crest from left abutment.

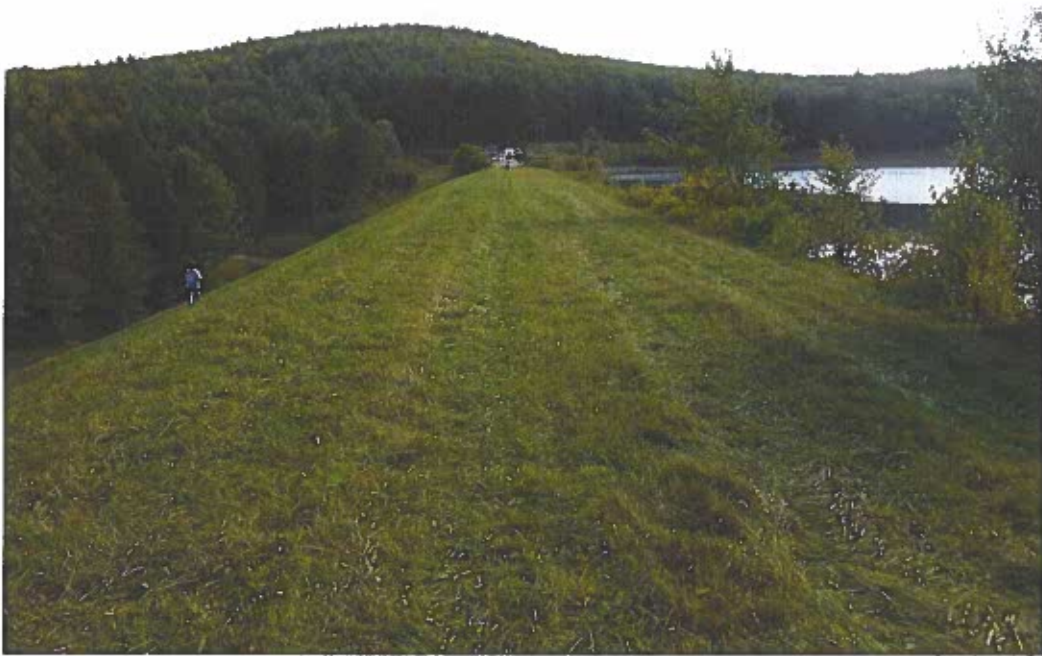
The abutment contacts of the earth embankments at the dam appear to be good (Photos 4 and 5). The crests and downstream slopes of the natural abutments are covered with maintained grass. The left and right abutments are riprap-lined on the upstream faces. The left abutment ties into natural ground, and the right abutment ties into bedrock on the right embankment.

Photo No. 5: Overview of crest from left abutment.

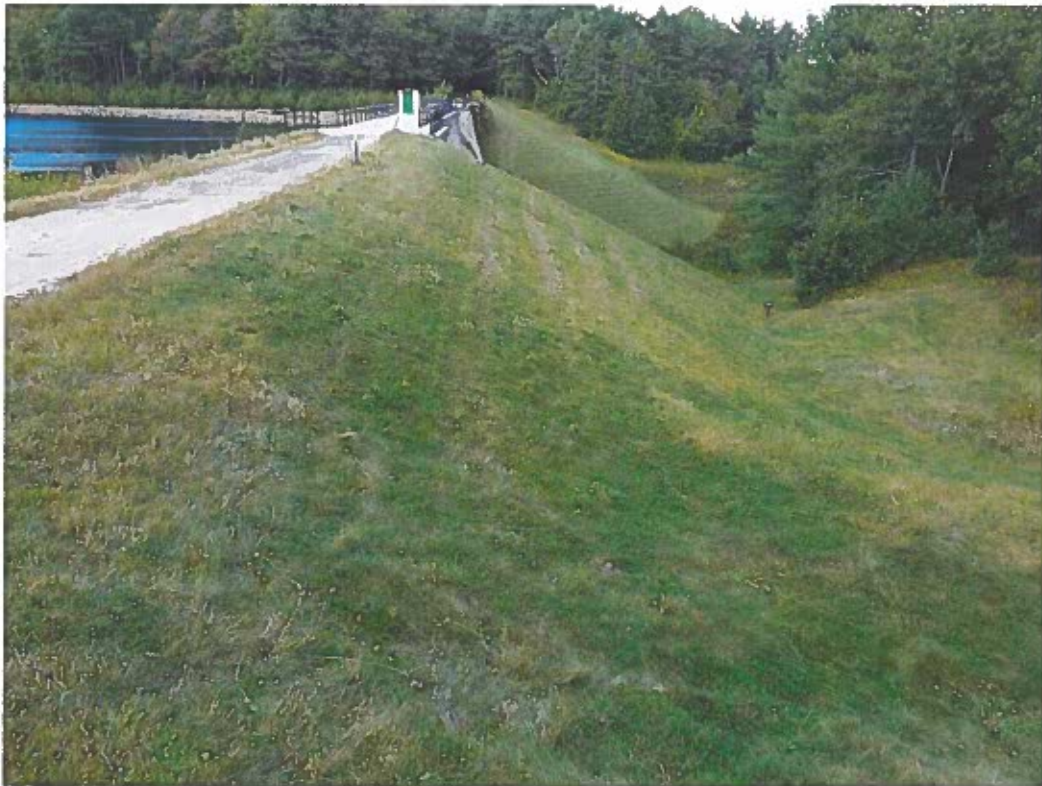
The grass-covered downstream slopes of the earth embankment are covered with maintained grass about 4 to 5 inches tall (Photos 6 and 7). Some tractor ruts and bare spots (Photo 37) were found parallel to the slope on the left downstream face. The area approximately 20-feet-wide by 40-feet-long at the base of the dam, right of the gate house, previously observed in 2012 as soft, damp ground, was much drier and firm during this inspection (Photo 14). Much of the shotcrete surface on the downstream face of the concrete dam is cracked, spalled and delaminated. Some vegetation has taken root in the cracks (Photos 29 and 30). Mineral deposits were noted below many of the spalled areas. One area has exposed wire mesh reinforcement from the shotcrete application performed between 1981 and 1982 (Photos 25 and 26). Calcium deposits were noted along the left concrete downstream face along with damp areas (Photo 27).

Photo No. 6: Overview of downstream slope from right abutment.

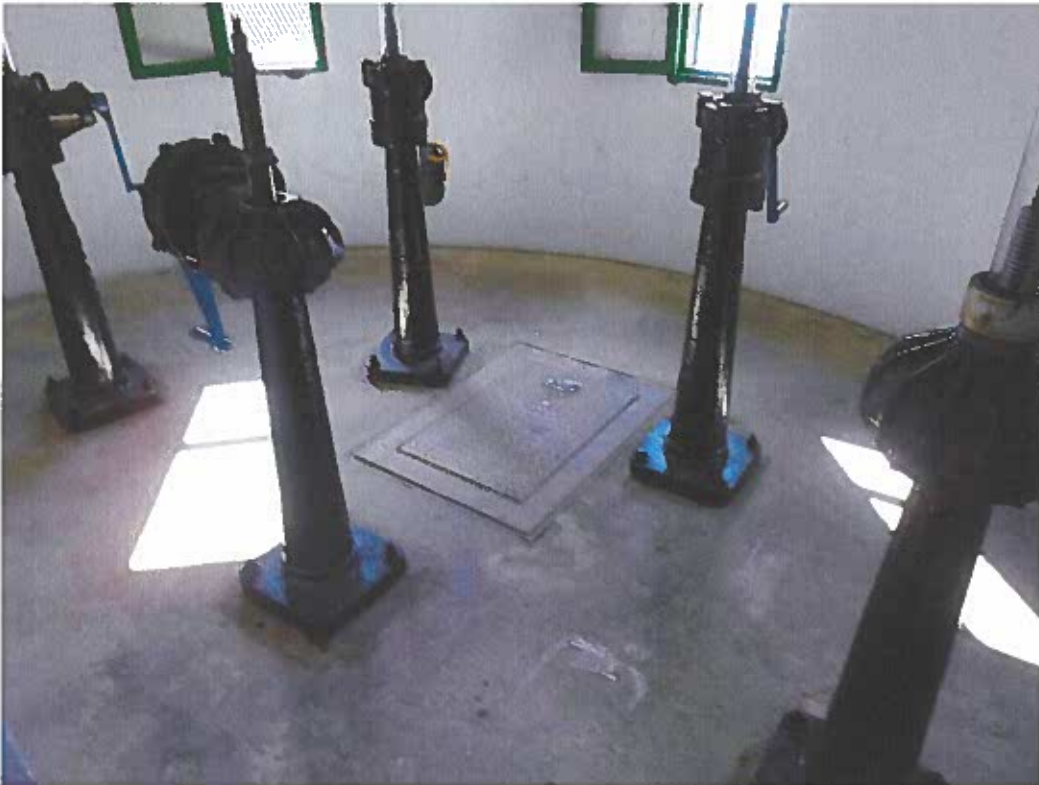
Photo No. 13: Overview of upper gatehouse interior and gate operators – mudgate, 24" x 26" sluice gate low-level outlet, 3 different level gates at reservoir.

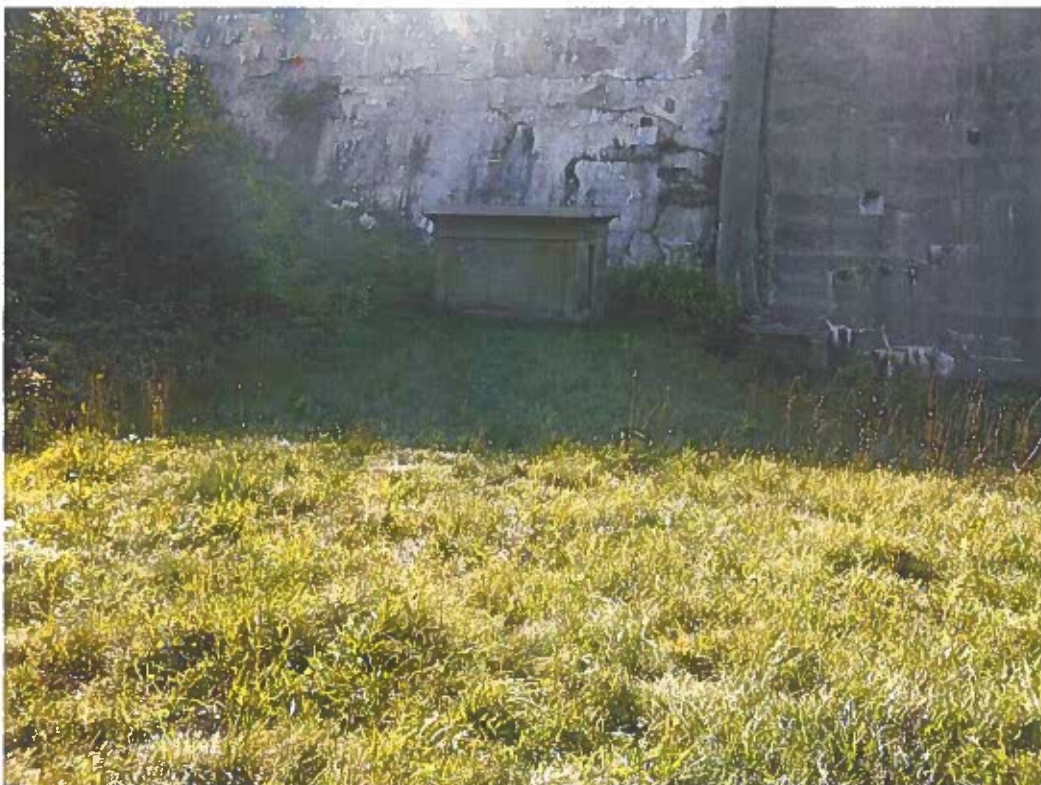
Photo No. 14: Overview of lower gatehouse exterior.

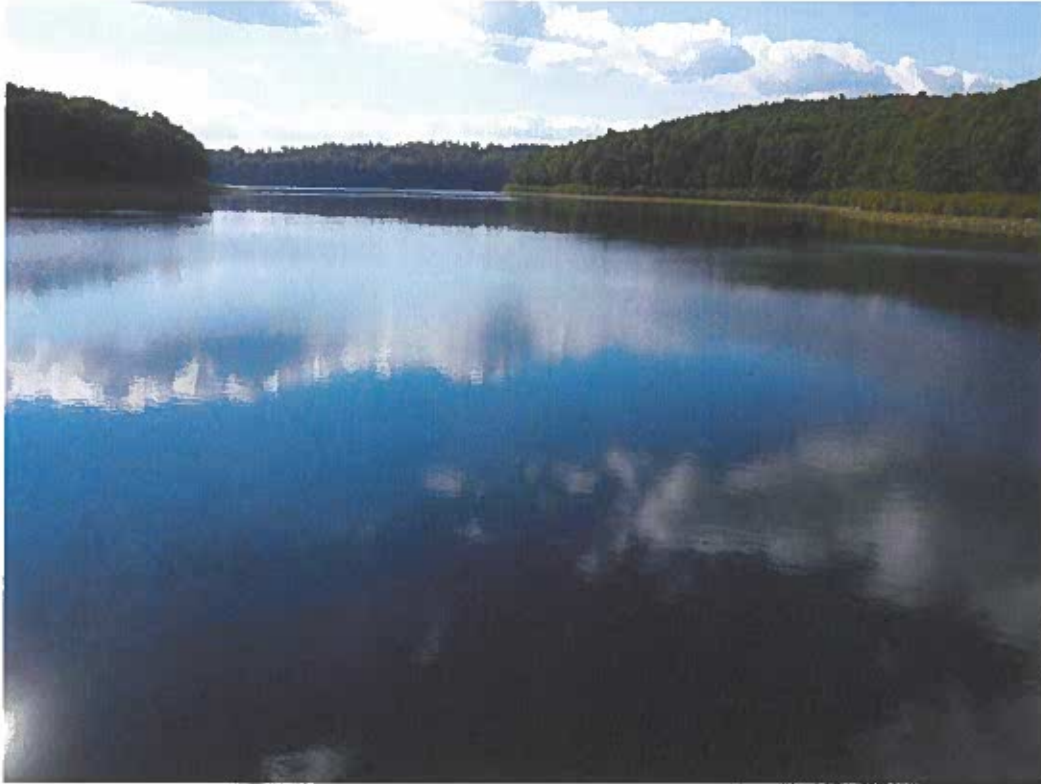
Photo No. 17: Overview of reservoir.

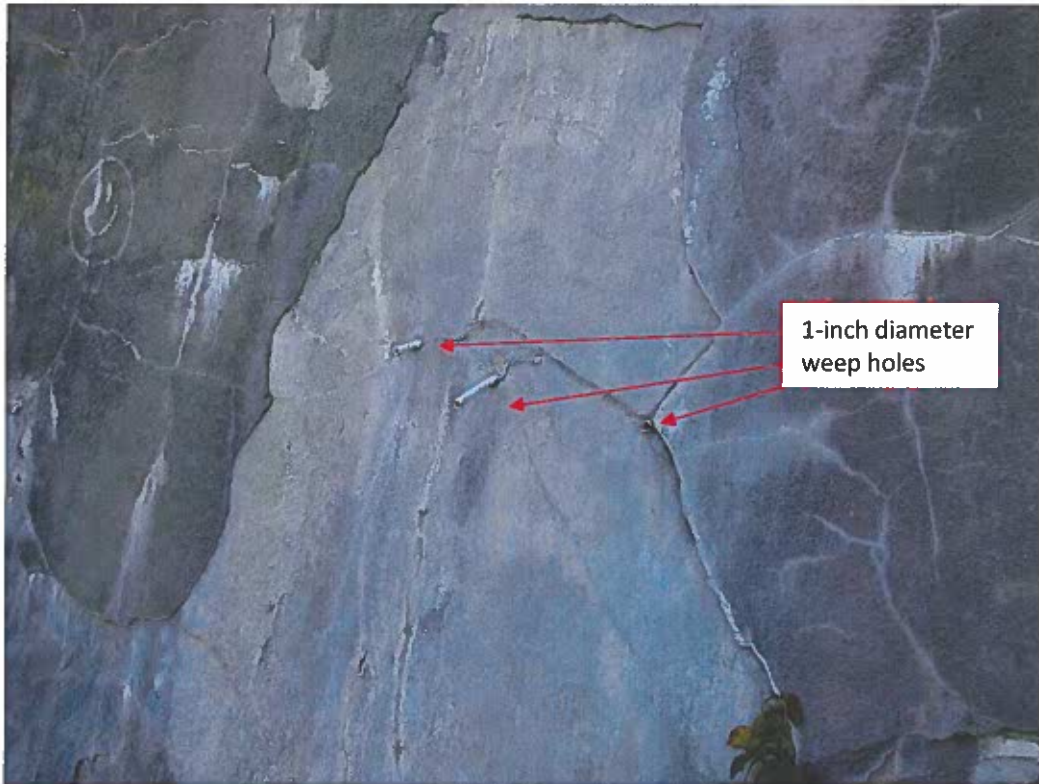
Several 1-inch diameter PVC pipes were observed on the downstream face of the concrete dam (Photo 31). These pipes were installed in the dam during the installation of shotcrete. A 9.5-inch deep weephole was observed on the downstream face of right dam section.

Photo No. 31: PVC weep holes on the downstream face of the dam to left of spillway. Weep holes were installed when dam face was sandblasted and shotcrete-covered in 1981 to 1982.

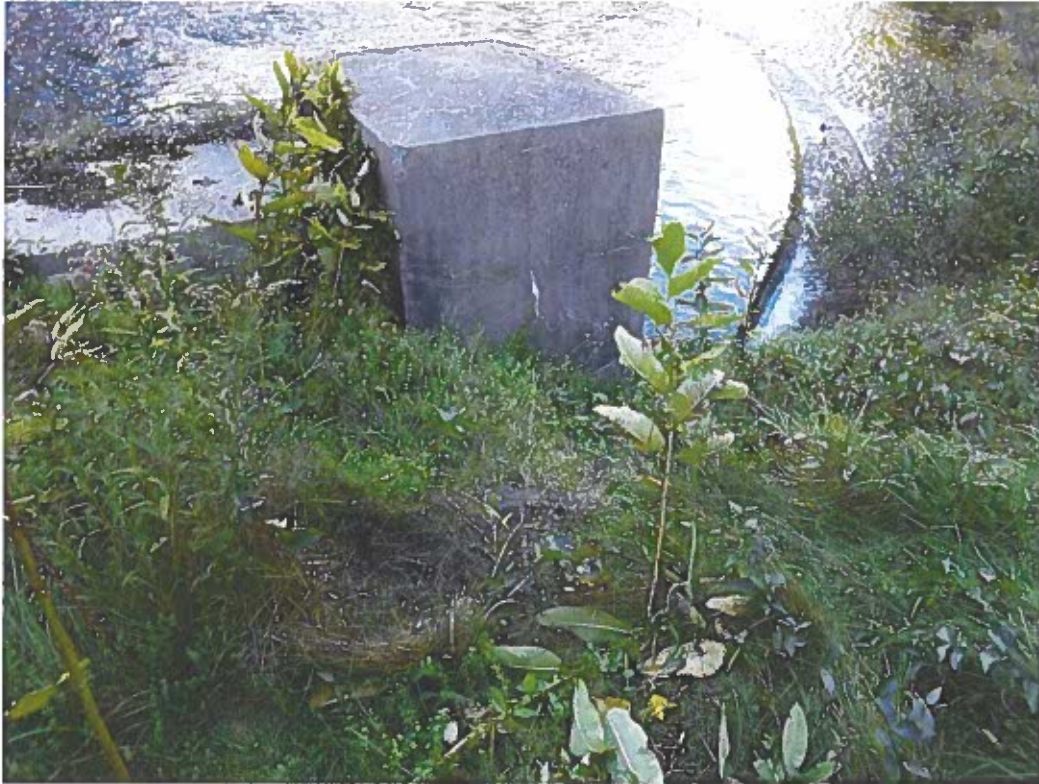
Photo No. 35: Manhole at the right downstream toe of the dam.
