# APPENDIX A

## TELEVISION INSPECTION REPORTS AND VIDEOS

## Inspection Report

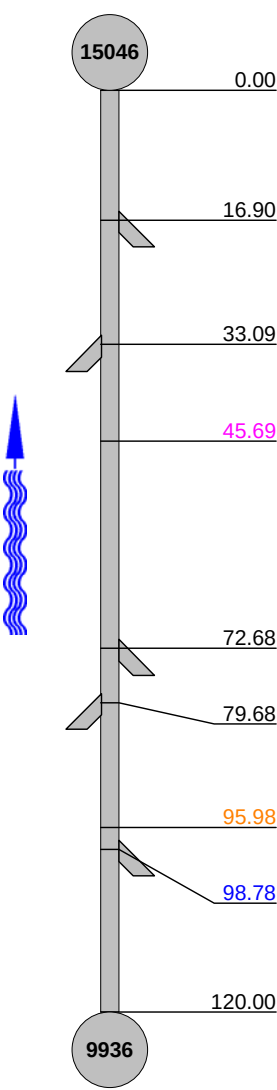
| 1:300 | Position | Observation | | |
|---|---|---|---|---|
| | 15046 | 0.00 | Downstream Manhole, Survey Begins | <br>45.69 FT |
| | | 16.90 | Tap Break-In, at 09 o'clock, -, within 8 inches of joint: NO, 6" | <br>79.68 FT |
| | | 33.09 | Tap Break-In, at 03 o'clock, -, within 8 inches of joint: NO, 6" | |
| | | 45.69 | Missing Brick, at 08 o'clock | |

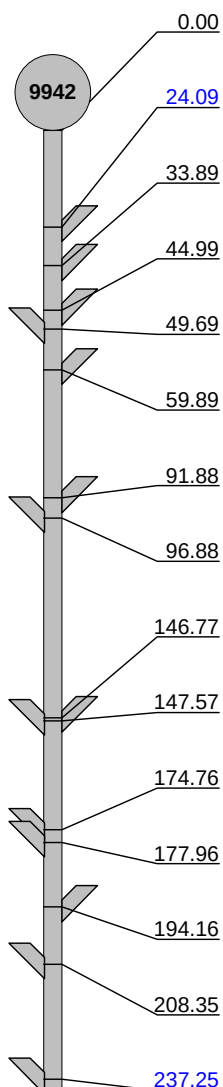
Upstream Manhole, Survey Begins

Tap Break-In Intruding, at 10 o'clock, -, -, within 8 inches of joint: NO, 1" 6"

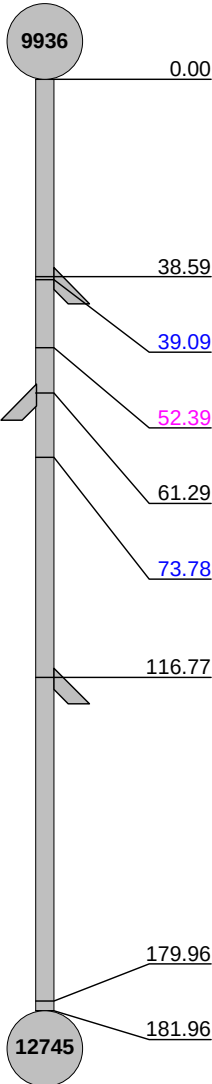
| 1:450 | Position | Observation | | | | | |
|---|---|---|---|---|---|---|---|
| | 9936<br>0.00 | Downstream Manhole, Survey Begins | <br>38.59 FT | | | | |
| | 38.59 | Tap Break-In, at 10 o'clock, -, within 8 inches of joint: NO, 6" | | | | | |
| | 39.09 | Deposits Attached Grease, 5 %of cross sectional area, from 09 to 12 o'clock, , within 8 inches of joint: NO | <br>39.09 FT | | | | |
| | 52.39 | Missing Brick, at 08 o'clock | | | | | |
