**HAZARDOUS MATERIALS SURVEY  
128 PROVIDENCE STREET  
WORCESTER, MASSACHUSETTS**

February 28, 2019

**Wilcox & Barton, Inc. Project No: WORC0006**

Wilcox & Barton, Inc. has completed a hazardous materials survey of the Former St. Vincent Hospital Nurses' Wing building at 128 Providence Street in Worcester, Massachusetts. The work was performed on behalf of the City of Worcester.

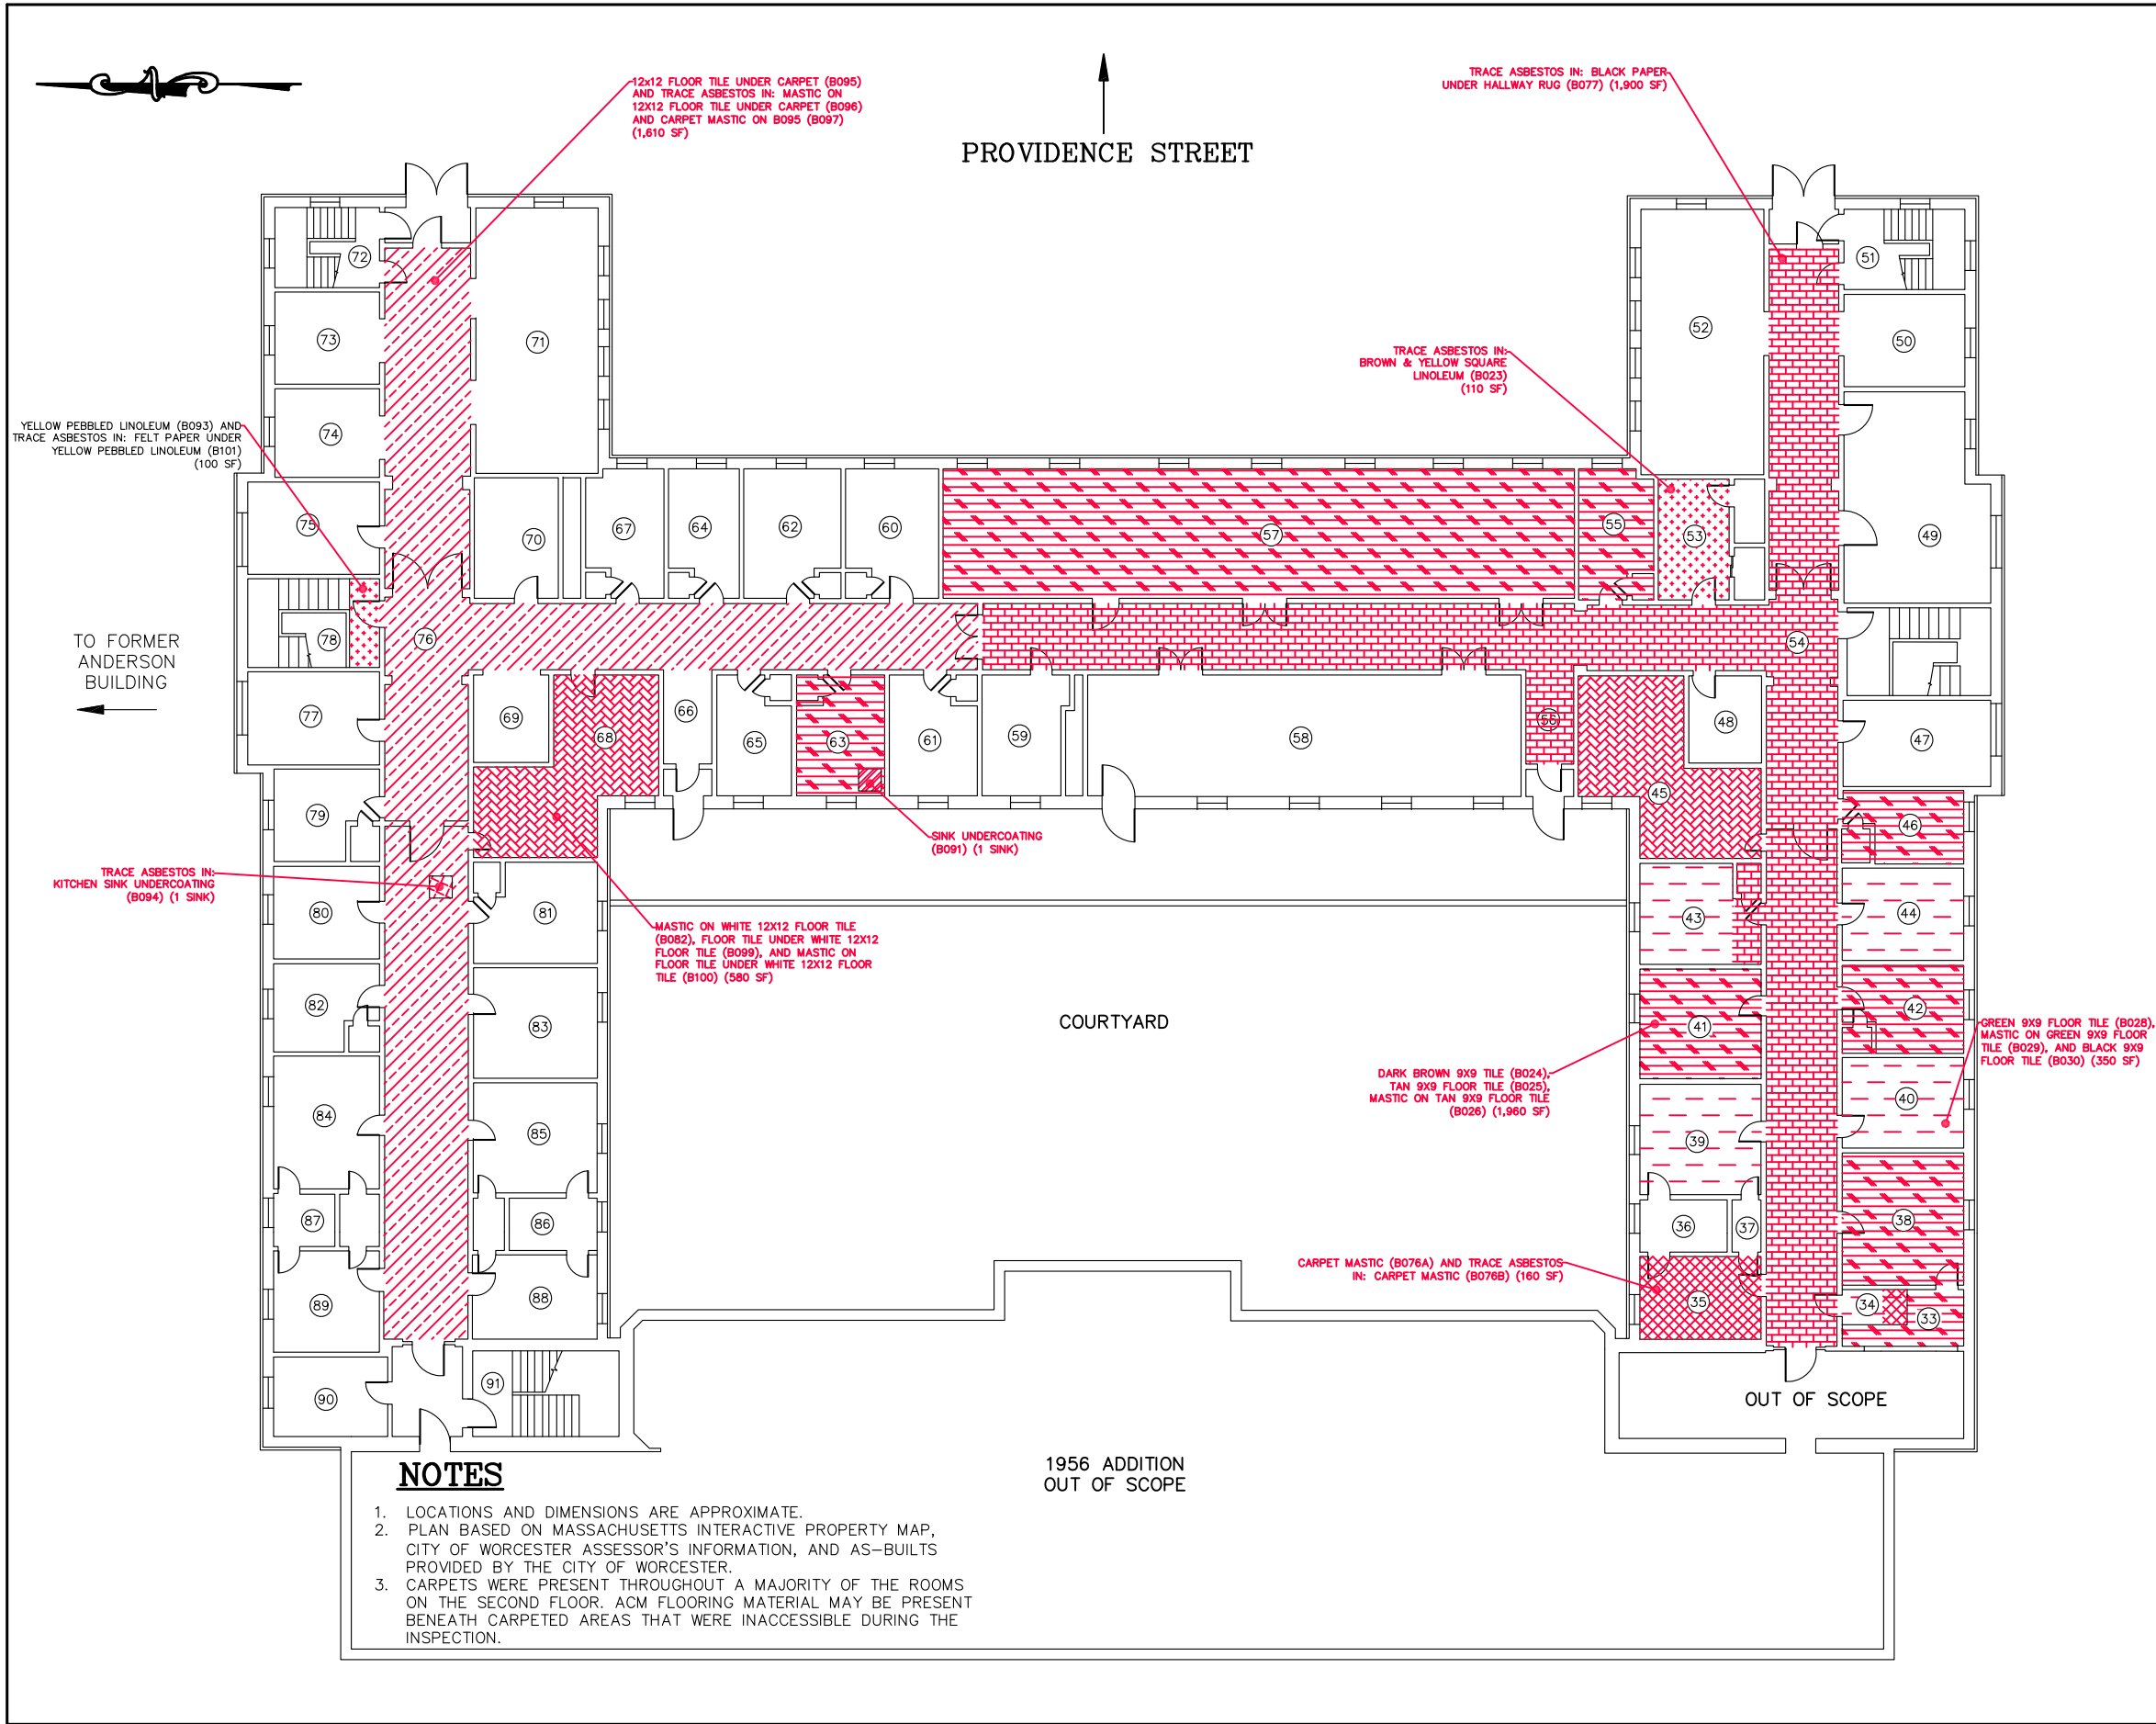
| LOCATION<br>Former St. Vincent Hospital Nurses' Wing<br>128 Providence Street<br>Worcester, Massachusetts | DRAWING NUMBER<br><b>FIGURE 3C</b> | |

A summary of sample locations, descriptions, and laboratory analytical results is presented in Table 1. The locations of the detected ACM and ACWM are depicted on Figures 3A through 3E.

| TITLE<br><b>HAZARDOUS MATERIALS SURVEY –<br/>ACM LOCATION PLAN –<br/>SECOND FLOOR</b> | | |

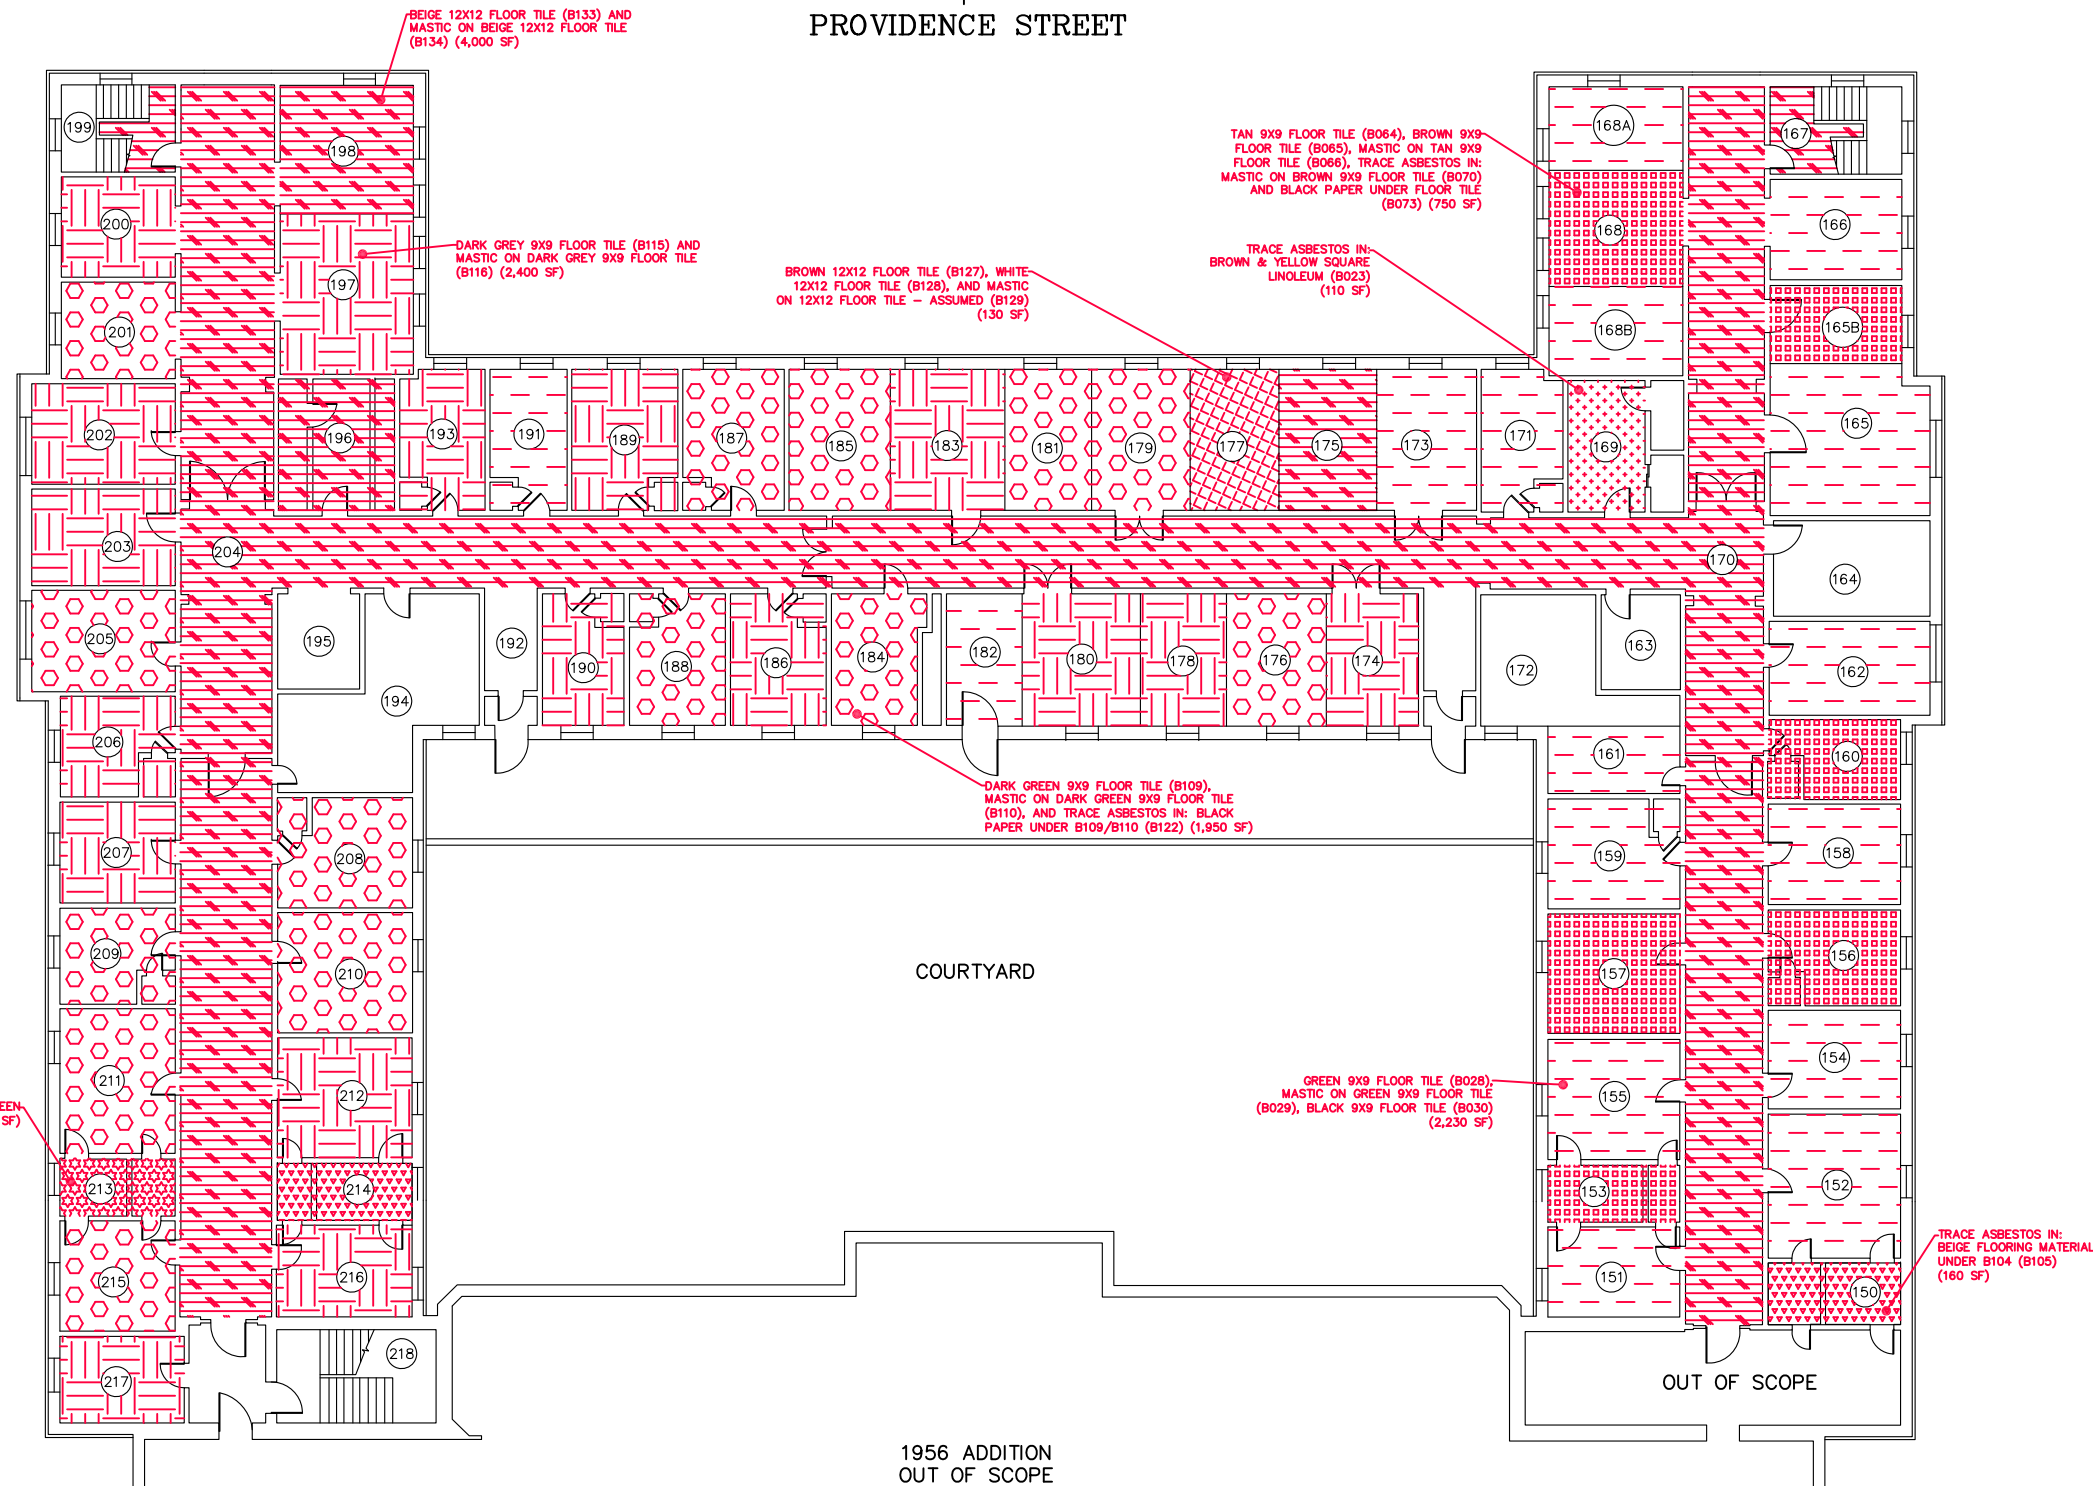
| LOCATION<br>Former St. Vincent Hospital Nurses' Wing<br>128 Providence Street<br>Worcester, Massachusetts | | DRAWING NUMBER<br><b>FIGURE 3E</b> |

| TITLE<br><b>HAZARDOUS MATERIALS SURVEY –<br/>ACM LOCATION PLAN –<br/>FOURTH FLOOR</b> | | |
