Multi-Way Stop Warrant Analysis

Southgate Street at Gardner Street Intersection September 6, 2023

Prepared by: Scott W. Galbraith, PE, Senior Traffic Engineer

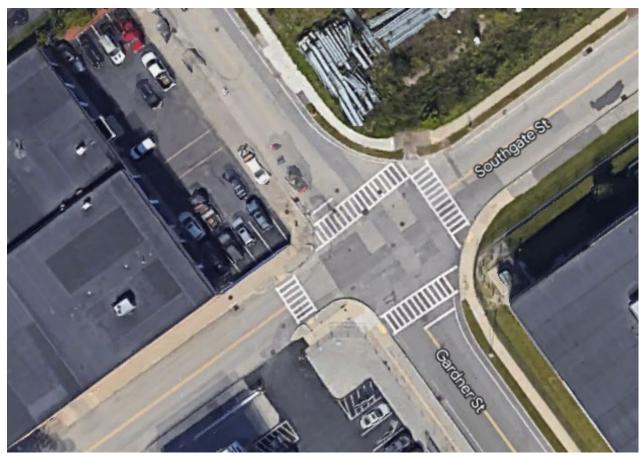
Figure 1: Aerial view of Southgate St-Gardner St intersection (source: Google Earth).

The intersection of Southgate Street and Gardner Street is in a mixed-use neighborhood with mostly commercial and industrial uses surrounding the intersection. Southgate Street leads northeast from this location to Southbridge Street after passing under a railroad bridge. To the West, Southgate Street connects to a residential neighborhood. To the northwest, Gardner Street links Southgate Street to Canterbury Street along which the 825 WRTA bus line travels. Gardner Street also provides access to a cold-storage facility and Armory Street to the southeast.

Southgate Street and Gardner Street are both classified as Local roadways. All approaches to this intersection are two-way having one travel lane in each direction. Parking is prohibited statutorily within 20 feet of the intersection. This is reinforced by curb extensions on the eastbound Southgate Street approach. There are four crosswalks at this intersection with a mixture of ADA-compliant and non-compliant curb ramps.

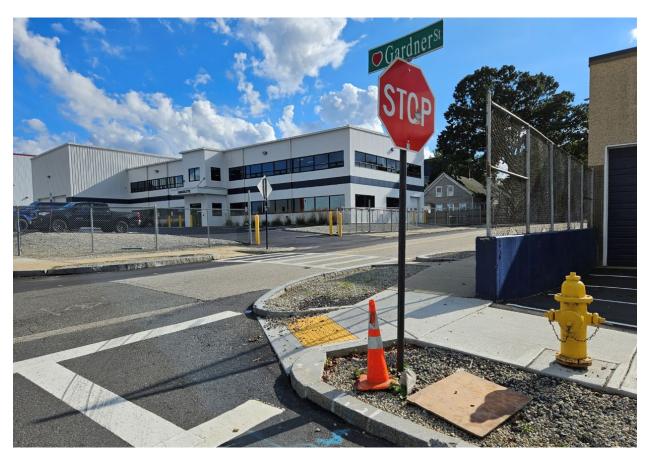
Figure 2: View westbound on Southgate St from Gardner St (source: 9/12/2023 DTM site visit)

Confirmed in the field and using City GIS imagery.

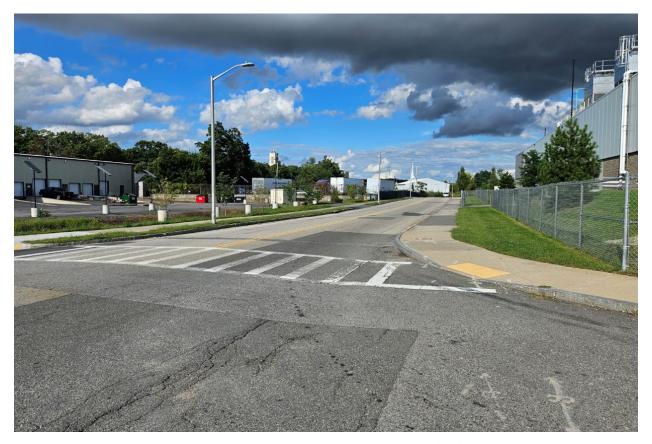
Figure 3: View eastbound on Southgate St from Gardner St (source: 9/12/2023 DTM site visit)
