## Lake Quinsigamond 2022 Winter Monitoring Plan and Results Following the Sewer Overflow at the Lake Ave Pump Station

6.10.22

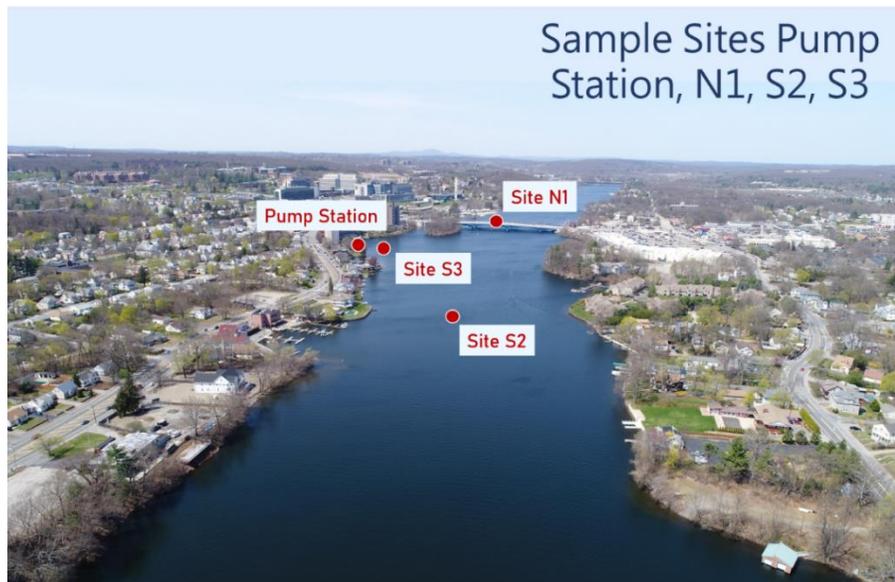
**Figure A.** L&P sampling locations, mid-lake looking north to the Rt 9 Bridge

The Lakes and Ponds Program sampled at four in-lake locations as well as from the shoreline behind the pump station (see *Figures A and B*). Sites were chosen to assess the extent of the impact of the event with increasing distance from the pump station.

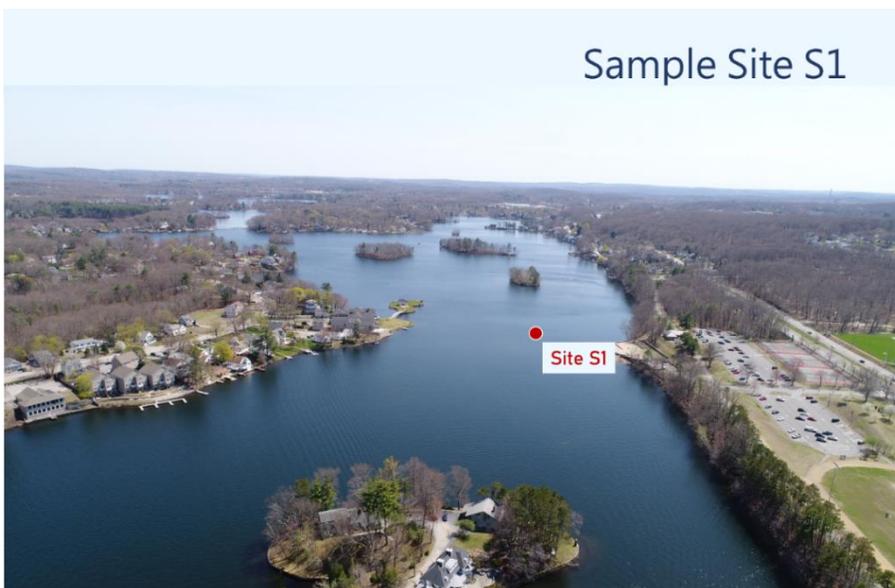
**Figure B.** L&P sampling locations, mid-lake looking south to Flint Pond
