CONDOMINIUM RESERVE STUDY

Denholm Building

**484 Main Street
Worcester, Massachusetts**

**Subject: Condominium Reserve Study & MEP/LS Report
Denholm Building
484 Main Street, Worcester, Massachusetts
EBI Project #1319000663**

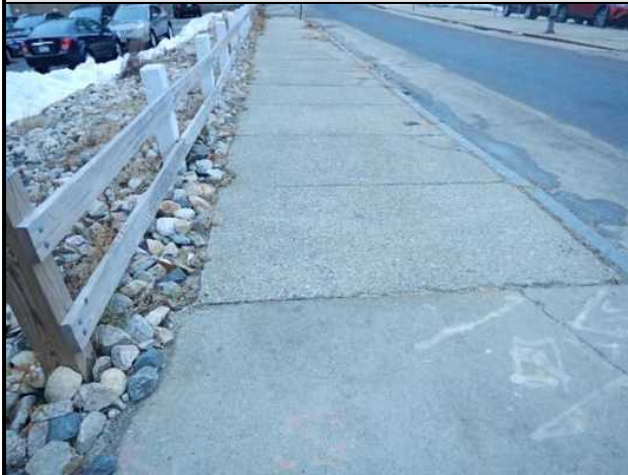
Sidewalk along remote parking lot	Deteriorated sidewalk at remote parking lot

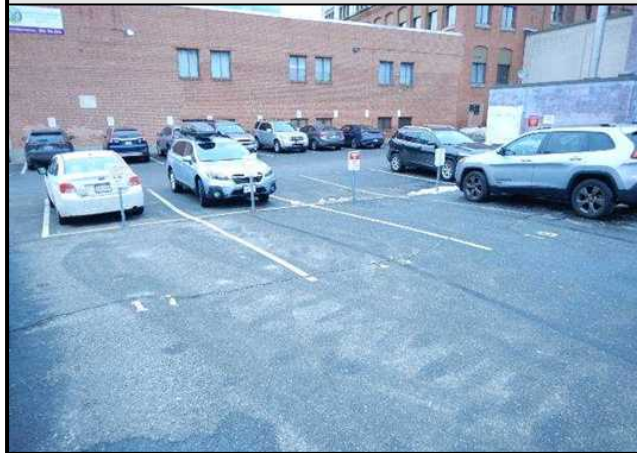
View of parking lot behind building

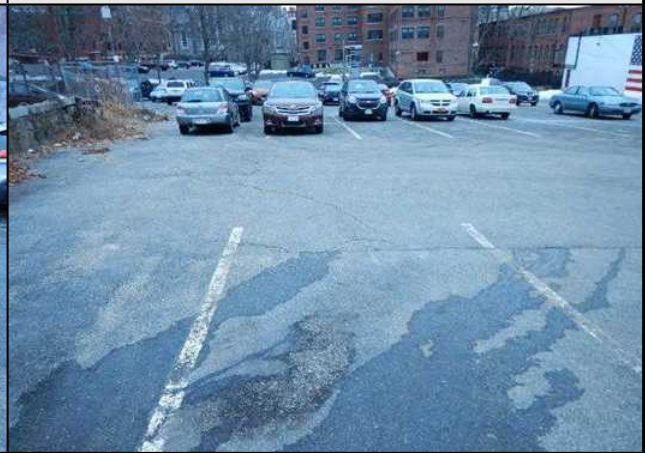
View of remote parking lot

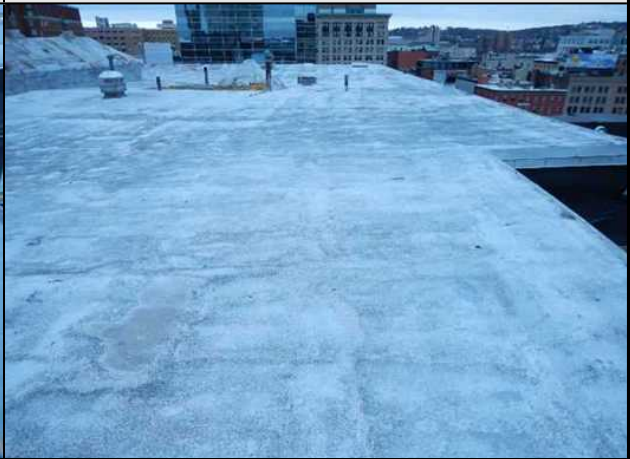
View of polyurethane foam roofing section C

4.1	Roof area C	EPDM 60 mil roof replacement - mid rise	7,015	\$9.64	20.0%	\$11.57	per square foot		✓	\$81,170.57	Replace built-up and foam roof section C.

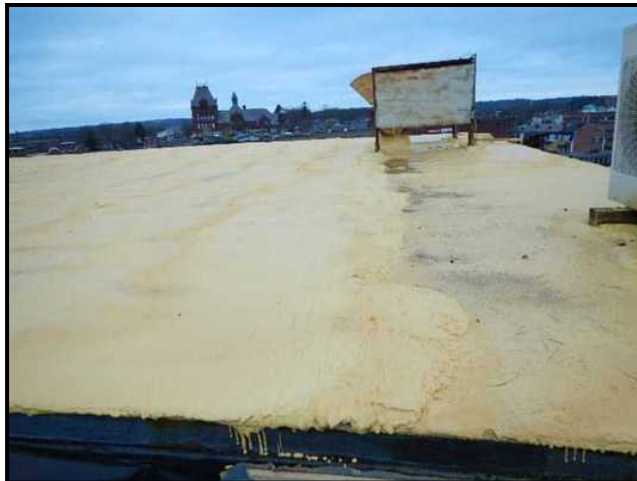
Unfinished polyurethane foam roof section E

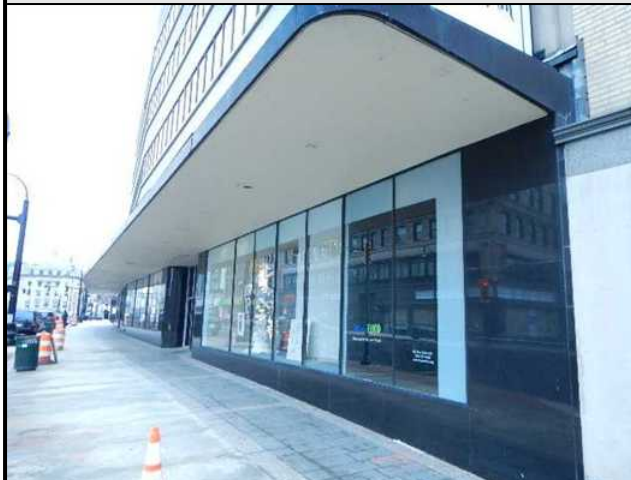
Front of building storefront assembly with canopy overhang

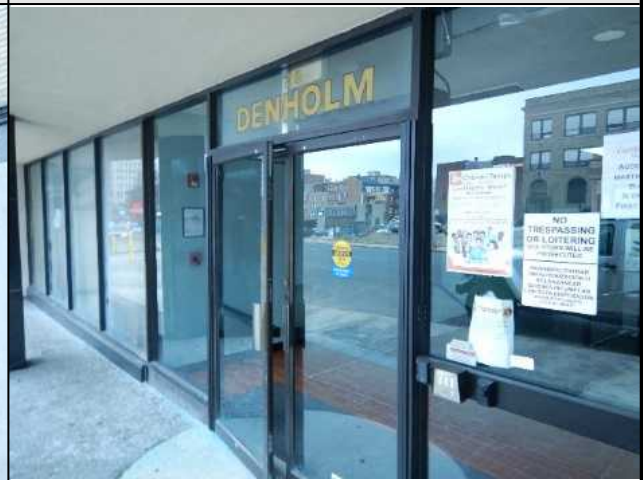
Storefront façade along western side

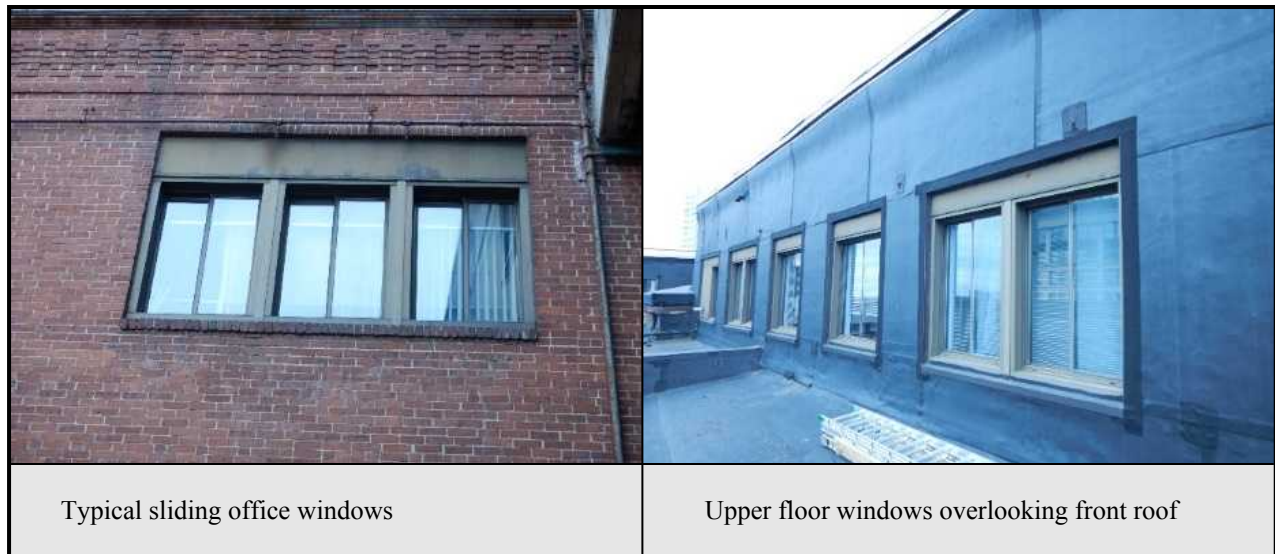
Typical sliding office windows

Upper floor windows overlooking front roof

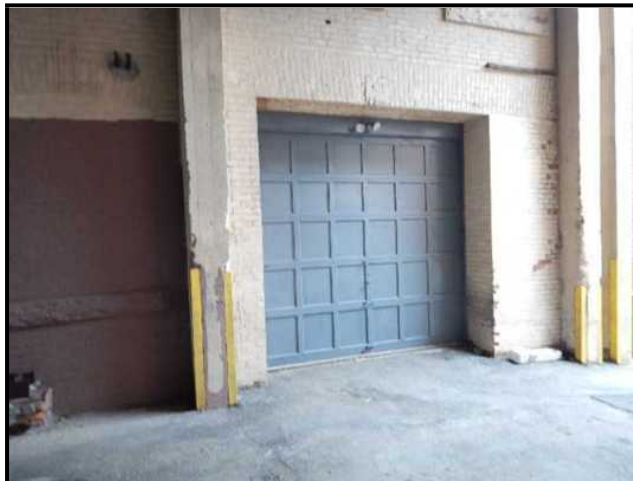
Service alley maintenance garage door

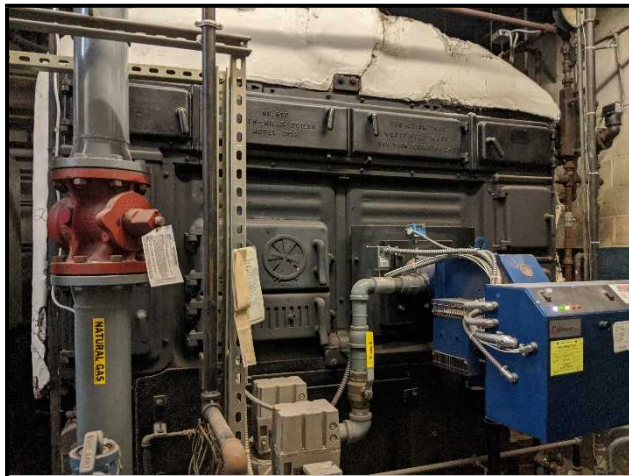
converted to natural gas. The operating natural gas-fired boiler is able to carry the load of the entire building, but in the case of failure, the building has no back-up and would be left with no heat. The Subject Property utilizes water treatment system for the condenser water system. The water is treated with various chemicals to prolong the life of the individual components of the HVAC. As defined at <http://www.answers.com>, "Water treatment is used to optimize most water-based industrial processes, such as: heating, cooling, processing, cleaning, and rinsing, so that operating costs and risks are reduced. Poor water treatment lets water interact with the surfaces of pipes and vessels which contain it. Steam boilers can scale up or corrode, and these deposits will mean more fuel is needed to heat the same amount of water. Cooling towers can also scale up and corrode, but left untreated, the warm dirty water they can contain will encourage bacteria to grow."

Central gas-fired steam boiler	Typical Radiator

- **Replace Gas-Fired Steam Boiler (3770 MBH)**
- **Licensed Engineering firm to evaluate the replacement and natural gas conversion of oil-fired steam boiler (3770 MBH) and provide cost**
- **Replace six (6) DX condensers**
- **Replace eight (8) SCAHU's**
- **Replace two (2) DX AHU**
- **Replace two (2) RTU's**

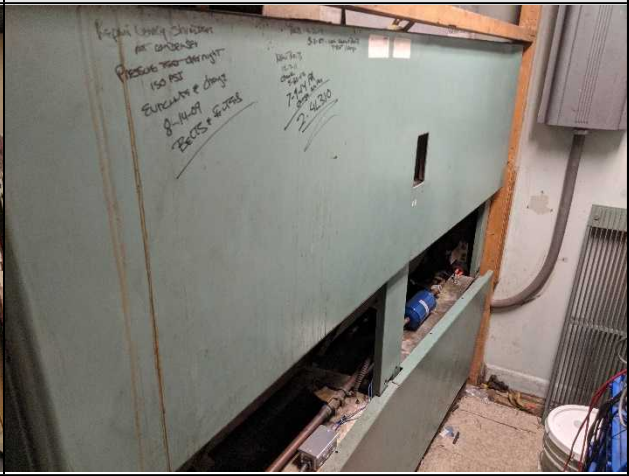
Water Treatment System	Typical Fan Coil Unit

Discussions with the owner's representative indicate that, according to the Subject Property lease terms, the owner is responsible for HVAC repairs and replacement. Based on the age of the HVAC equipment Replacement Reserves are recommended for replacement of approximately 15 fan coil units and 9 rooftop condensers.

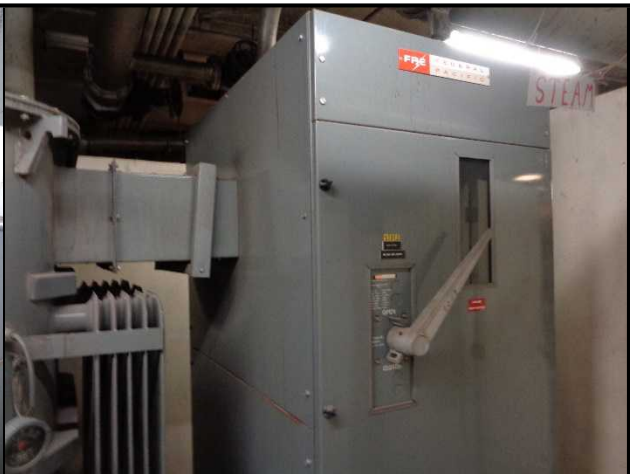
Main Switchgear

The electrical main/switchboard components at the Subject Property generally appear to be in fair to poor condition. Although no problems were identified during the MEPSE II survey, the two 3000-amp, 120/208-Volt service switchboard generally appears to be in fair to poor condition and approximately 40-60 years old. EBI recommends that a licensed electrician be engaged to inspect the main Federal Pacific Electric switchboards and distribution panels and provide recommendations regarding the equipment in regards to repair/replacement. Costs for the inspection are included as an Immediate Repair item.

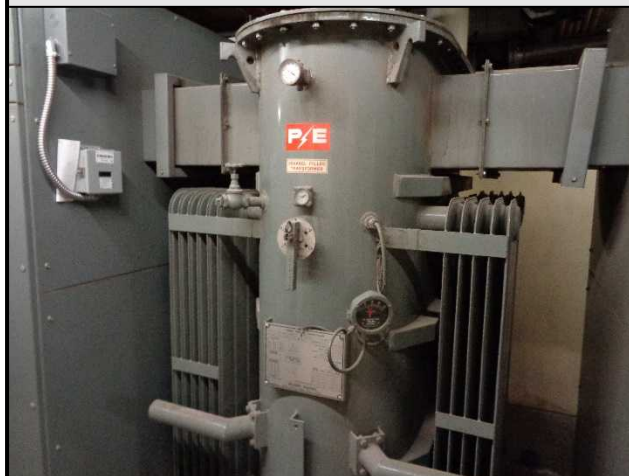
Main transformer

The main switchgear 1000 KVa transformer are approximately 40 years old, appears to be in fair overall condition, with no reported problems noted. The average useful life of transformers of this size and type is approximately 40 to 50 years, depending upon its location, maintenance and use type. Based on their average effective useful life, current condition and reported maintenance program, Replacement Reserves are recommended to replace the main switchgear 1000 KVa transformers at the beginning of the analysis term.

- **Transformer replacement**

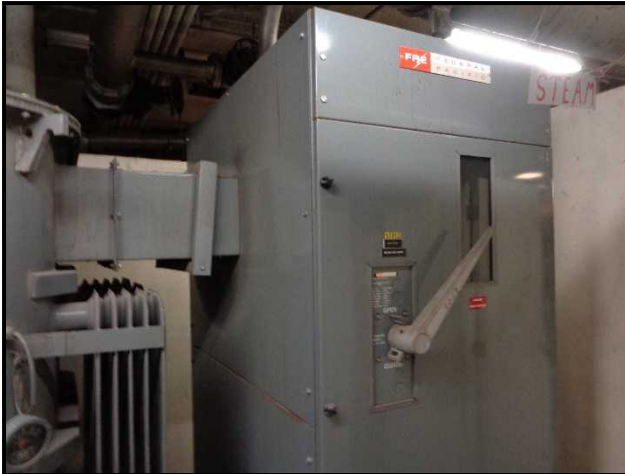
Federal Pacific Switchgear	Federal Pacific Panelboard

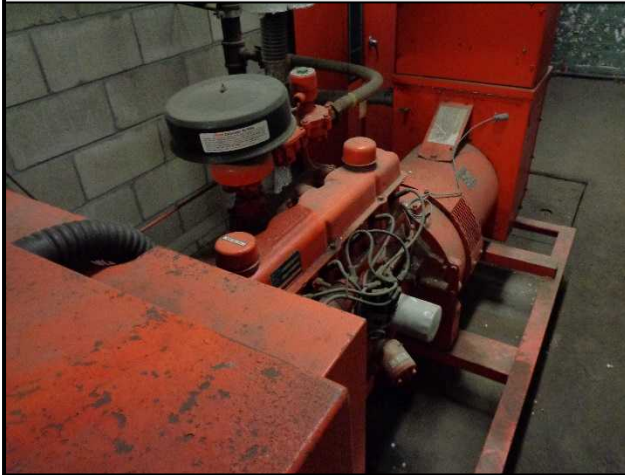
The emergency generator is approximately 40 years old and appears to be in fair to poor condition. Generators of this size and type have an average expected useful life of approximately 25 to 30 years, depending on their maintenance and amount of regular testing and usage, but can be extended with refurbishment/overhaul of the unit. The emergency generator was not operated during our on-site assessment. According to maintenance personnel, the generator is exercised at regular intervals during the year and was last tested. Based on its reported age, current condition, and expected useful life, Short Term Repairs are recommended for replacement of the emergency generator.

Emergency Generator	Disconnects with hot spots

- **Replace Gas-Fired Emergency Generator (60 kW)**

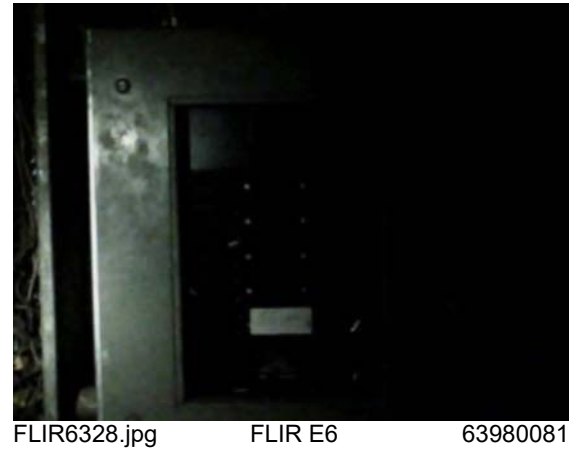
Bx1	Max	71.3 °F
	Min	66.7 °F
	Average	67.9 °F

The surface temperatures recorded at the electrical panel fall within the safe temperature range defined by the InterNational Electrical Testing Association (NETA).

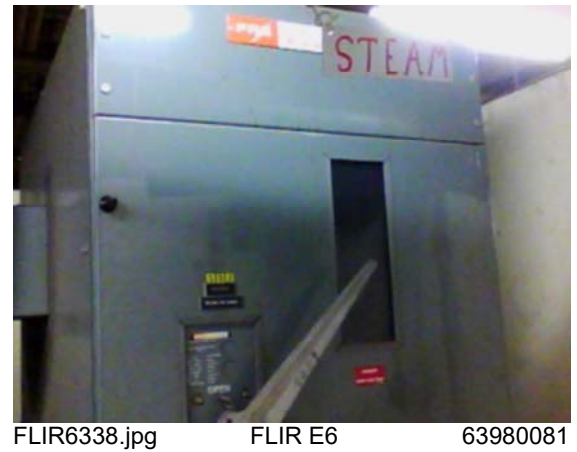
Bx1	Max	75.3 °F
	Min	72.5 °F
	Average	73.7 °F

The surface temperatures recorded at the switchgear fall within the safe temperature range defined by the InterNational Electrical Testing Association (NETA).

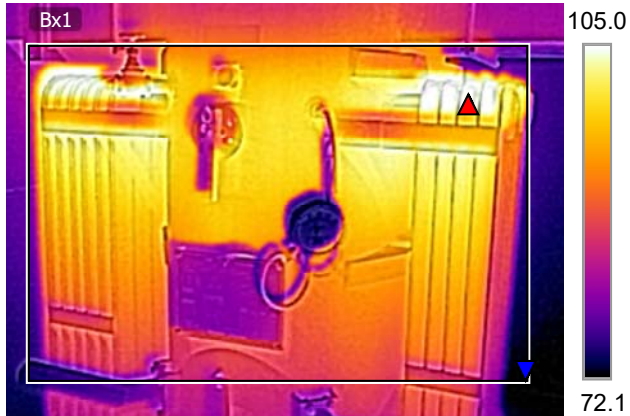
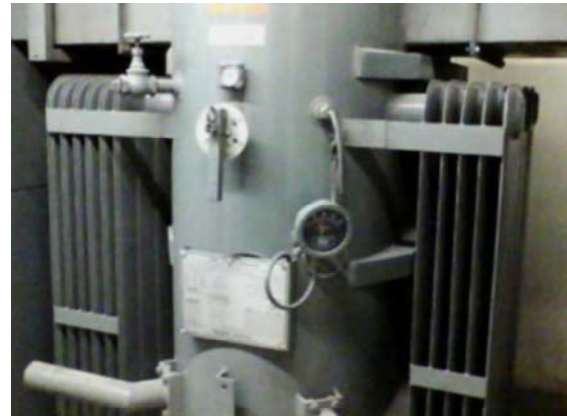
Switchgear 1 - PE Xformer

Transformers are typically labeled with standard temperature rises of 80°C (176°F), 115°C (239°F), or 150°C (302°F), which is the temperature rise above ambient conditions which the transformer is rated to. The transformers in the electrical room appear to be below the typical temperature range.

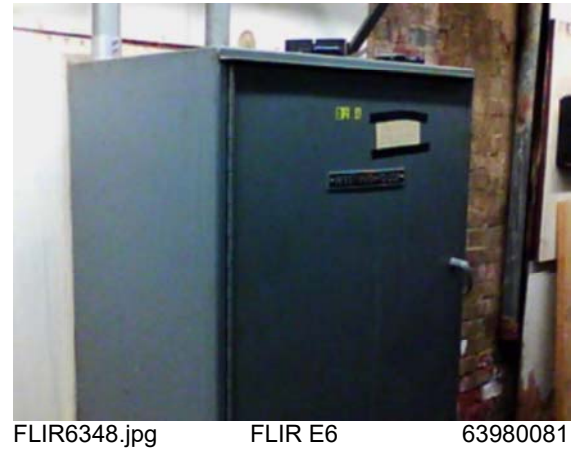
The surface temperatures recorded at this transformer fall within the safe temperature range.

Tranformers are typically labeled with standard temperature rises of 80°C (176°F), 115°C (239°F), or 150°C (302°F), which is the temperature rise above ambient conditions which the transformer is rated to. The transformers in the electrical room appear to be below the typical temperature range.

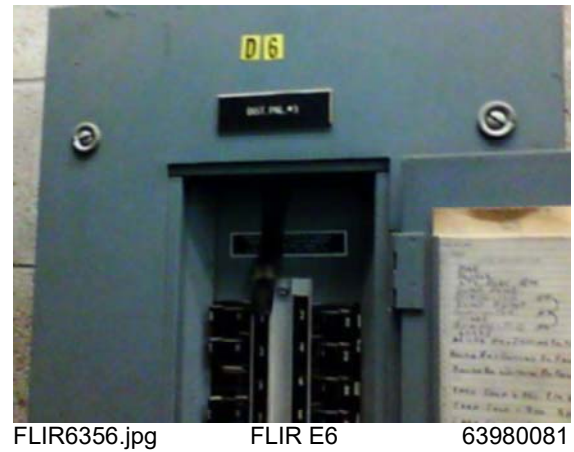
Distribution Panel - D6

The surface temperatures recorded at the electrical panel fall within the safe temperature range defined by the InterNational Electrical Testing Association (NETA).

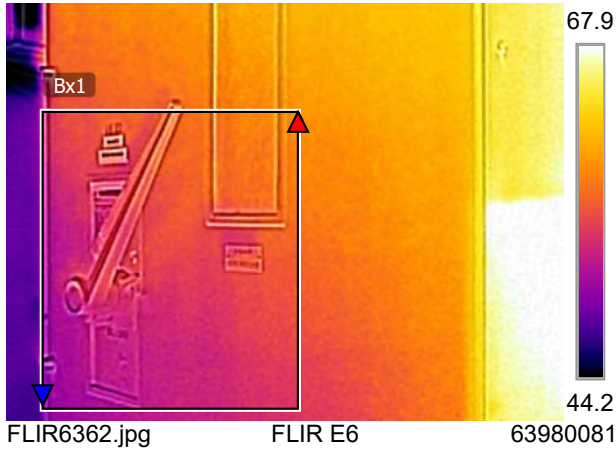
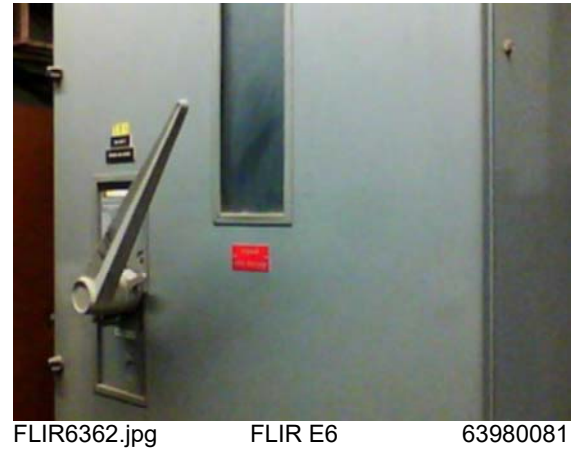
Switchgear - SD4

The surface temperatures recorded at the switchgear fall within the safe temperature range defined by the InterNational Electrical Testing Association (NETA).

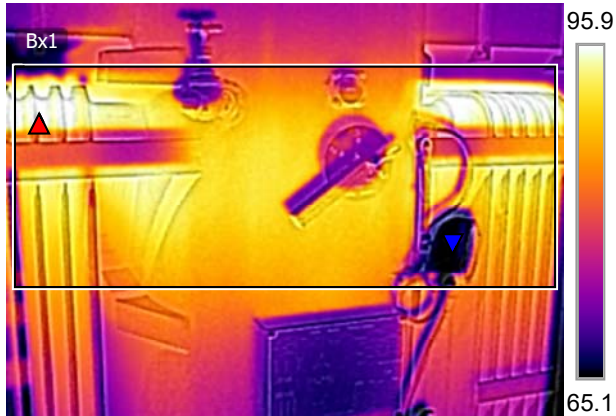
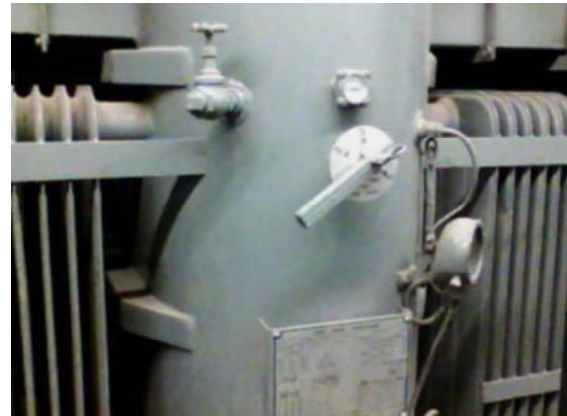
Switchgear 2 - PE Xformer

The surface temperatures recorded at this transformer fall within the safe temperature range.

Transformers are typically labeled with standard temperature rises of 80°C (176°F), 115°C (239°F), or 150°C (302°F), which is the temperature rise above ambient conditions which the transformer is rated to. The transformers in the electrical room appear to be below the typical temperature range.

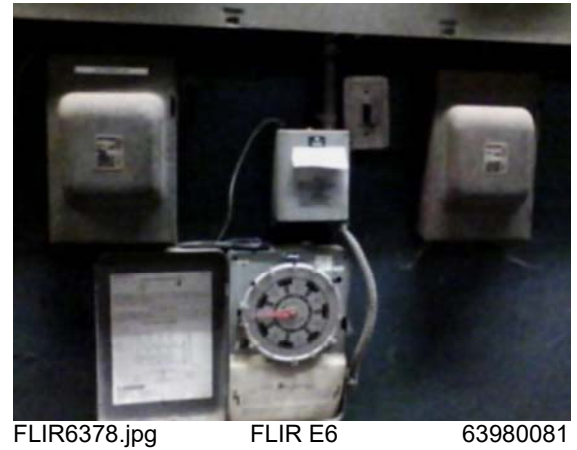
Bx1	Max	93.5 °F
	Min	63.9 °F
	Average	71.0 °F

The surface temperatures recorded at the electrical panel DO NOT fall within the safe temperature range defined by the InterNational Electrical Testing Association (NETA).

2.3	Electric	Inspection electrical equipment by licensed electrical contractor	1	\$3,000.00	20.0%	\$3,600.00	#N/A	\$3,600.00			EBI observed that panels and local disconnects (identified in red in the table of the report) appear to need retorquing and tightening to ensure proper connections due to above normal temperatures. Immediate Repairs are recommended for retorquing of these panels and disconnects by a qualified electrician.

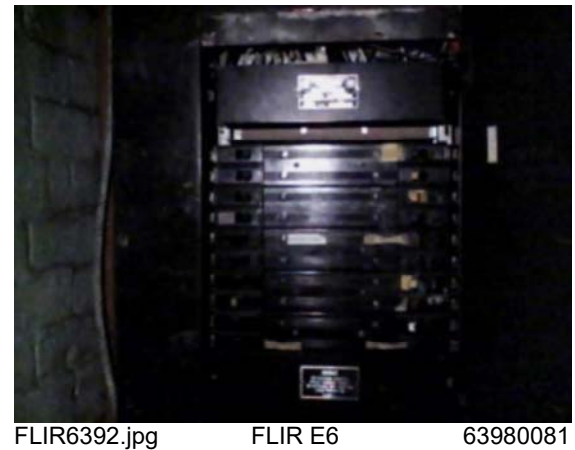
Distribution Panel - No Tag (Basement)

The surface temperatures recorded at the electrical panel fall within the safe temperature range defined by the InterNational Electrical Testing Association (NETA).

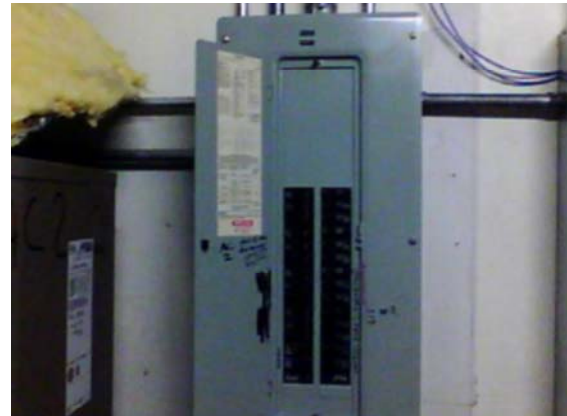
The surface temperatures recorded at the electrical panel fall within the safe temperature range defined by the InterNational Electrical Testing Association (NETA).

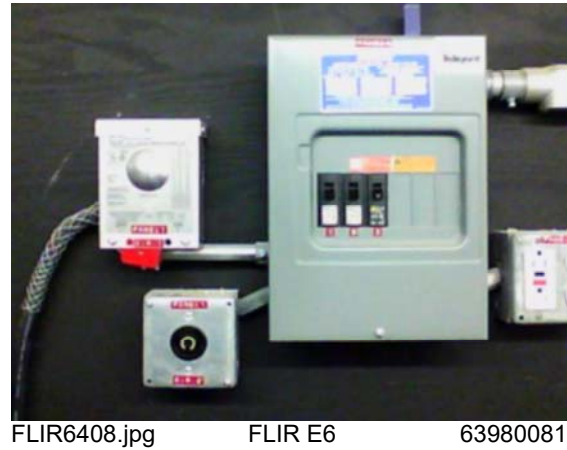
Distribution Panel - No Tag (1st Floor)

The surface temperatures recorded at the electrical panel fall within the safe temperature range defined by the InterNational Electrical Testing Association (NETA).

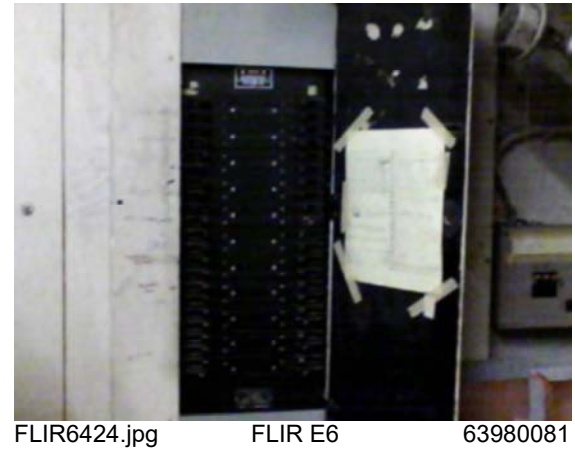
Distribution Panel - D3-1

The surface temperatures recorded at the electrical panel fall within the safe temperature range defined by the InterNational Electrical Testing Association (NETA).

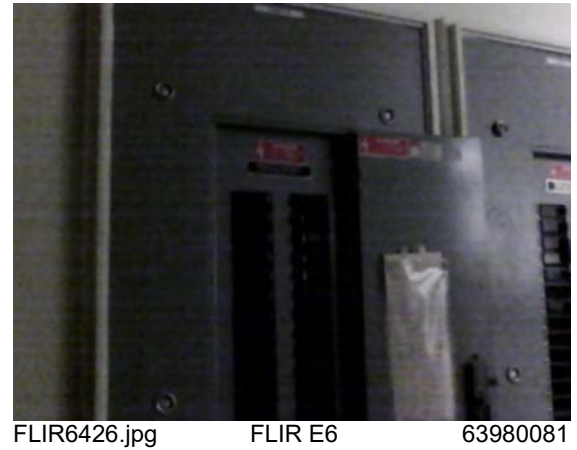
The surface temperatures recorded at the electrical panel fall within the safe temperature range defined by the InterNational Electrical Testing Association (NETA).

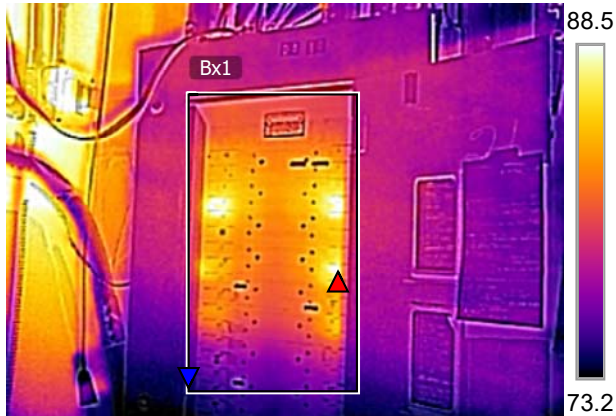
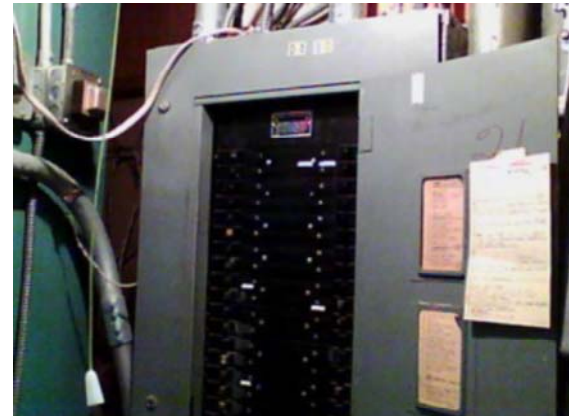
Distribution Panel - D4-10 section 1

The surface temperatures recorded at the electrical panel fall within the safe temperature range defined by the InterNational Electrical Testing Association (NETA).

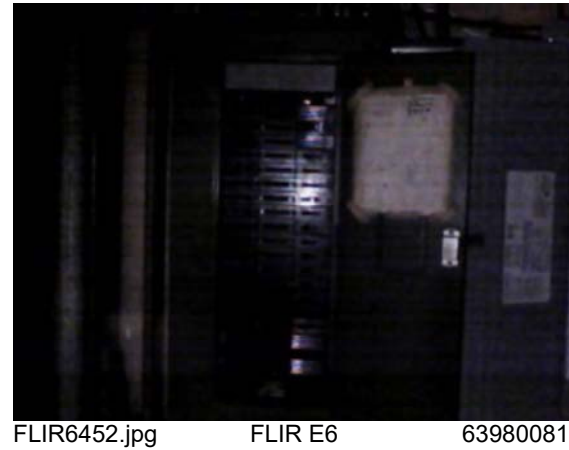
Distribution Panel - No Tag (Suite 450)

Bx1	Max	73.2 °F
	Min	69.5 °F
	Average	71.8 °F

The surface temperatures recorded at the electrical panel fall within the safe temperature range defined by the InterNational Electrical Testing Association (NETA).

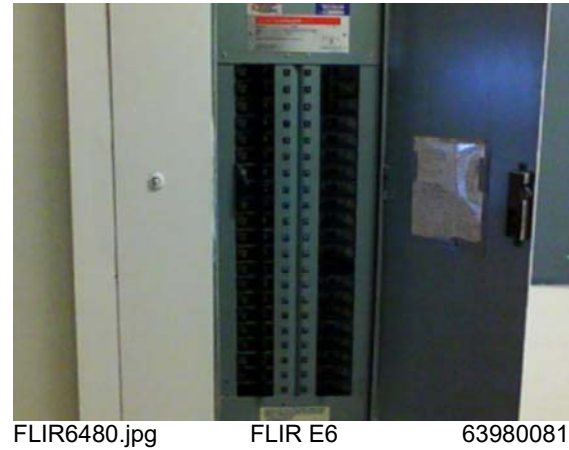
Distribution Panel - No Tag

The surface temperatures recorded at the electrical panel fall within the safe temperature range defined by the InterNational Electrical Testing Association (NETA).

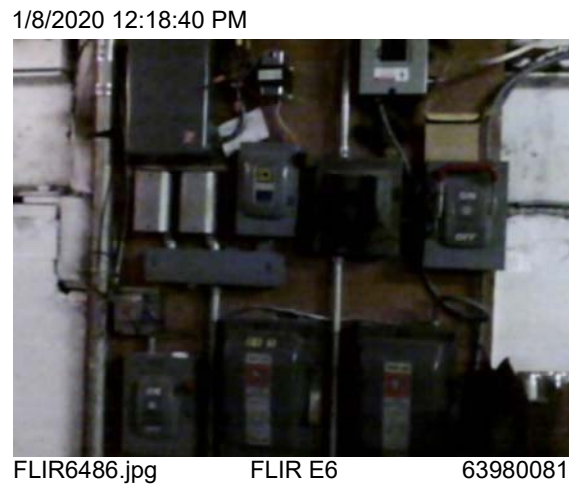
The surface temperatures recorded at the electrical panel fall within the safe temperature range defined by the InterNational Electrical Testing Association (NETA).

Guidelines from NETA recommend immediate repairs when the temperature difference (ΔT) between a component and the ambient air exceeds 20°F and 7° between similar components adjacent to one another.
