# APPENDIX A

## TELEVISION INSPECTION REPORTS AND VIDEOS

Project Name: <b>WS WORCESTER WI</b>	Project Number:	Date:
---	-----------------	-------

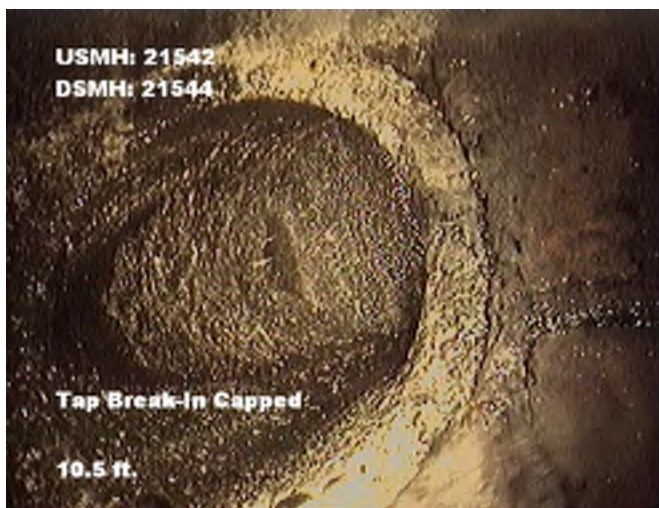
Distance: 10.5 ft. Grade: 2  
Condition: Tap Break-In Capped  
Remarks: N/A

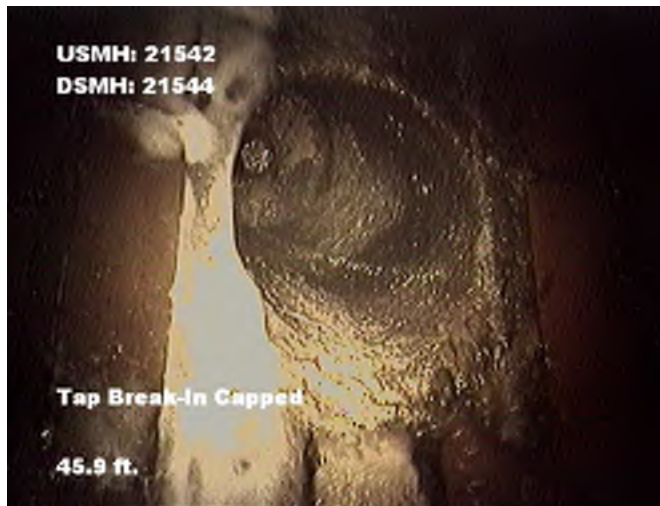
Distance: 45.9 ft. Grade: 2  
Condition: Tap Break-In Capped  
Remarks: N/A

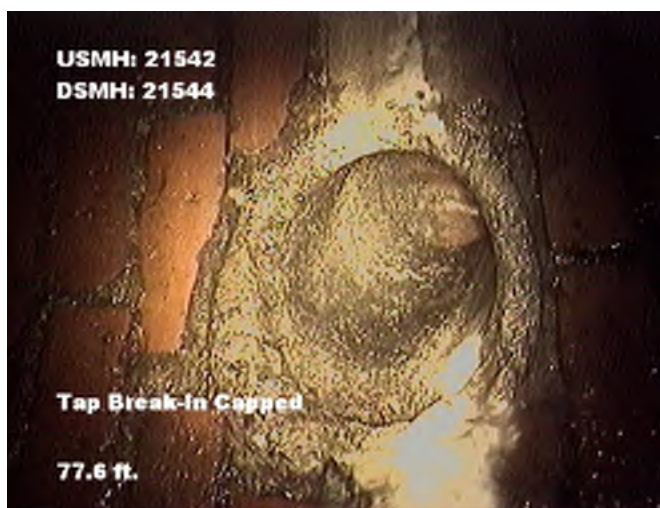
Distance: 77.6 ft. Grade: 2  
Condition: Tap Break-In Capped  
Remarks: N/A

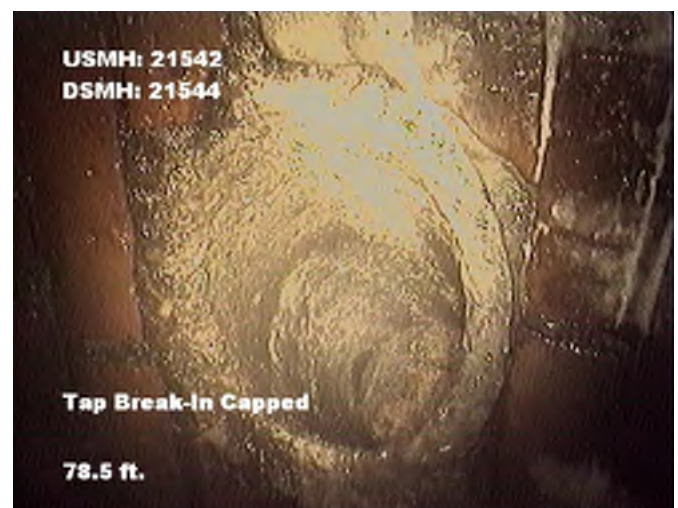
Distance: 78.5 ft. Grade: 2  
Condition: Tap Break-In Capped  
Remarks: N/A

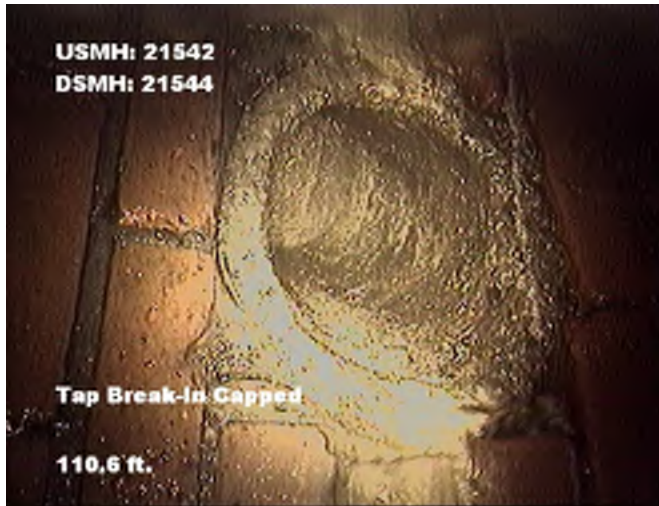
Distance: 110.6 ft. Grade: 2  
Condition: Tap Break-In Capped  
Remarks: N/A

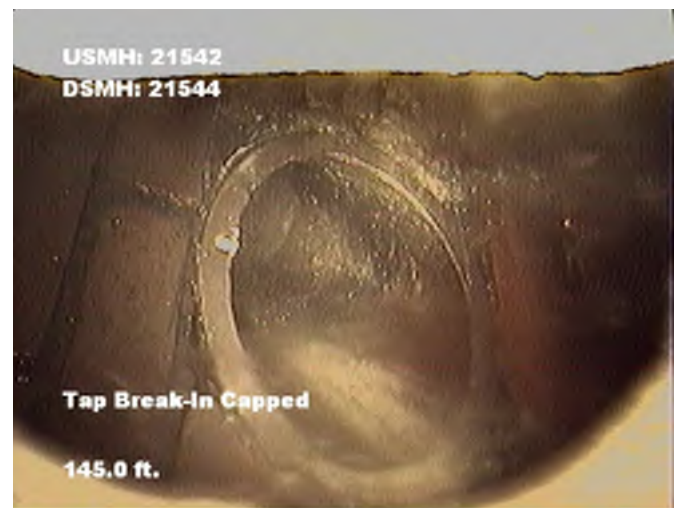
Distance: 145.0 ft. Grade: 2  
Condition: Tap Break-In Capped  
Remarks: N/A

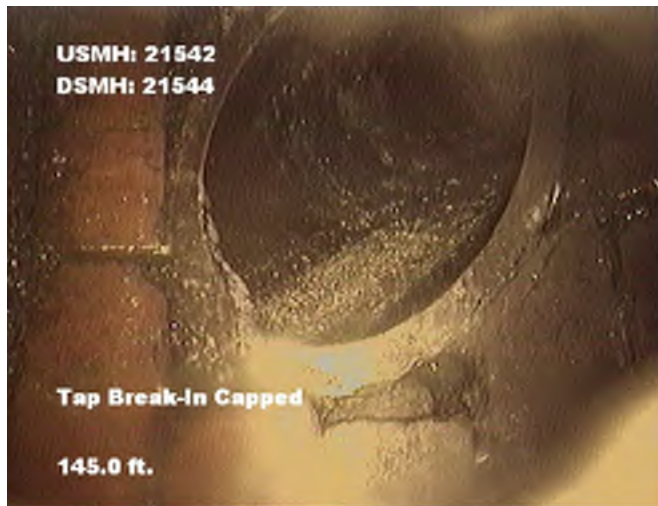
Distance: 145.0 ft. Grade: 2  
Condition: Tap Break-In Capped  
Remarks: N/A

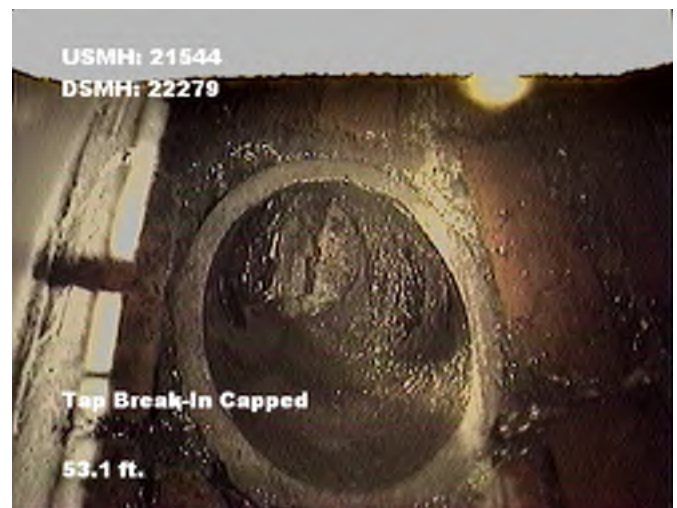
Distance: 53.1 ft. Grade: 2  
Condition: Tap Break-In Capped  
Remarks: N/A

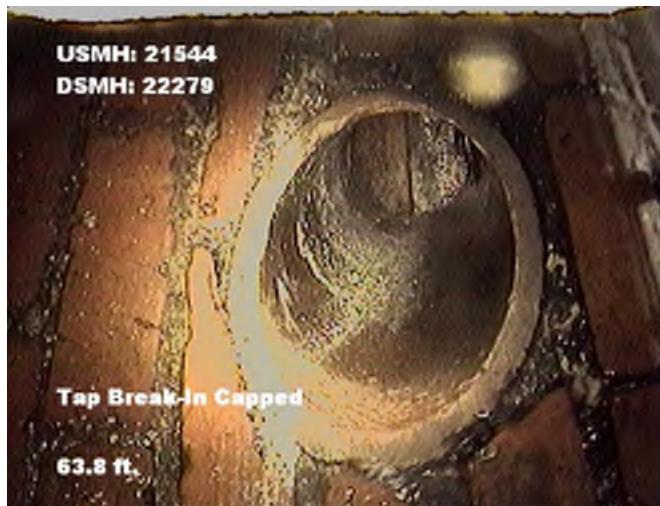
Distance: 63.8 ft. Grade: 2  
Condition: Tap Break-In Capped  
Remarks: N/A

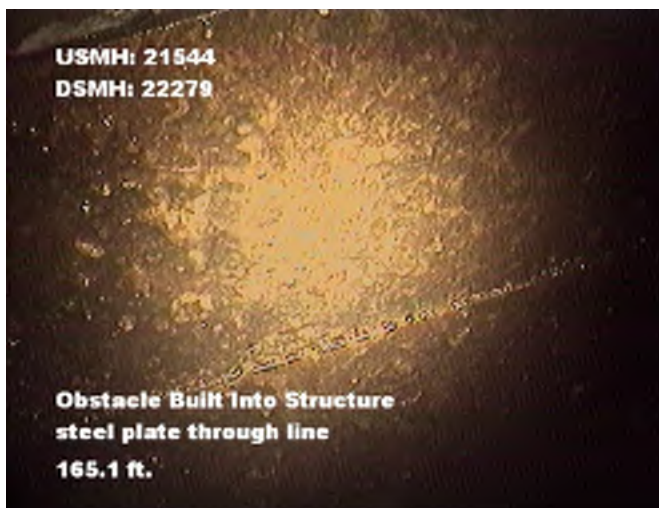
Distance: 165.1 ft. Grade: 2  
Condition: Obstacle Built Into Structure  
Remarks: steel plate through line

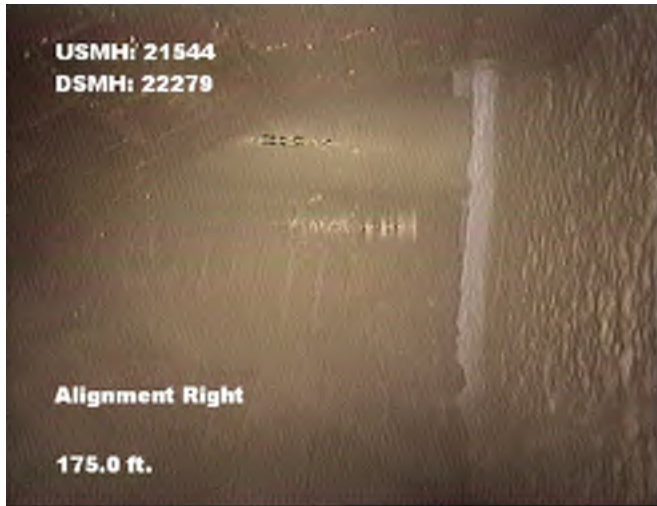
Distance: 175.0 ft. Grade: 1  
Condition: Alignment Right  
Remarks: N/A

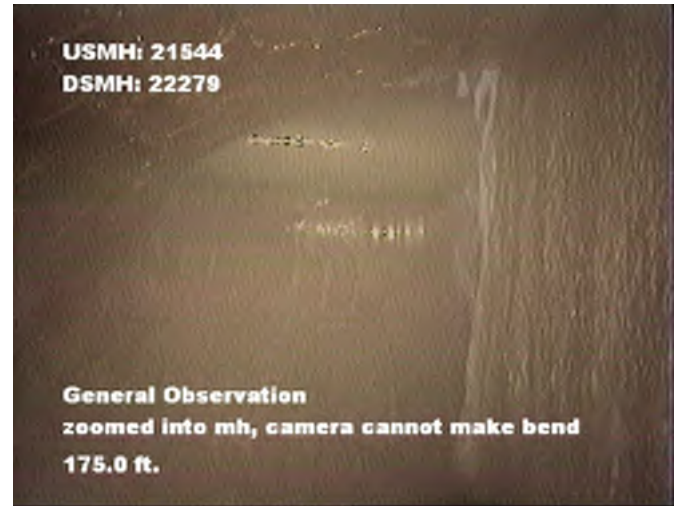
Distance: 175.0 ft. Grade: 0  
Condition: General Observation  
Remarks: zoomed into mh- camera cannot make bend

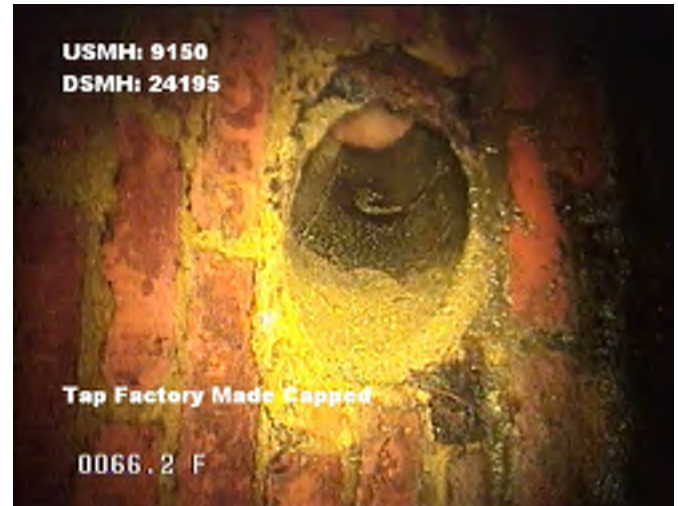
Distance: 66.2 ft. Grade: 0  
Condition: Tap Factory Made Capped  
Remarks: N/A

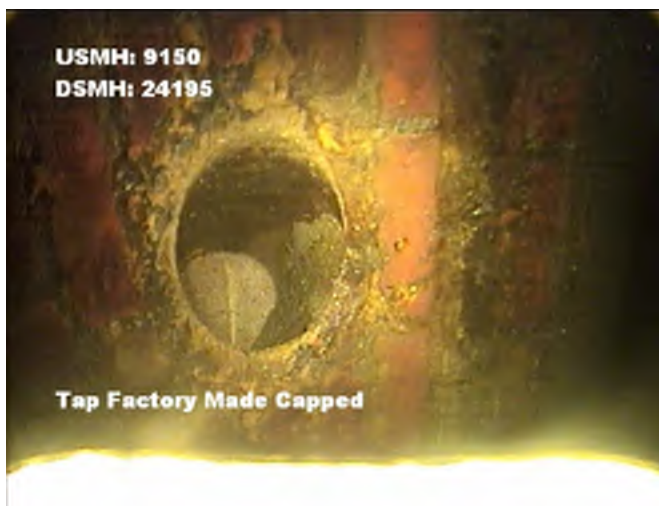
Distance: 66.2 ft. Grade: 0  
Condition: Tap Factory Made Capped  
Remarks: N/A

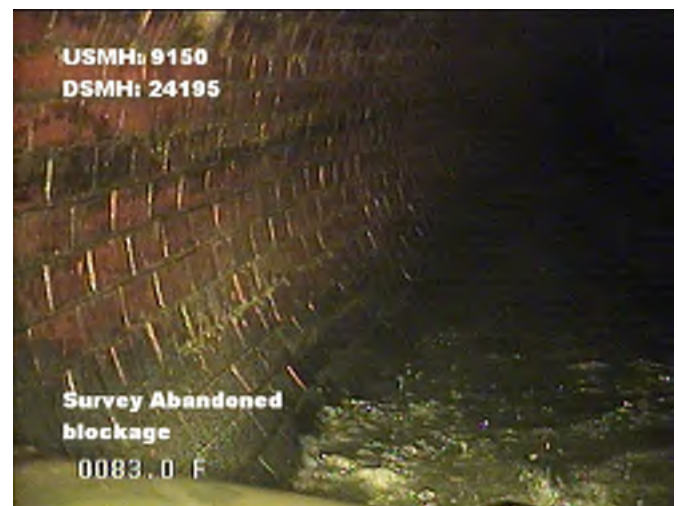
Distance: 83.0 ft. Grade: 0  
Condition: Survey Abandoned  
Remarks: blockage

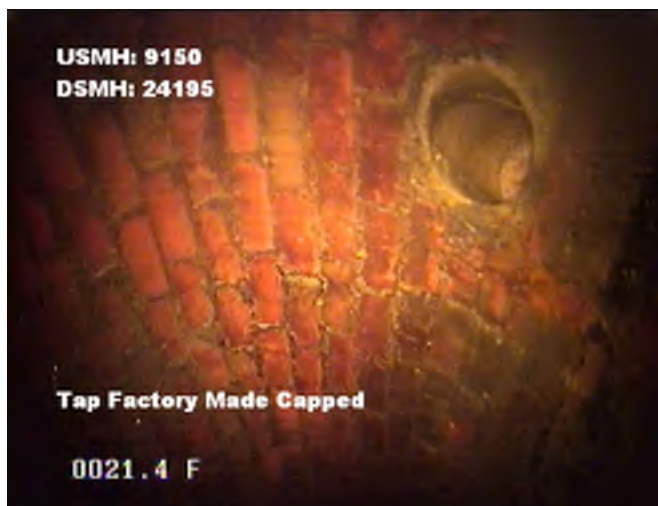
Distance: 21.4 ft. Grade: 0  
Condition: Tap Factory Made Capped  
Remarks: N/A

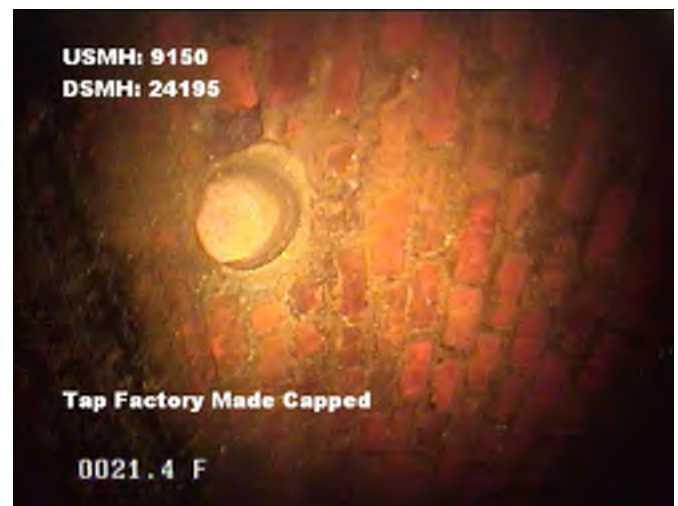
Distance: 21.4 ft. Grade: 0  
Condition: Tap Factory Made Capped  
Remarks: N/A

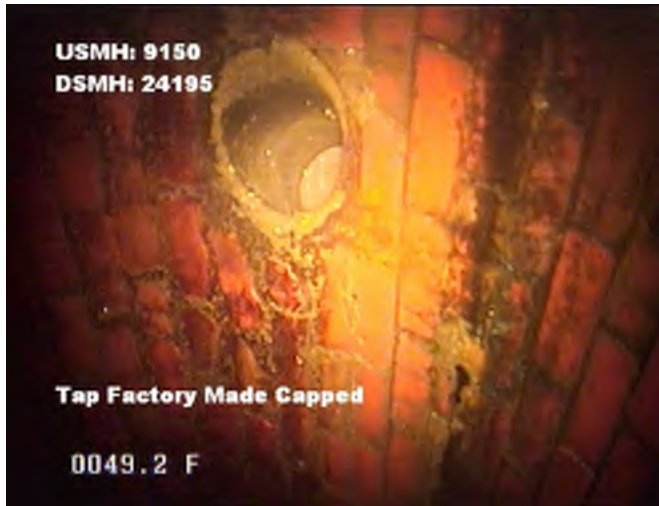
Distance: 49.2 ft. Grade: 0  
Condition: Tap Factory Made Capped  
Remarks: N/A

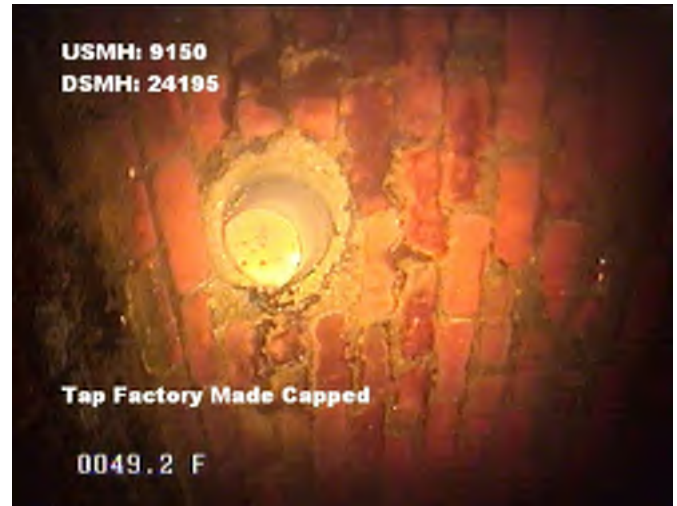
Distance: 49.2 ft. Grade: 0  
Condition: Tap Factory Made Capped  
Remarks: N/A

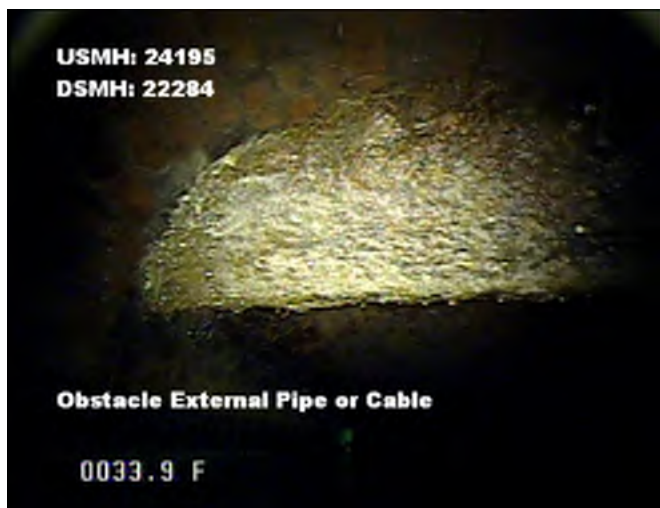
Distance: 33.9 ft. Grade: 3  
Condition: Obstacle External Pipe or Cable  
Remarks: N/A

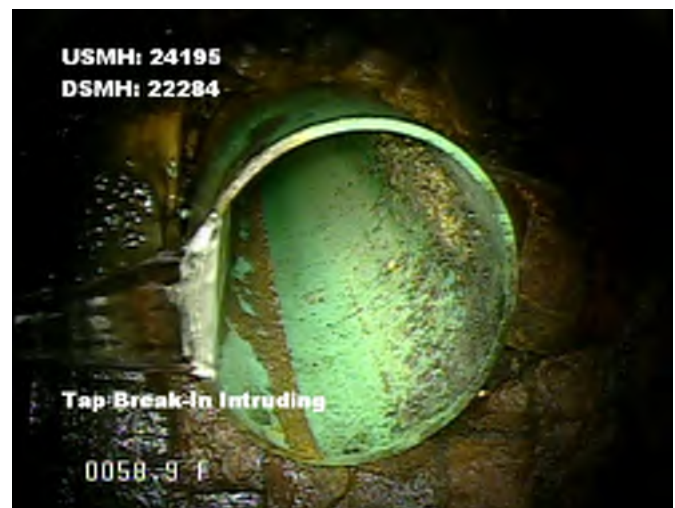
Distance: 58.9 ft. Grade: 2  
Condition: Tap Break-In Intruding  
Remarks: N/A

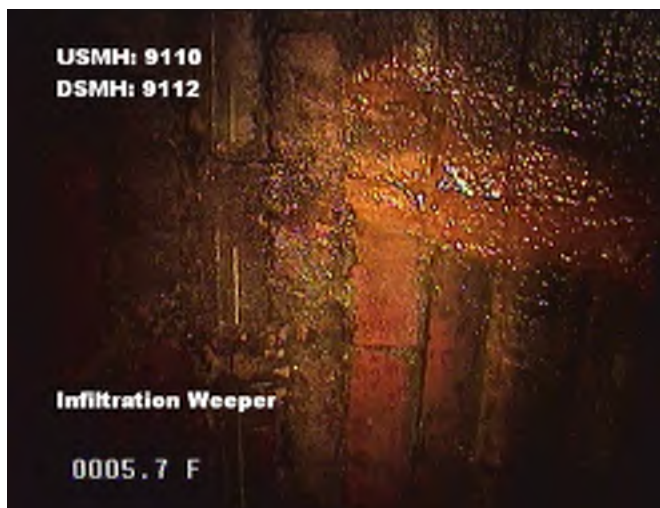
Distance: 5.7 ft. Grade: 2  
Condition: Infiltration Weeper  
Remarks: N/A

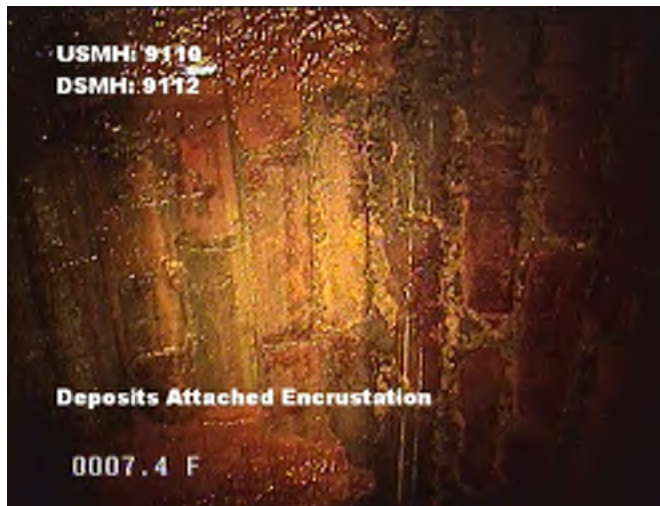
Distance: 7.4 ft. Grade: 2  
Condition: Deposits Attached Encrustation  
Remarks: N/A

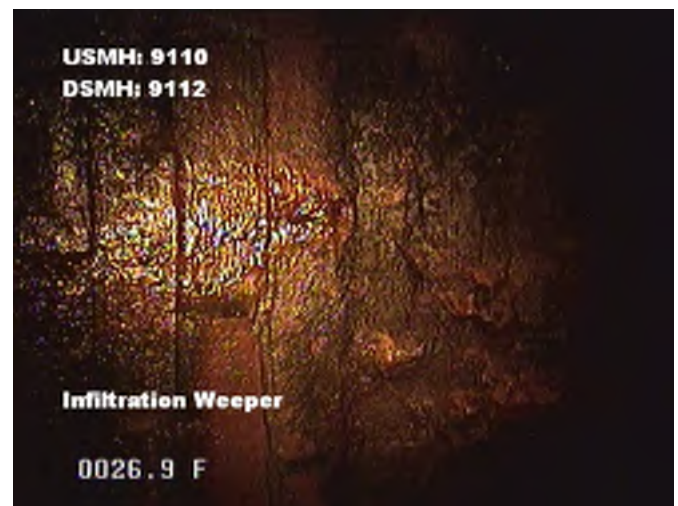
Distance: 26.9 ft. Grade: 2  
Condition: Infiltration Weeper  
Remarks: N/A

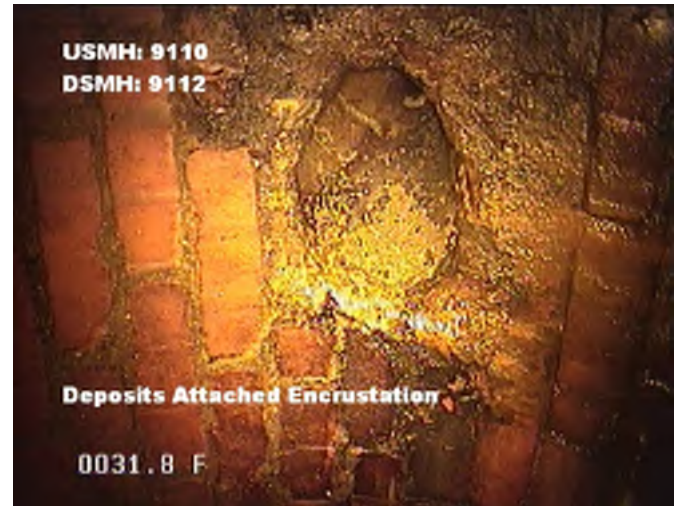
Distance: 31.7 ft. Grade: 2  
Condition: Deposits Attached Encrustation  
Remarks: N/A

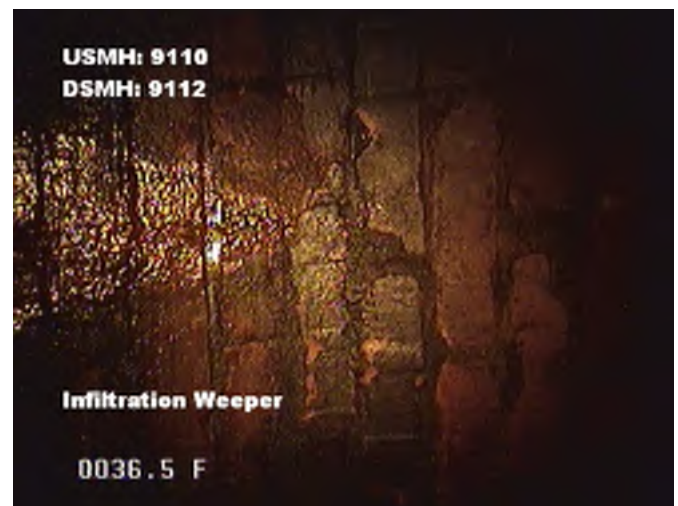
Distance: 36.5 ft. Grade: 2  
Condition: Infiltration Weeper  
Remarks: N/A

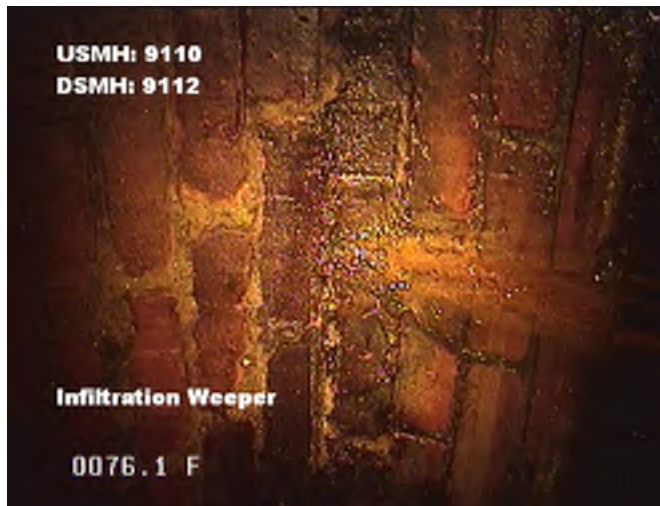
Distance: 76.1 ft. Grade: 2  
Condition: Infiltration Weeper  
Remarks: N/A

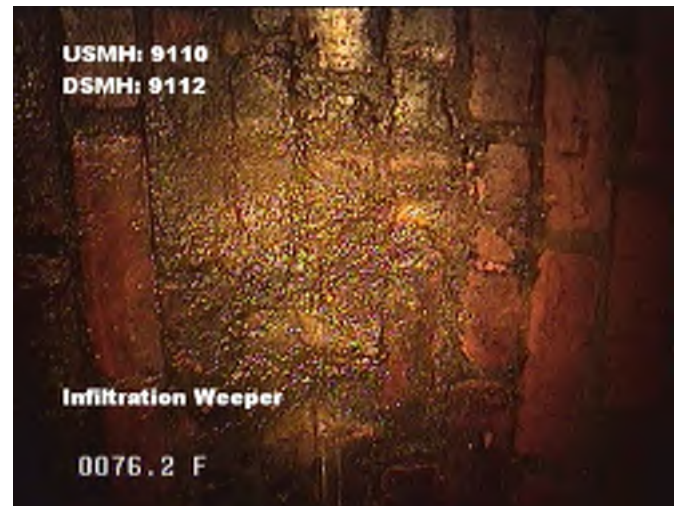
Distance: 76.2 ft. Grade: 2  
Condition: Infiltration Weeper  
Remarks: N/A

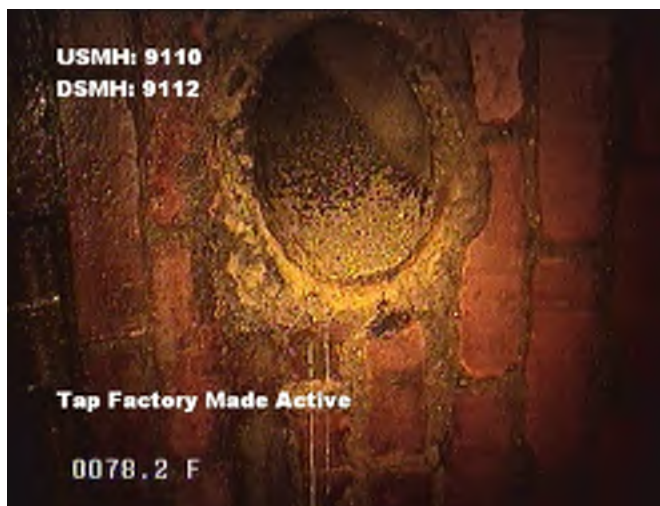
Distance: 78.2 ft. Grade: 0  
Condition: Tap Factory Made Active  
Remarks: N/A

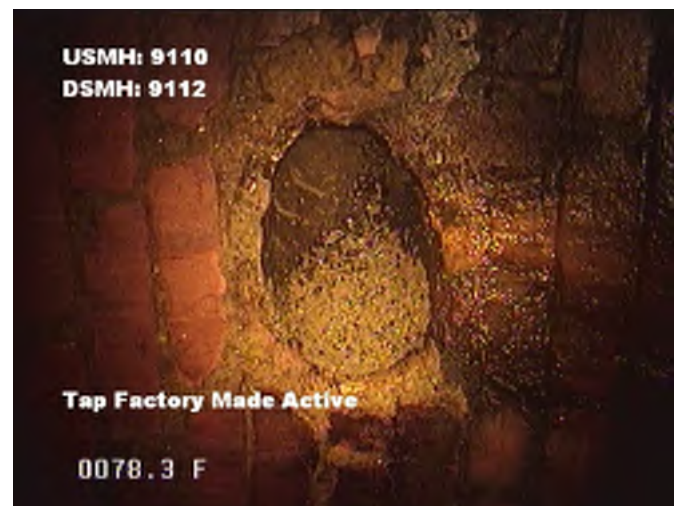
Distance: 78.3 ft. Grade: 0  
Condition: Tap Factory Made Active  
Remarks: N/A

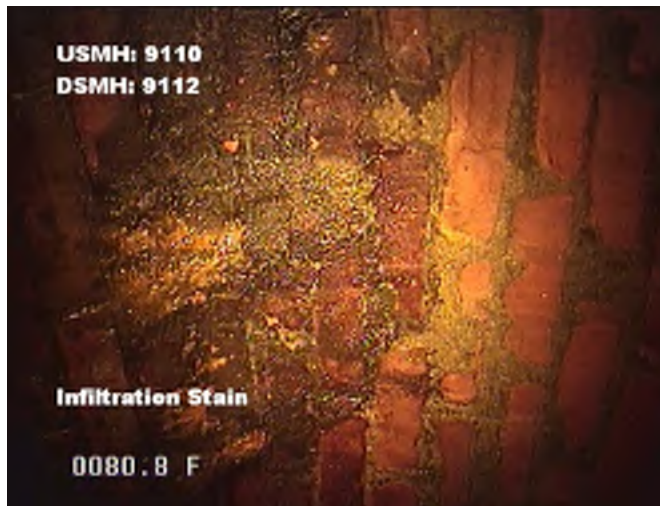
80.8 ft. Infiltration Stain

Distance: 80.8 ft. Grade: 0  
Condition: Infiltration Stain  
Remarks: N/A

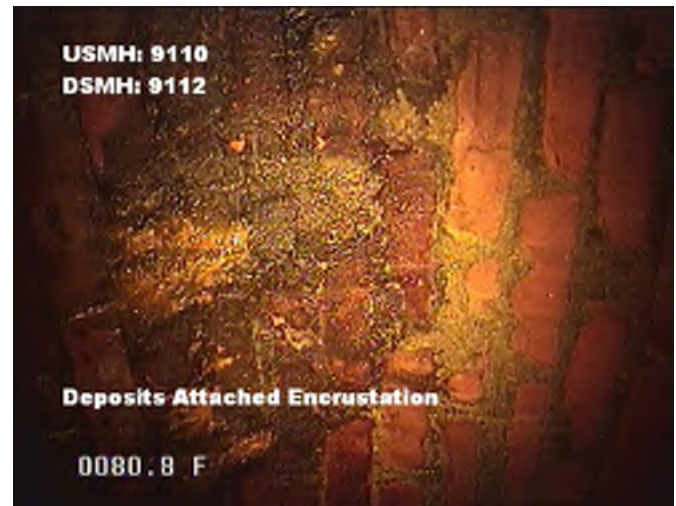
Distance: 80.8 ft. Grade: 2  
Condition: Deposits Attached Encrustation  
Remarks: N/A

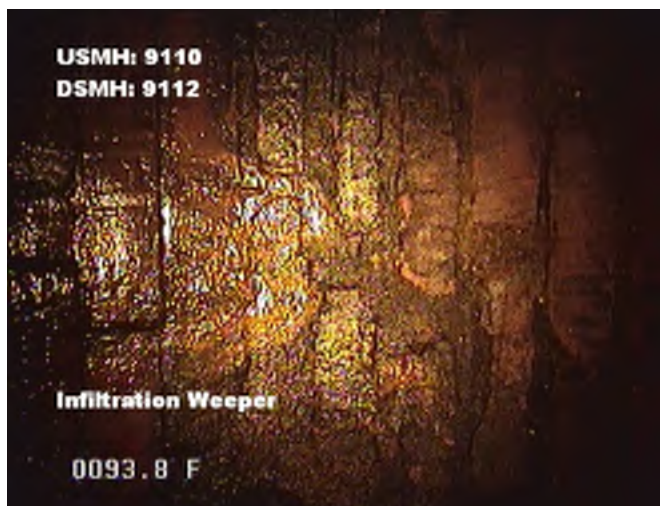
93.8 ft. Infiltration Weeper

Distance: 93.8 ft. Grade: 2  
Condition: Infiltration Weeper  
Remarks: N/A

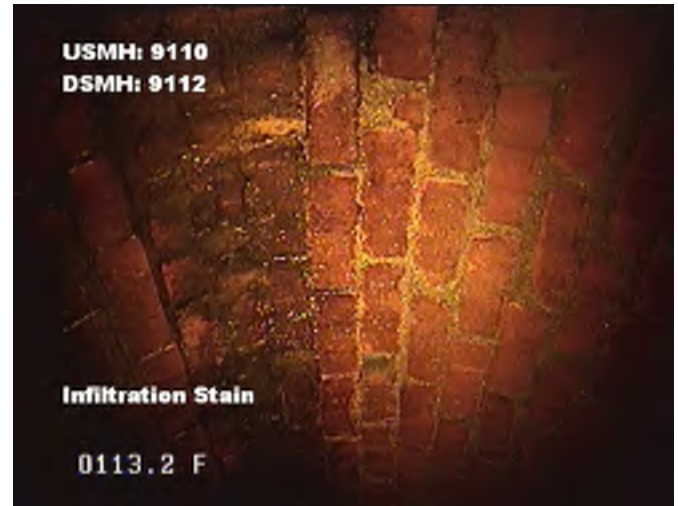
113.2 ft. Infiltration Stain

Distance: 113.2 ft. Grade: 0  
Condition: Infiltration Stain  
Remarks: N/A

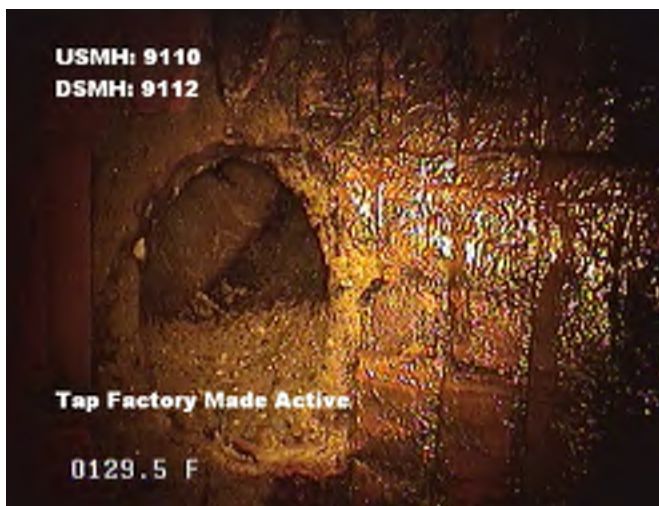
Distance: 129.5 ft. Grade: 0  
Condition: Tap Factory Made Active  
Remarks: N/A

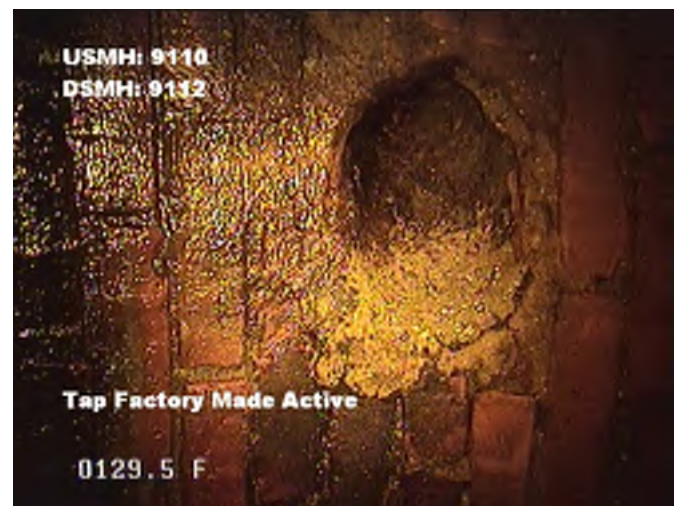
Distance: 129.5 ft. Grade: 0  
Condition: Tap Factory Made Active  
Remarks: N/A

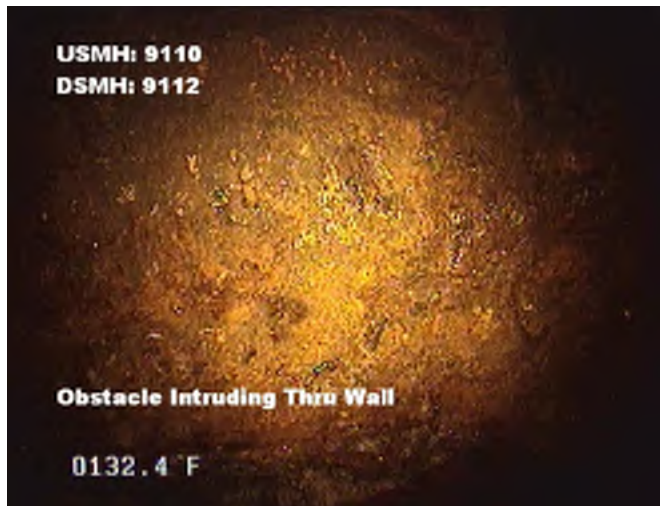
Distance: 132.4 ft. Grade: 2  
Condition: Obstacle Intruding Thru Wall  
Remarks: N/A

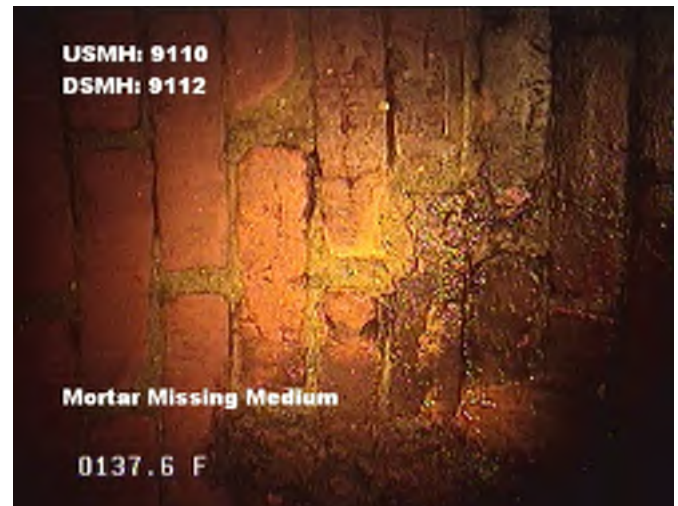
137.6 ft. Mortar Missing Medium

Distance: 137.6 ft. Grade: 3  
Condition: Mortar Missing Medium  
Remarks: N/A

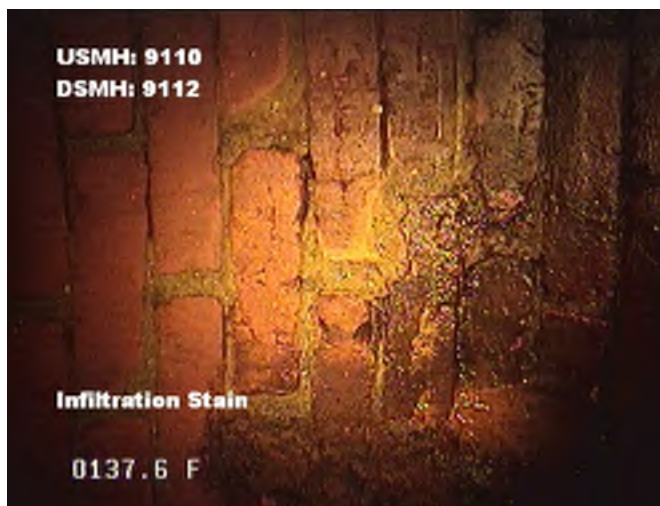
137.6 ft. Infiltration Stain

Distance: 137.6 ft. Grade: 0  
Condition: Infiltration Stain  
Remarks: N/A

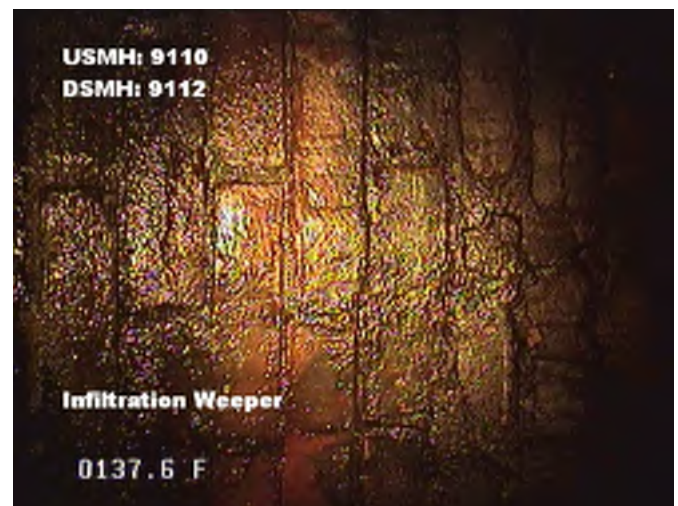
137.6 ft. Infiltration Weeper

Distance: 137.6 ft. Grade: 2  
Condition: Infiltration Weeper  
Remarks: N/A

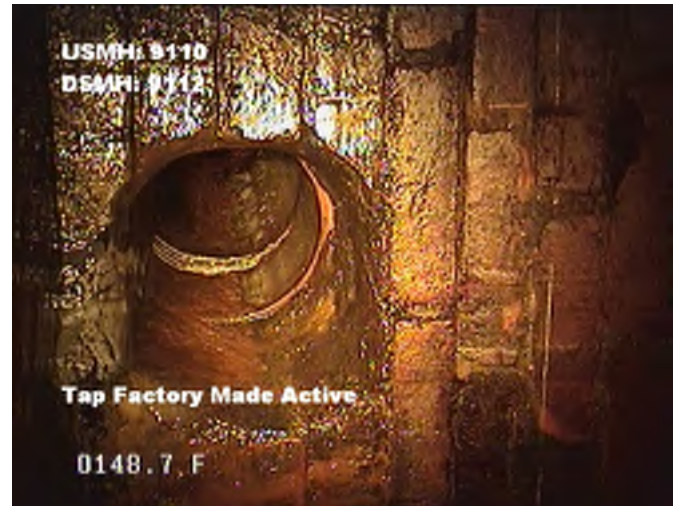
Distance: 148.7 ft. Grade: 0  
Condition: Tap Factory Made Active  
Remarks: N/A

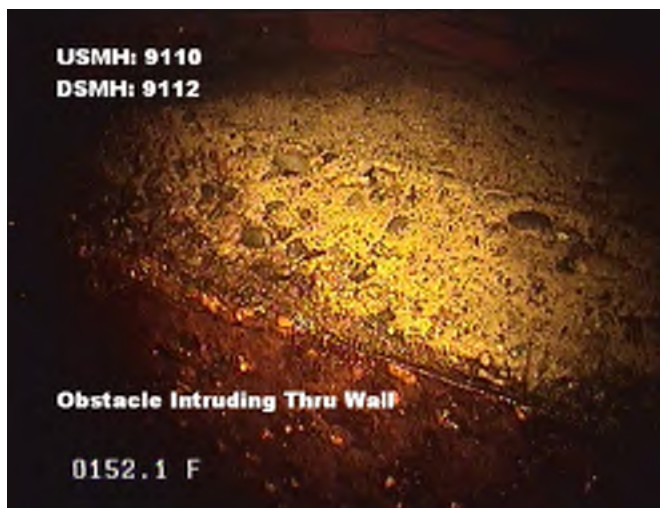
Distance: 152.1 ft. Grade: 2  
Condition: Obstacle Intruding Thru Wall  
Remarks: N/A

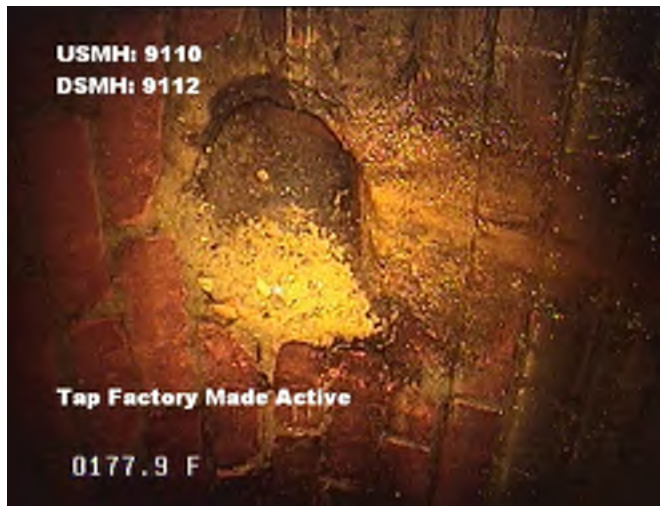
Distance: 177.9 ft. Grade: 0  
Condition: Tap Factory Made Active  
Remarks: N/A

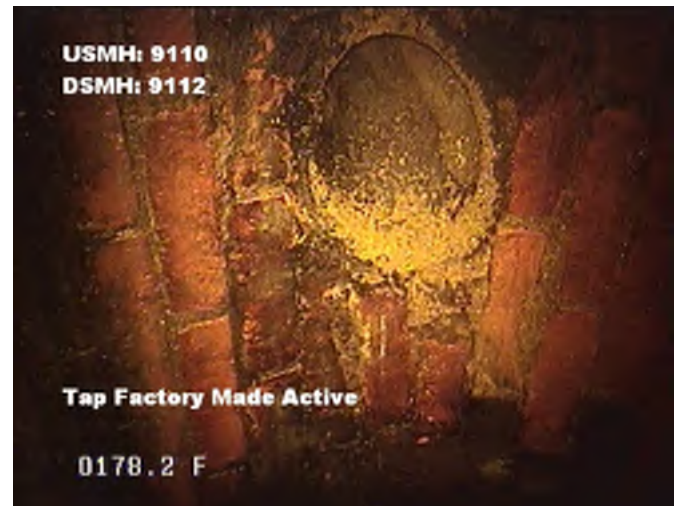
Distance: 178.2 ft. Grade: 0  
Condition: Tap Factory Made Active  
Remarks: N/A

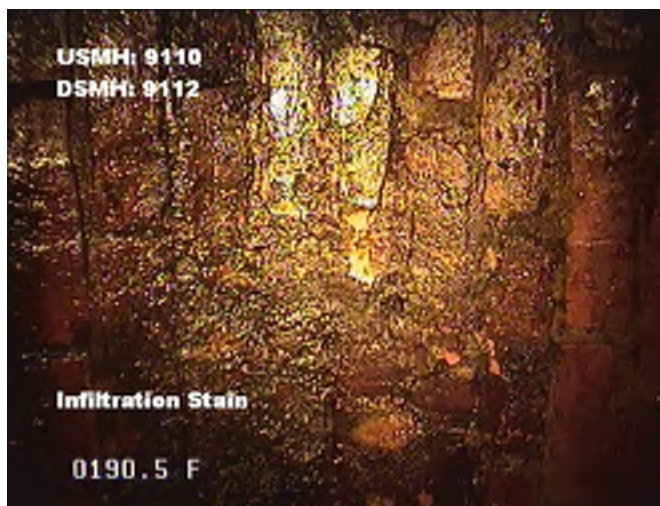
190.5 ft. Infiltration Stain

Distance: 190.5 ft. Grade: 0  
Condition: Infiltration Stain  
Remarks: N/A

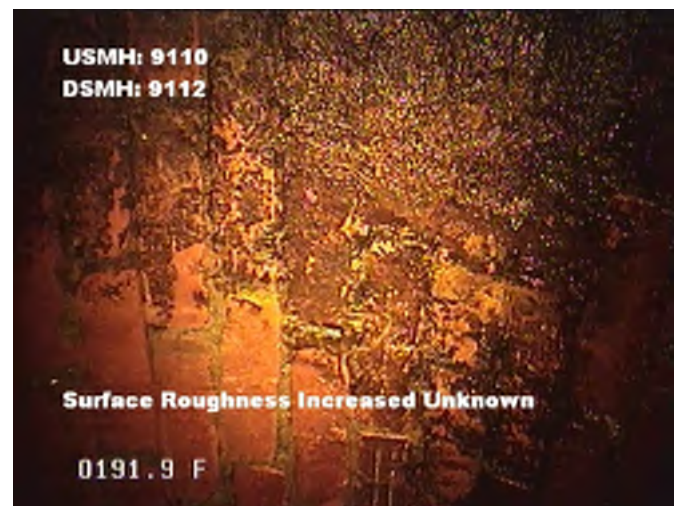
Distance: 191.9 ft. Grade: 1  
Condition: Surface Roughness Increased Unknown  
Remarks: N/A

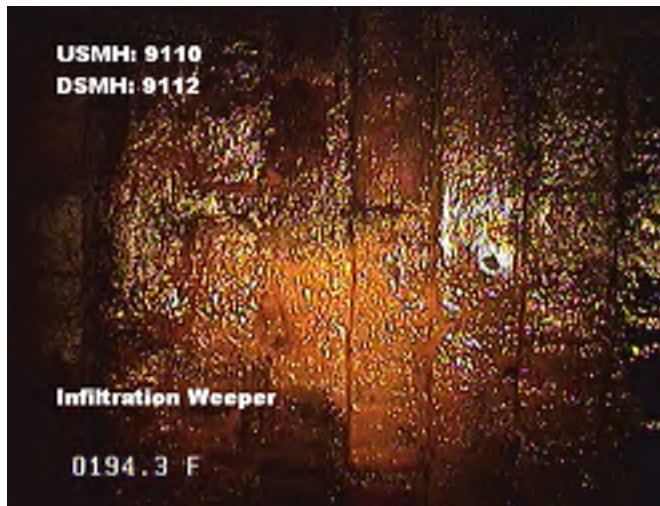
194.3 ft. Infiltration Weeper

Distance: 194.3 ft. Grade: 2  
Condition: Infiltration Weeper  
Remarks: N/A

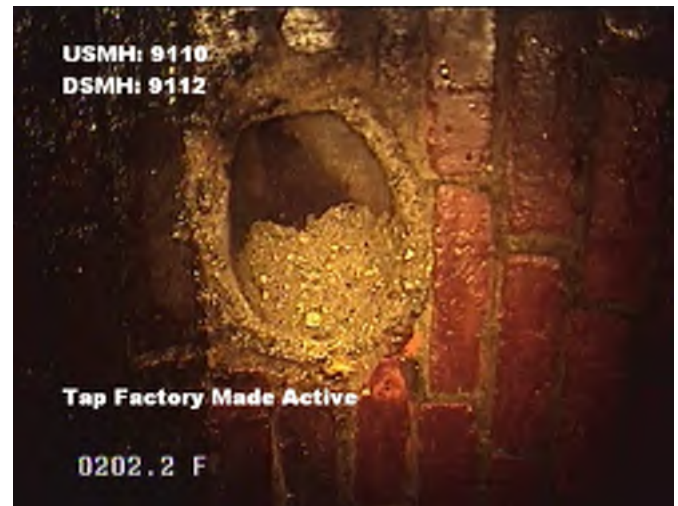
Distance: 202.2 ft. Grade: 0  
Condition: Tap Factory Made Active  
Remarks: N/A

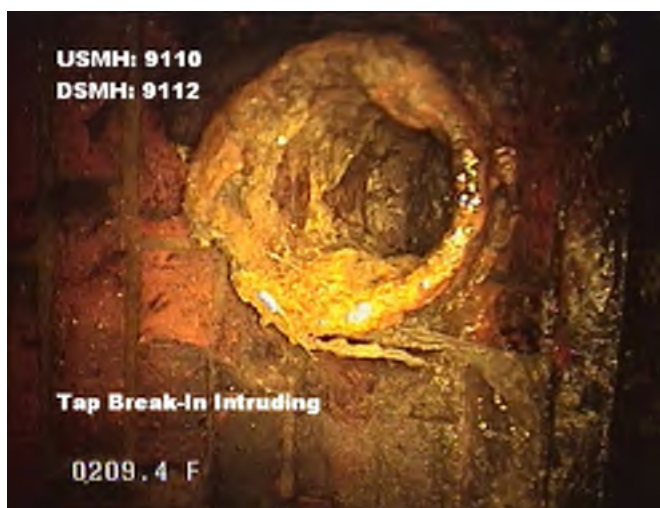
Distance: 209.4 ft. Grade: 2  
Condition: Tap Break-In Intruding  
Remarks: N/A

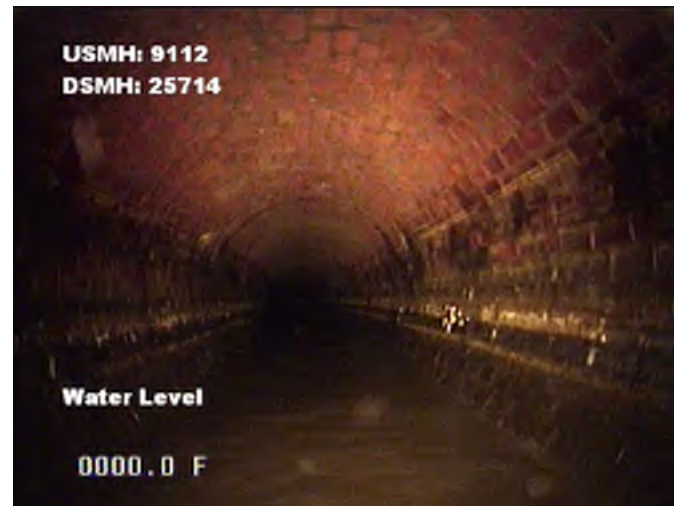
Distance: 0.0 ft. Grade: 0  
Condition: Water Level  
Remarks: N/A

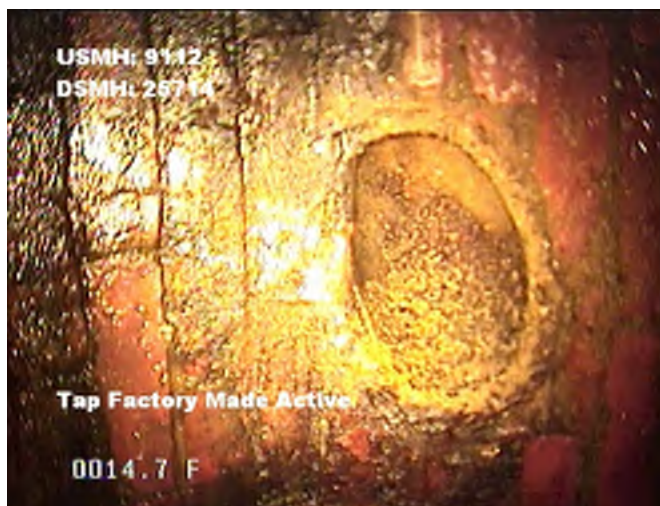
Distance: 14.7 ft. Grade: 0  
Condition: Tap Factory Made Active  
Remarks: N/A

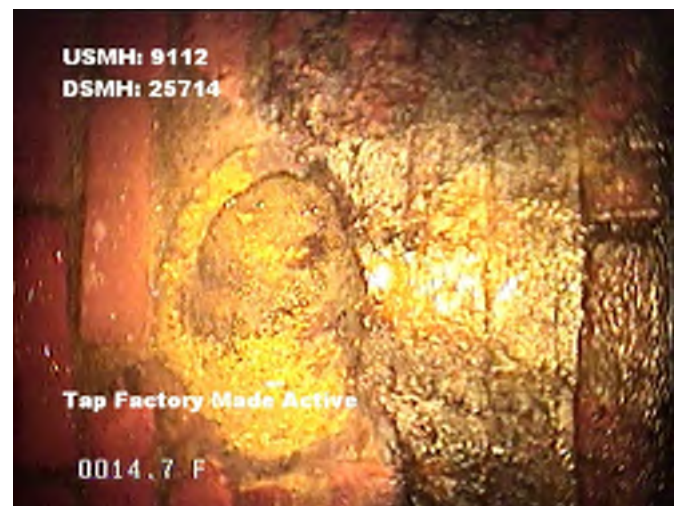
Distance: 14.7 ft. Grade: 0  
Condition: Tap Factory Made Active  
Remarks: N/A

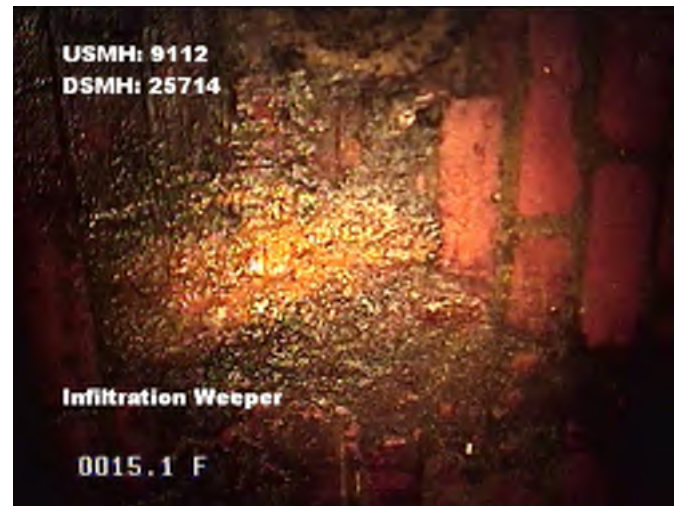
Distance: 15.1 ft. Grade: 2  
Condition: Infiltration Weeper  
Remarks: N/A

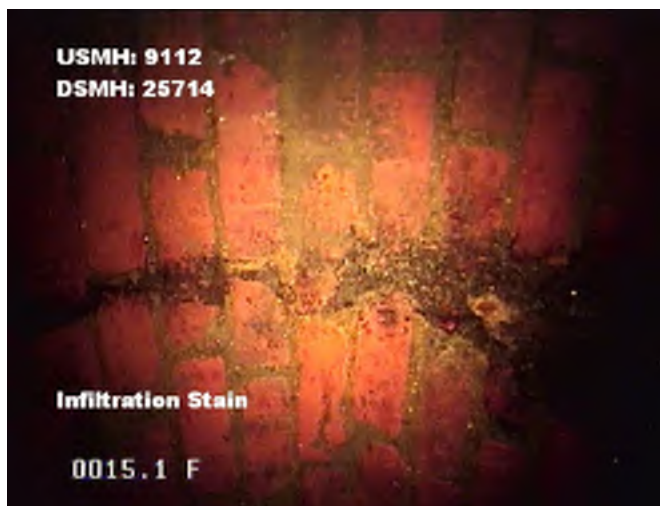
Distance: 15.1 ft. Grade: 0  
Condition: Infiltration Stain  
Remarks: N/A

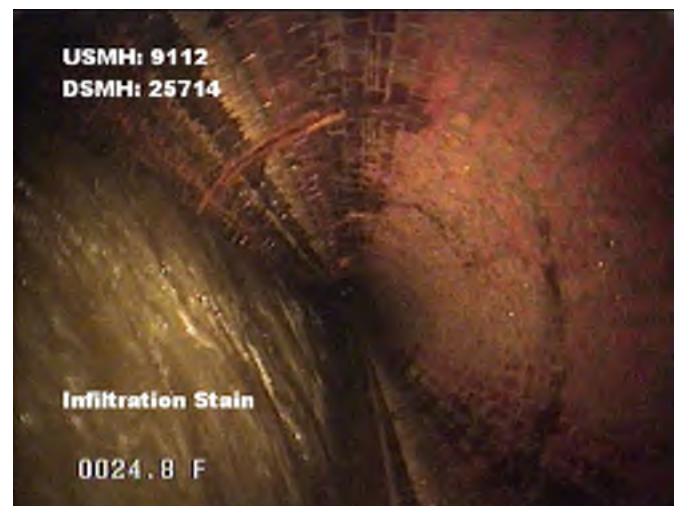
24.8 ft. Infiltration Stain - S01

Distance: 24.8 ft. Grade: 0  
Condition: Infiltration Stain  
Remarks: N/A

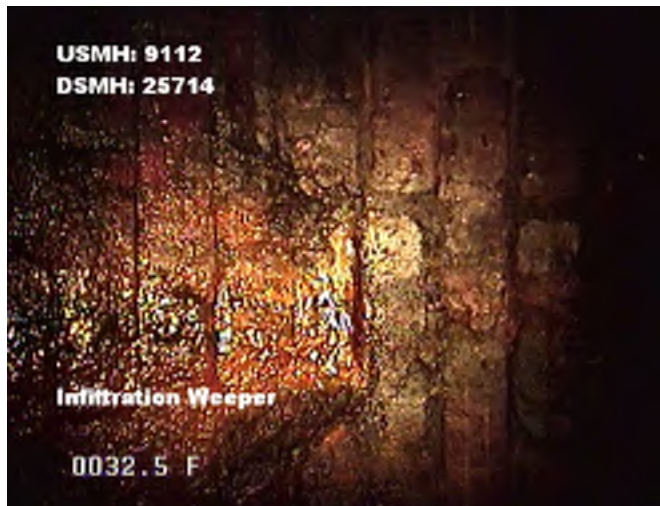
32.5 ft. Infiltration Weeper

Distance: 32.5 ft. Grade: 2  
Condition: Infiltration Weeper  
Remarks: N/A

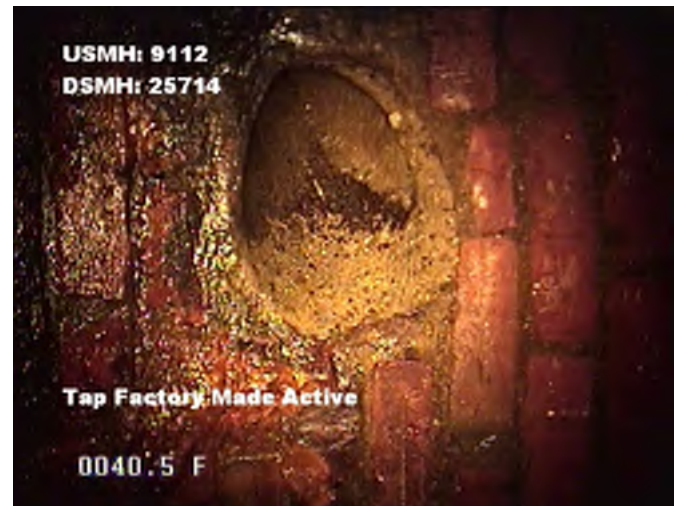
Distance: 40.5 ft. Grade: 0  
Condition: Tap Factory Made Active  
Remarks: N/A

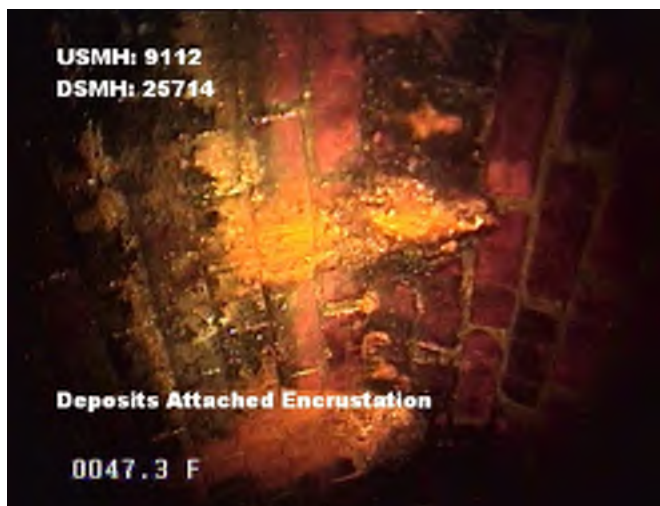
Distance: 47.3 ft. Grade: 2  
Condition: Deposits Attached Encrustation  
Remarks: N/A

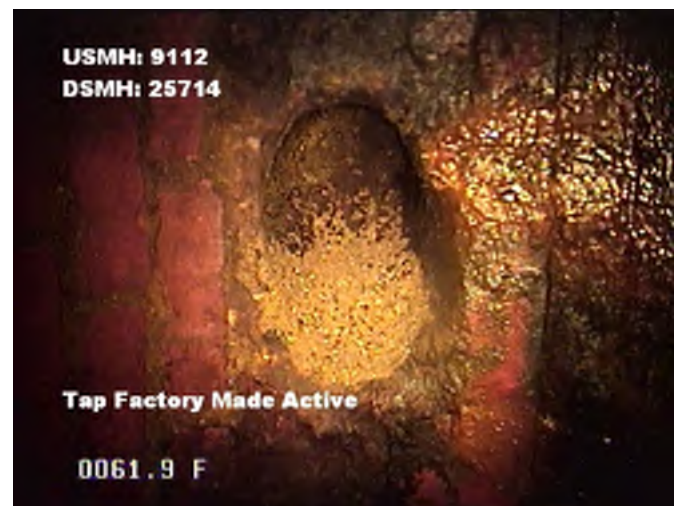
Distance: 61.9 ft. Grade: 0  
Condition: Tap Factory Made Active  
Remarks: N/A

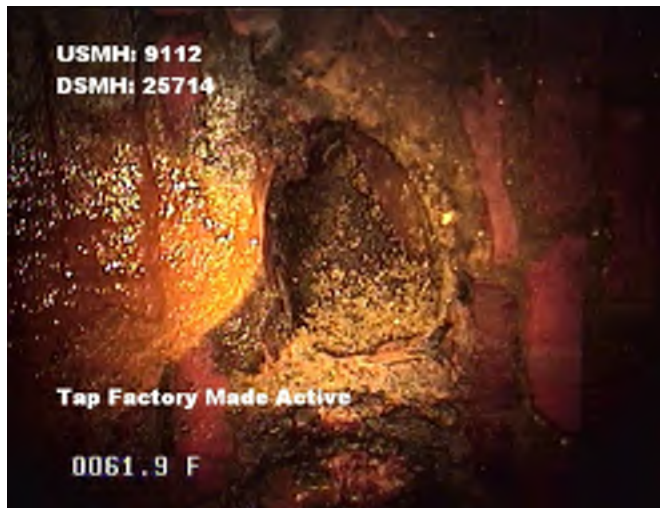
Distance: 61.9 ft. Grade: 0  
Condition: Tap Factory Made Active  
Remarks: N/A

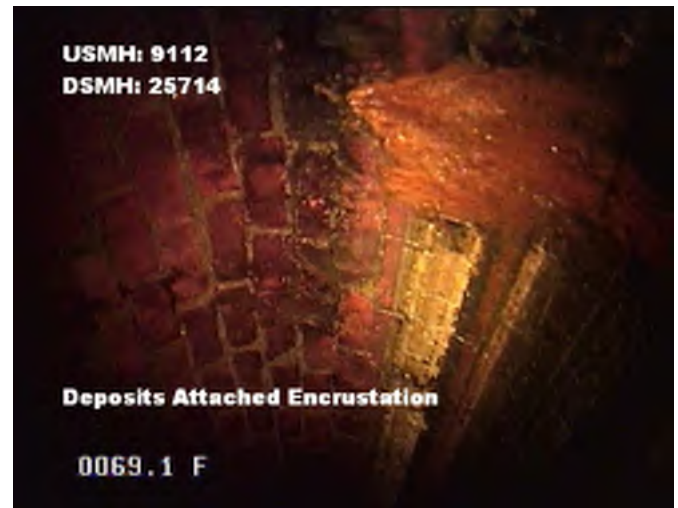
Distance: 69.1 ft. Grade: 2  
Condition: Deposits Attached Encrustation  
Remarks: N/A

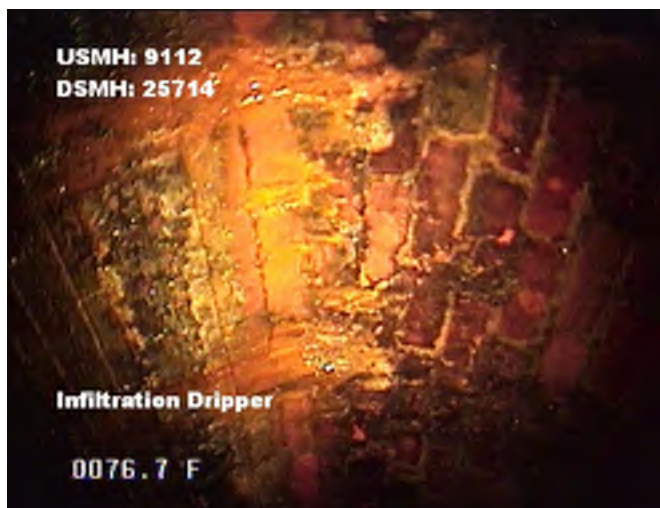
Distance: 76.7 ft. Grade: 3  
Condition: Infiltration Dripper  
Remarks: N/A

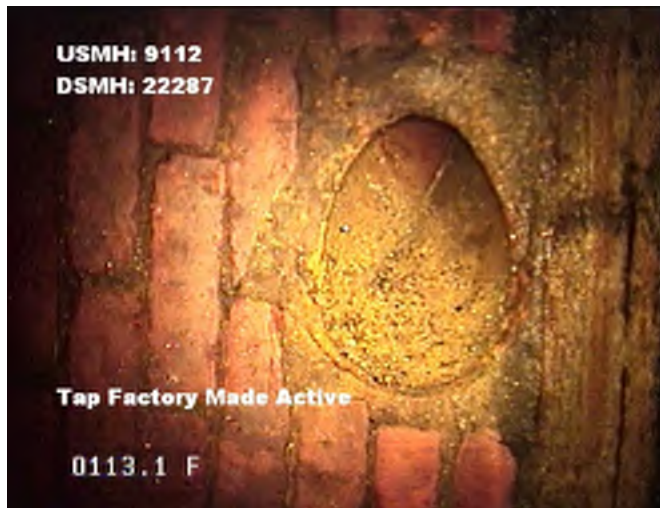
Distance: 113.1 ft. Grade: 0  
Condition: Tap Factory Made Active  
Remarks: N/A

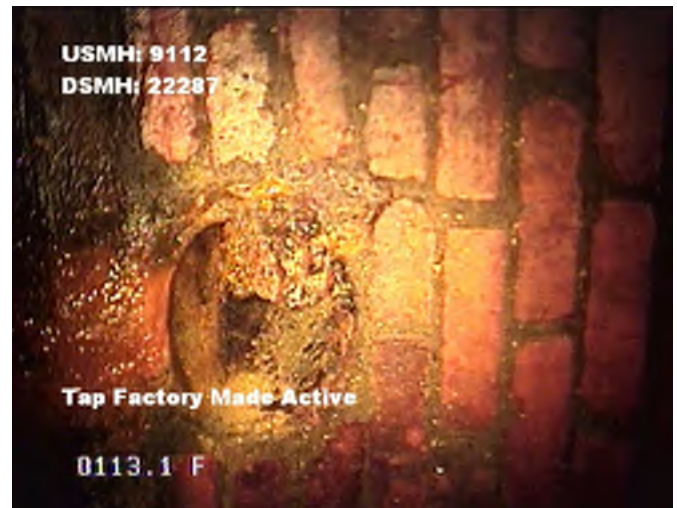
Distance: 113.1 ft. Grade: 0  
Condition: Tap Factory Made Active  
Remarks: N/A
