# APPENDIX A

## TELEVISION INSPECTION REPORTS AND VIDEOS

Project Name: <b>WS WORCESTER WI</b>	Project Number:	Date:
---	-----------------	-------

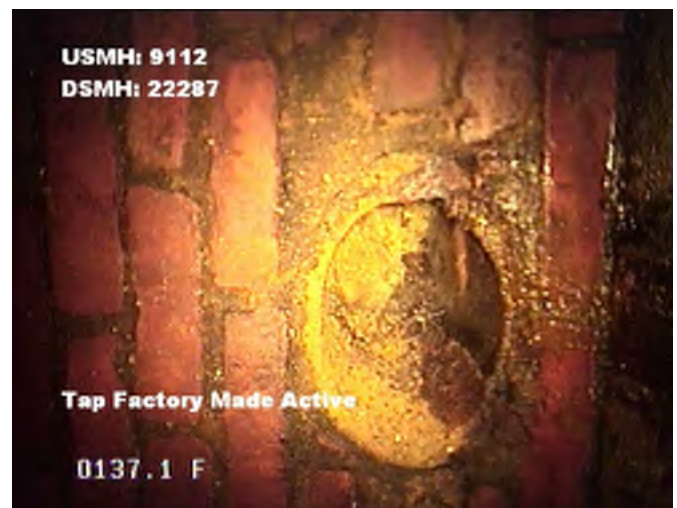
Distance: 137.1 ft. Grade: 0  
Condition: Tap Factory Made Active  
Remarks: N/A

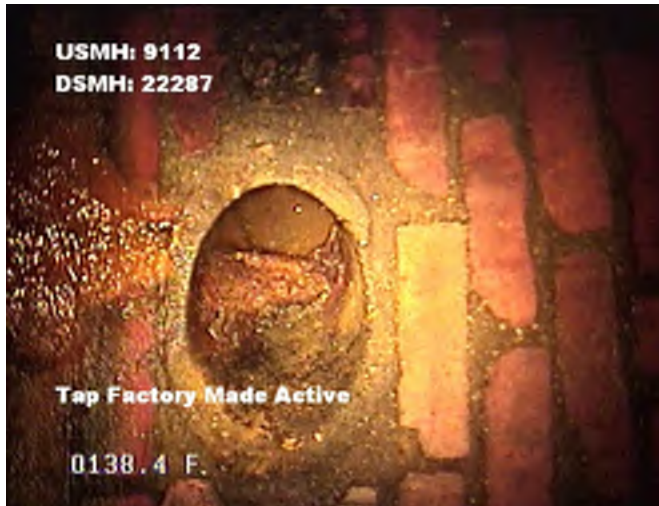
Distance: 138.4 ft. Grade: 0  
Condition: Tap Factory Made Active  
Remarks: N/A

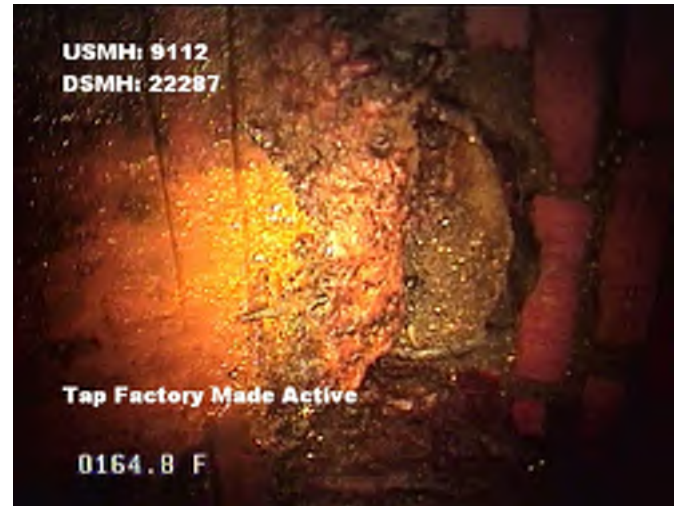
Distance: 164.8 ft. Grade: 0  
Condition: Tap Factory Made Active  
Remarks: N/A

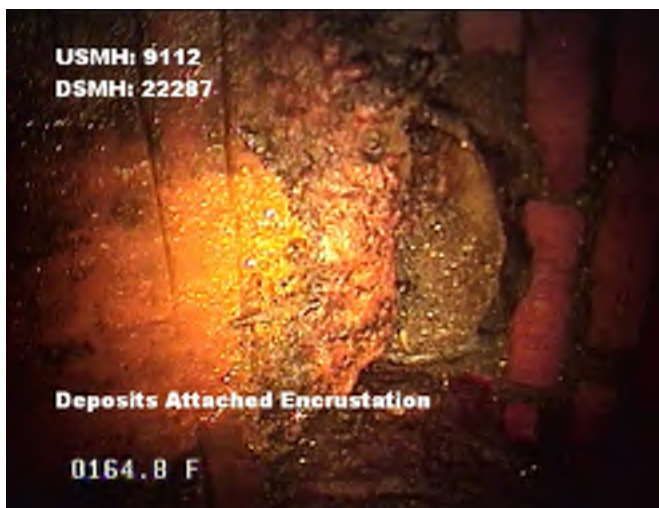
Distance: 164.8 ft. Grade: 2  
Condition: Deposits Attached Encrustation  
Remarks: N/A

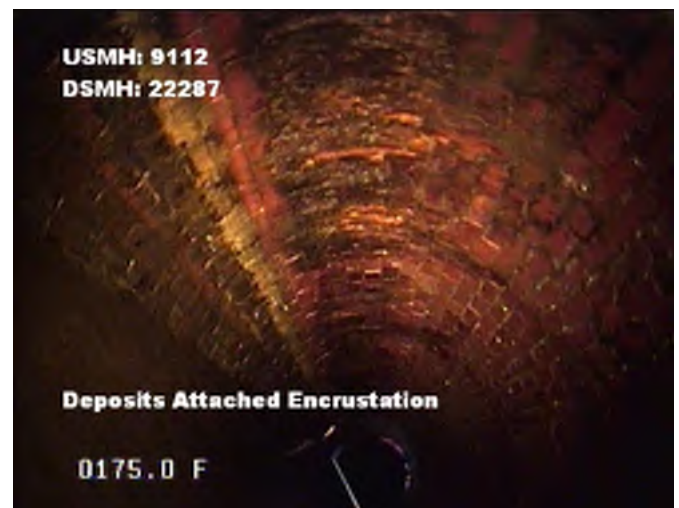
Distance: 175.0 ft. Grade: 2  
Condition: Deposits Attached Encrustation  
Remarks: N/A

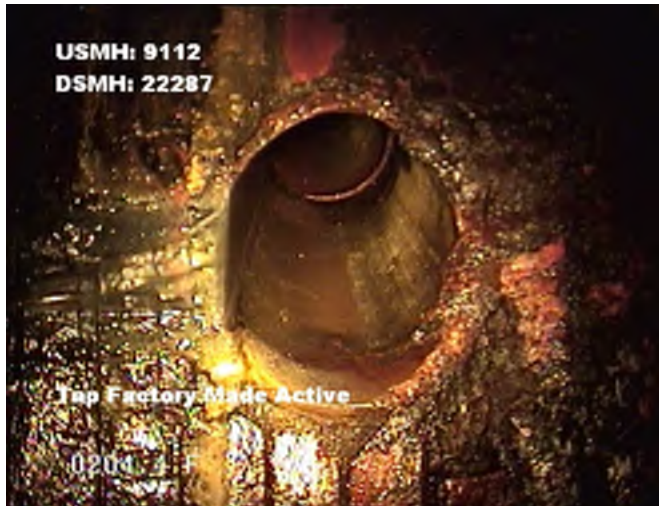
Distance: 204.4 ft. Grade: 0  
Condition: Tap Factory Made Active  
Remarks: N/A

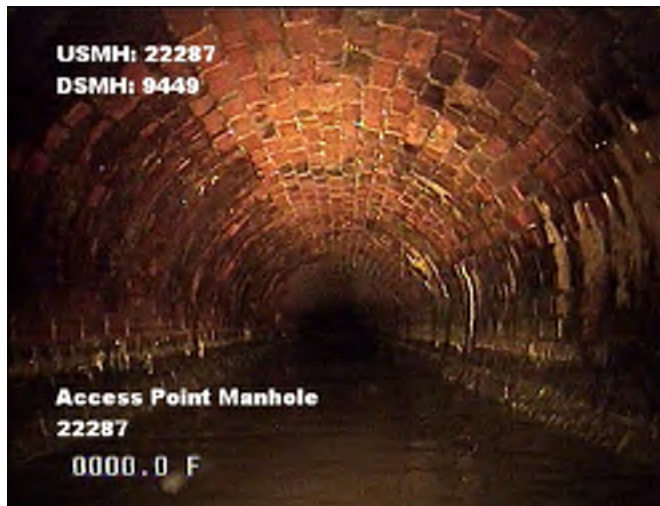
Distance: 0.0 ft. Grade: 0  
Condition: Access Point Manhole  
Remarks: 22287

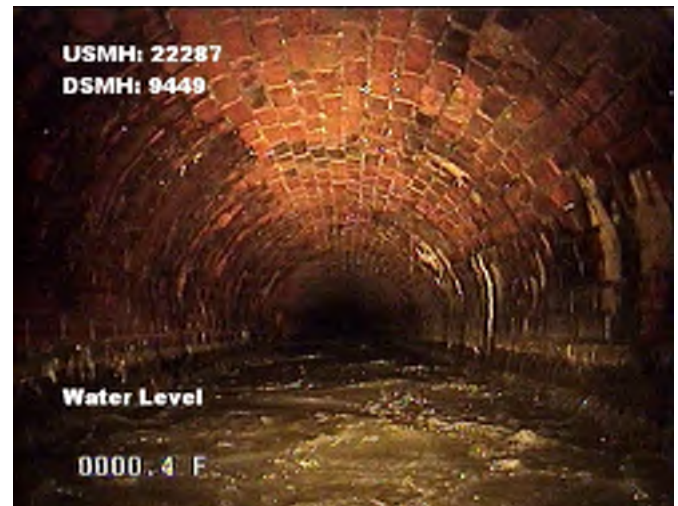
Distance: 0.0 ft. Grade: 0  
Condition: Water Level  
Remarks: N/A

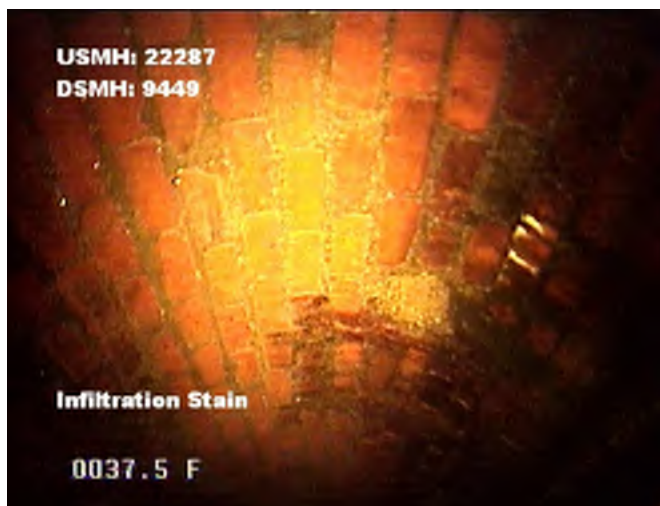
Distance: 37.5 ft. Grade: 0  
Condition: Infiltration Stain  
Remarks: N/A

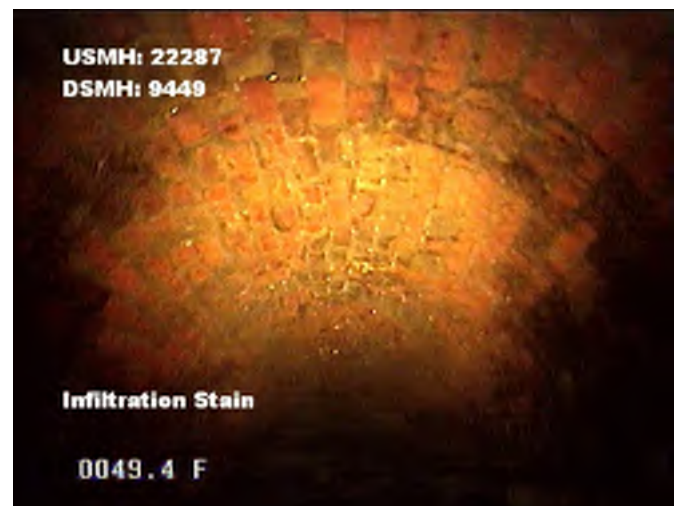
Distance: 49.4 ft. Grade: 0  
Condition: Infiltration Stain  
Remarks: N/A

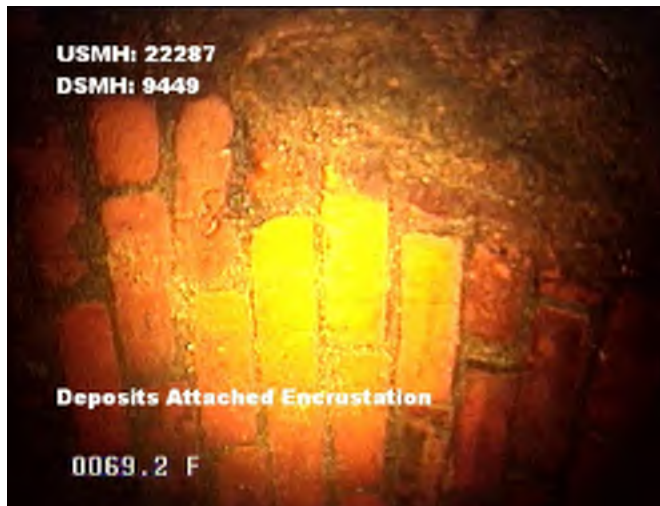
Distance: 69.2 ft. Grade: 2  
Condition: Deposits Attached Encrustation  
Remarks: N/A

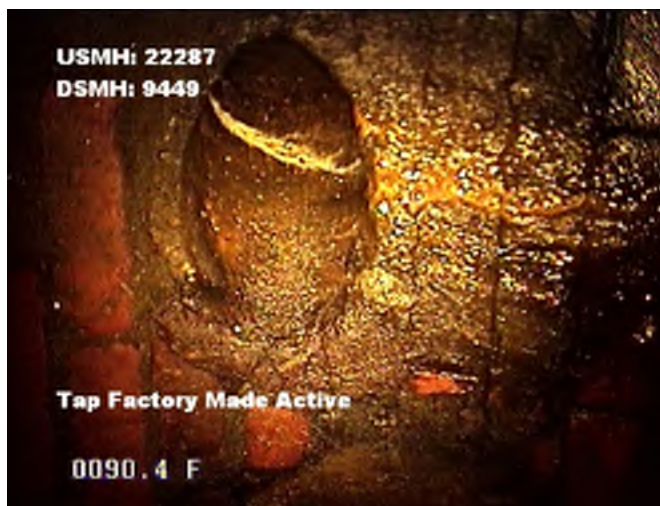
Distance: 90.4 ft. Grade: 0  
Condition: Tap Factory Made Active  
Remarks: N/A

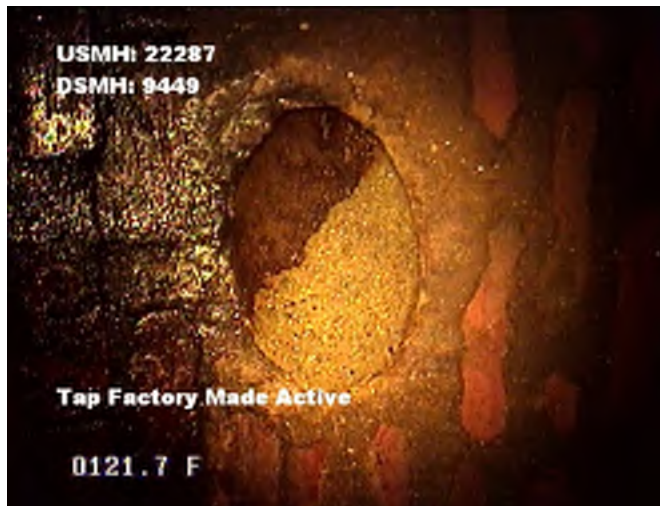
Distance: 121.7 ft. Grade: 0  
Condition: Tap Factory Made Active  
Remarks: N/A

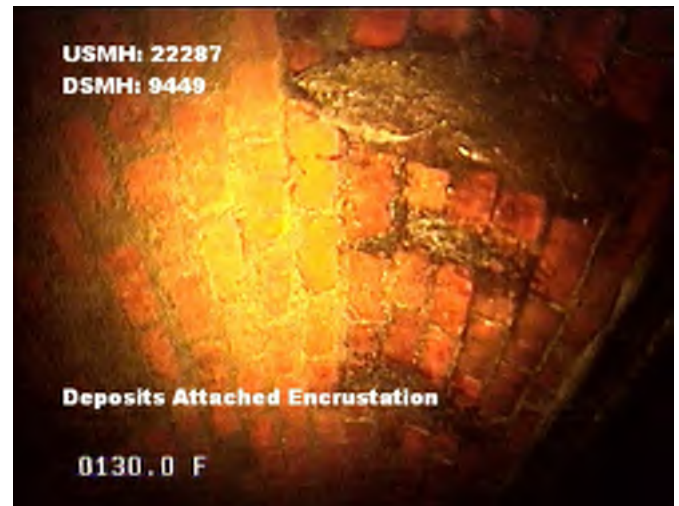
Distance: 130.0 ft. Grade: 2  
Condition: Deposits Attached Encrustation  
Remarks: N/A

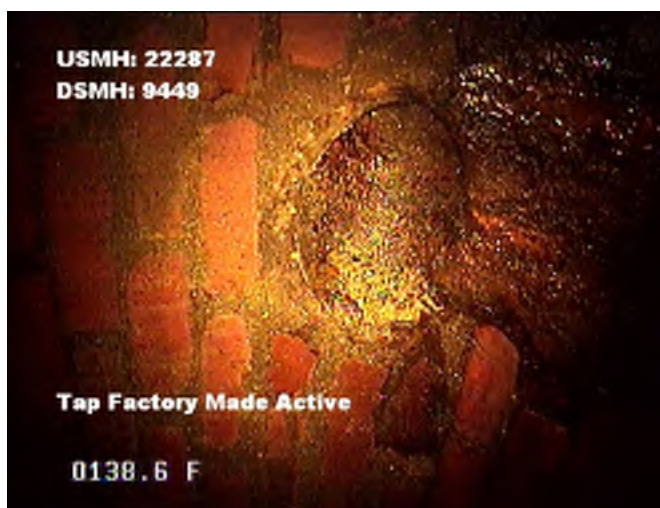
Distance: 138.6 ft. Grade: 0  
Condition: Tap Factory Made Active  
Remarks: N/A

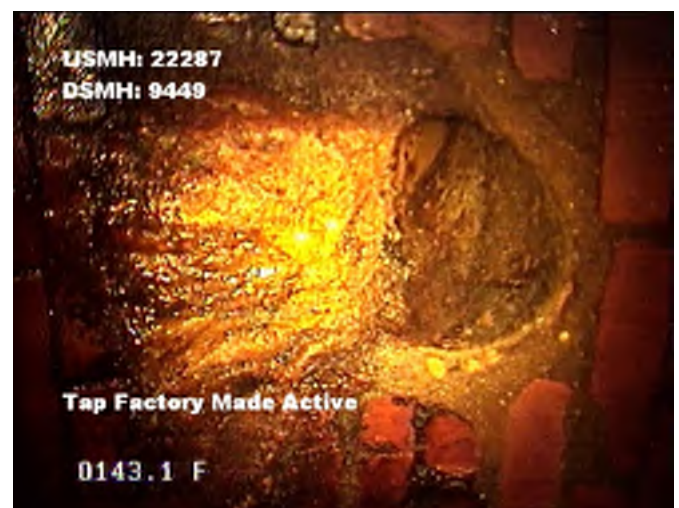
Distance: 143.1 ft. Grade: 0  
Condition: Tap Factory Made Active  
Remarks: N/A

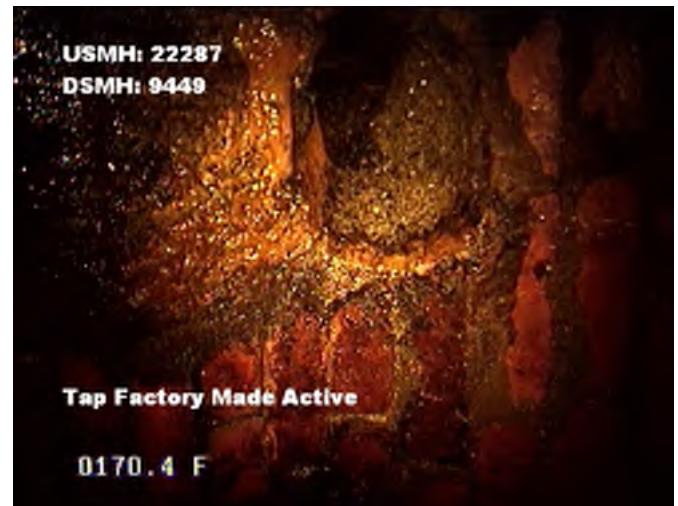
Distance: 170.4 ft. Grade: 0  
Condition: Tap Factory Made Active  
Remarks: N/A

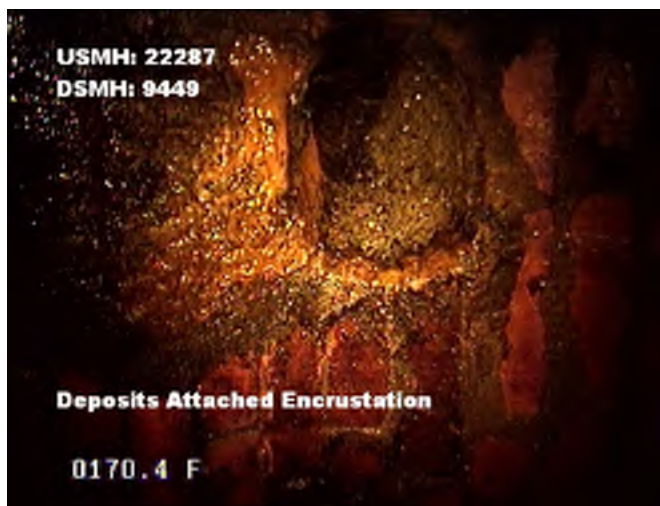
Distance: 170.4 ft. Grade: 2  
Condition: Deposits Attached Encrustation  
Remarks: N/A

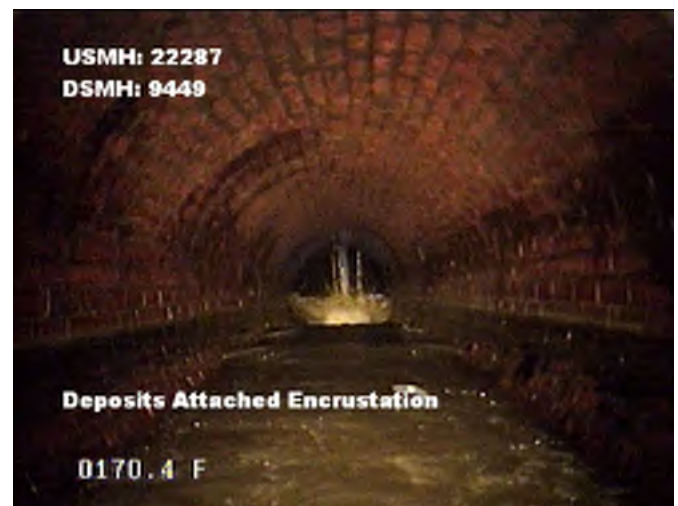
Distance: 170.4 ft. Grade: 2  
Condition: Deposits Attached Encrustation  
Remarks: N/A

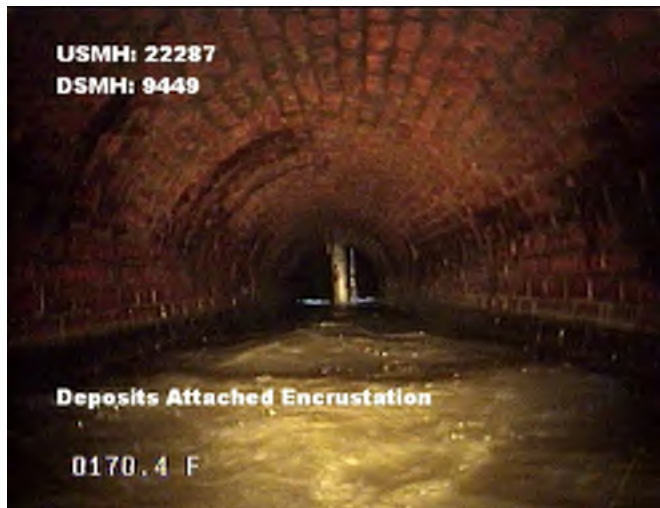
Distance: 170.4 ft. Grade: 2  
Condition: Deposits Attached Encrustation  
Remarks: N/A

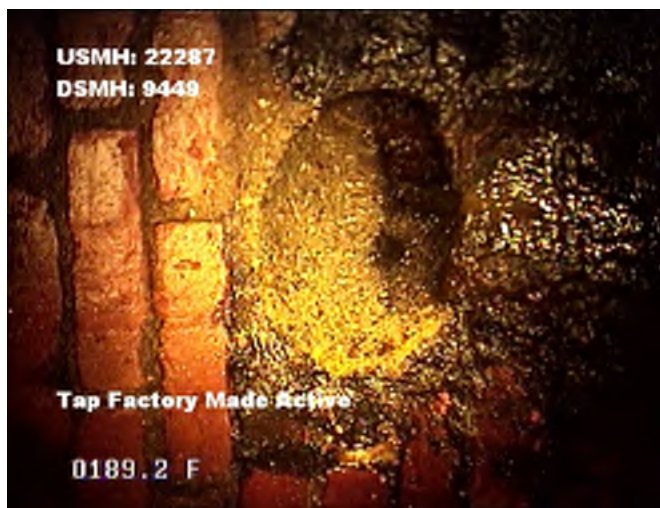
Distance: 189.2 ft. Grade: 0  
Condition: Tap Factory Made Active  
Remarks: N/A

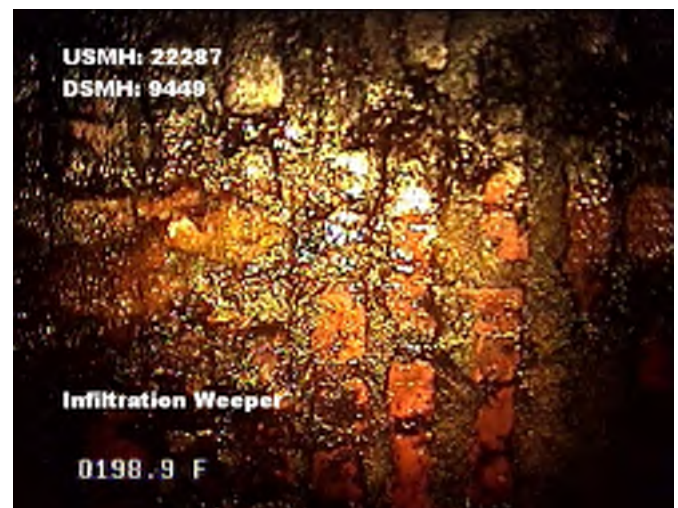
198.9 ft. Infiltration Weeper

Distance: 198.9 ft. Grade: 2  
Condition: Infiltration Weeper  
Remarks: N/A

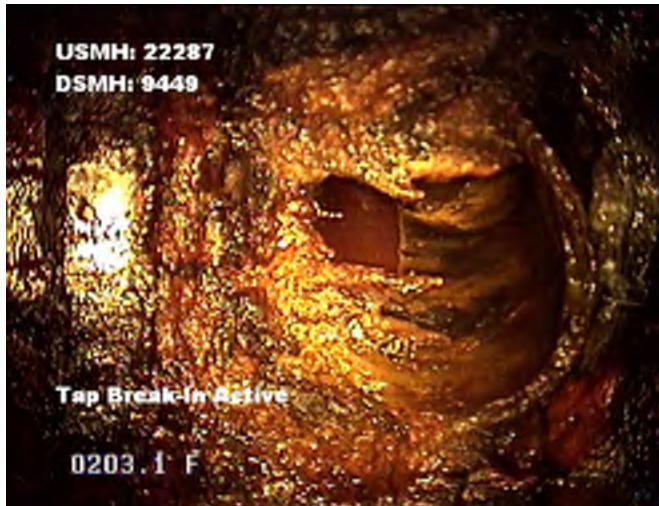
Distance: 203.1 ft. Grade: 0  
Condition: Tap Break-In Active  
Remarks: N/A

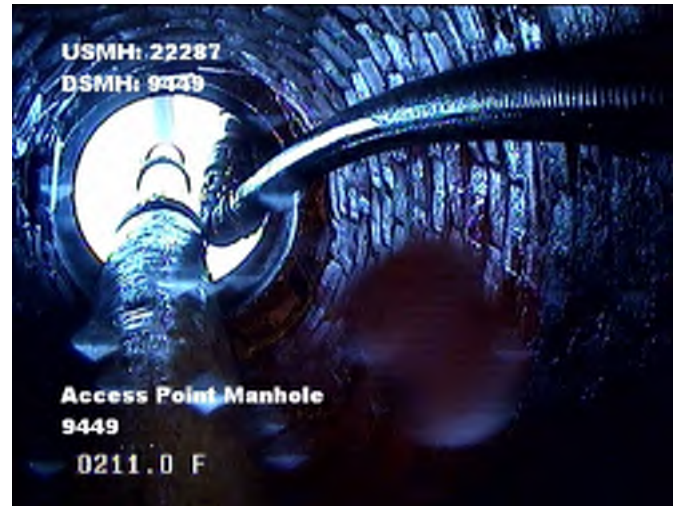
Distance: 211.0 ft. Grade: 0  
Condition: Access Point Manhole  
Remarks: 9449

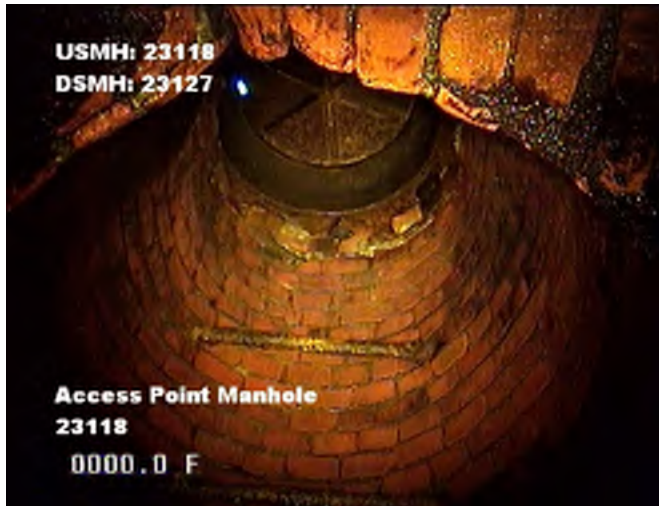
Distance: 0.0 ft. Grade: 0  
Condition: Access Point Manhole  
Remarks: 23118

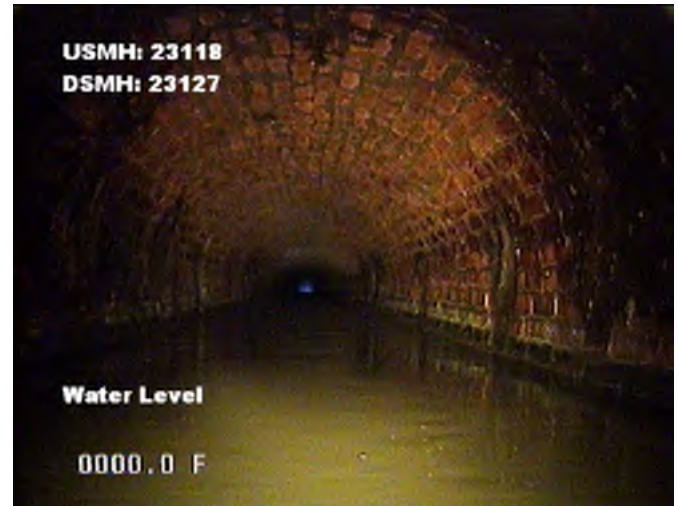
Distance: 0.0 ft. Grade: 0  
Condition: Water Level  
Remarks: N/A

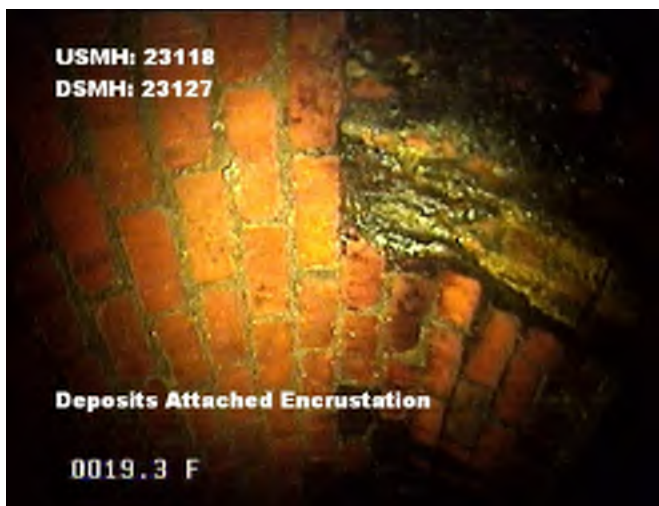
Distance: 19.3 ft. Grade: 2  
Condition: Deposits Attached Encrustation  
Remarks: N/A

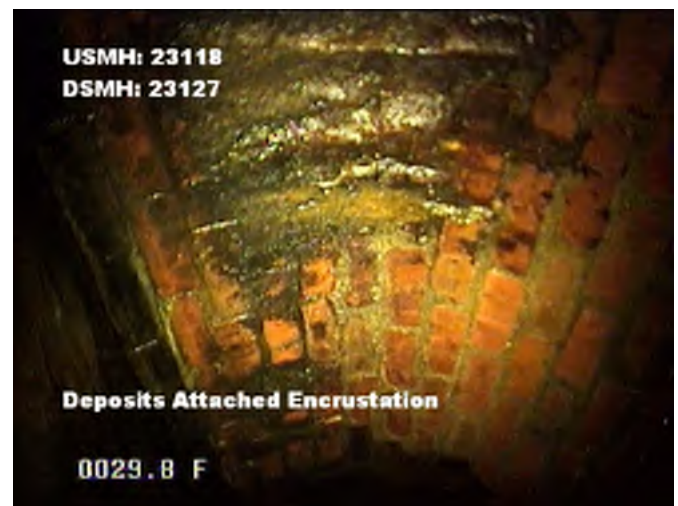
Distance: 29.8 ft. Grade: 2  
Condition: Deposits Attached Encrustation  
Remarks: N/A

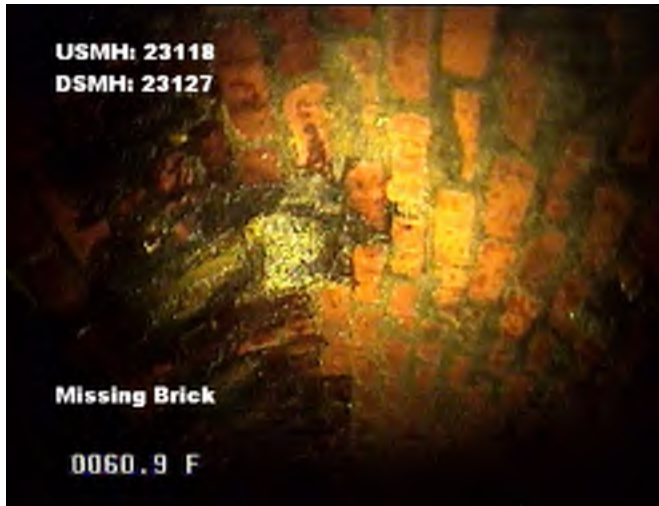
Distance: 60.9 ft. Grade: 4  
Condition: Missing Brick  
Remarks: N/A

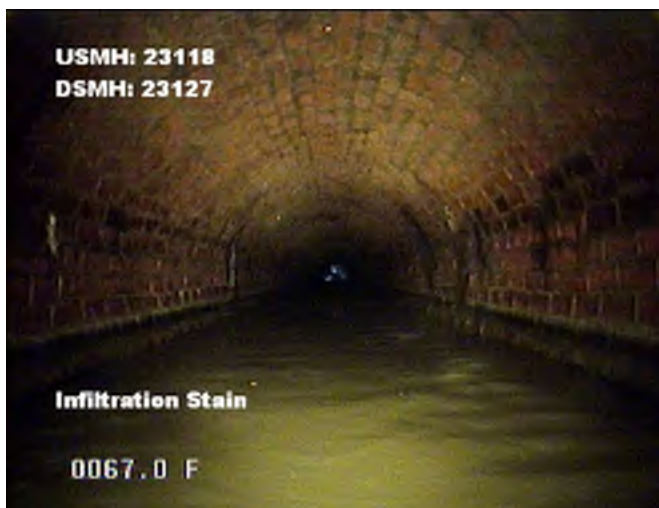
Distance: 67.0 ft. Grade: 0  
Condition: Infiltration Stain  
Remarks: N/A

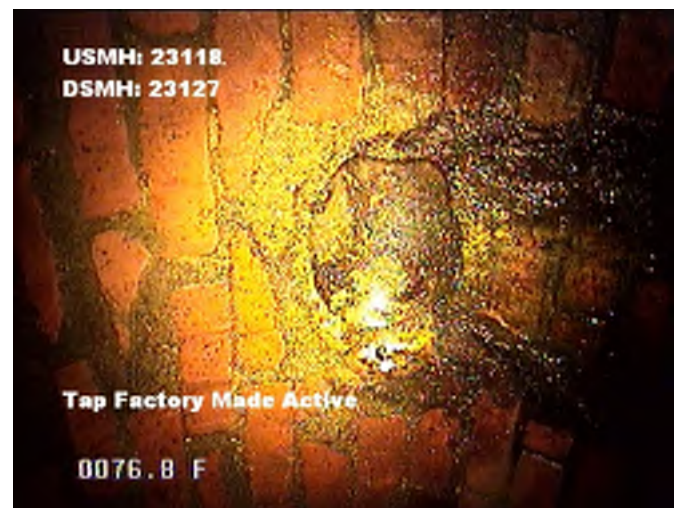
Distance: 76.8 ft. Grade: 0  
Condition: Tap Factory Made Active  
Remarks: N/A

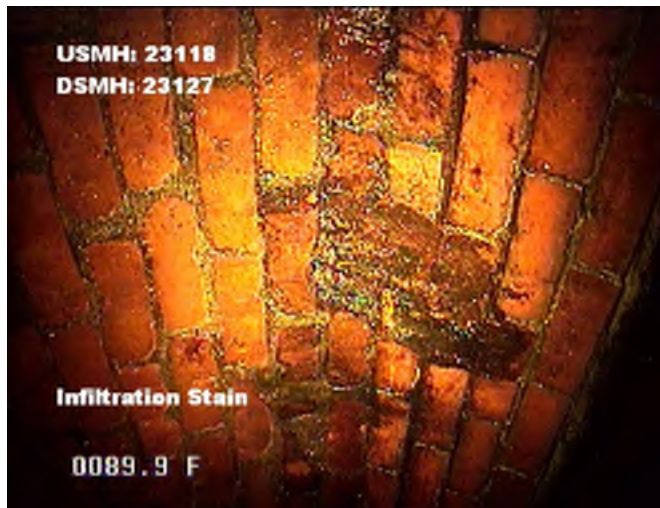
89.9 ft. Infiltration Stain - S02

Distance: 89.9 ft. Grade: 0  
Condition: Infiltration Stain  
Remarks: N/A

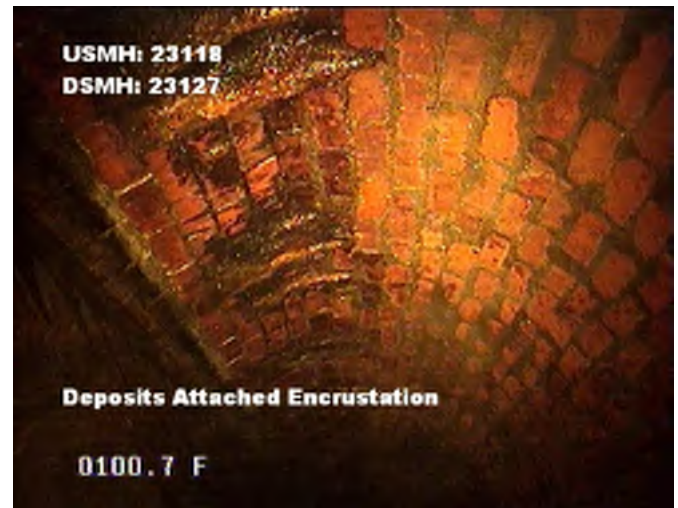
Distance: 100.7 ft. Grade: 2  
Condition: Deposits Attached Encrustation  
Remarks: N/A

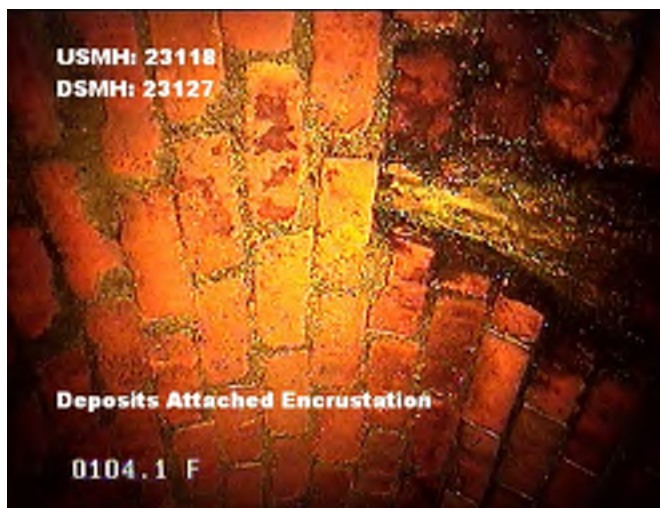
Distance: 104.1 ft. Grade: 2  
Condition: Deposits Attached Encrustation  
Remarks: N/A

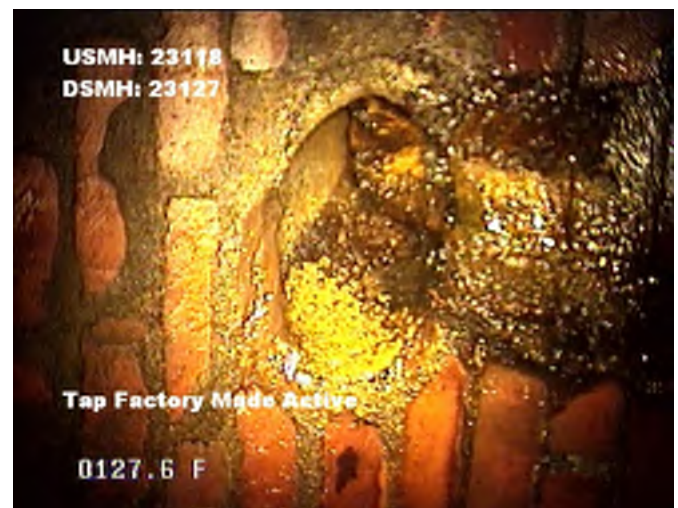
Distance: 127.6 ft. Grade: 0  
Condition: Tap Factory Made Active  
Remarks: N/A

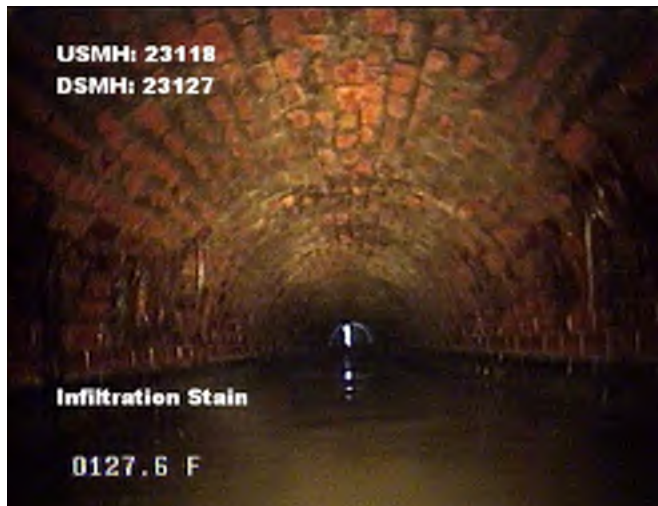
127.6 ft. Infiltration Stain - F02

Distance: 127.6 ft. Grade: 0  
Condition: Infiltration Stain  
Remarks: N/A

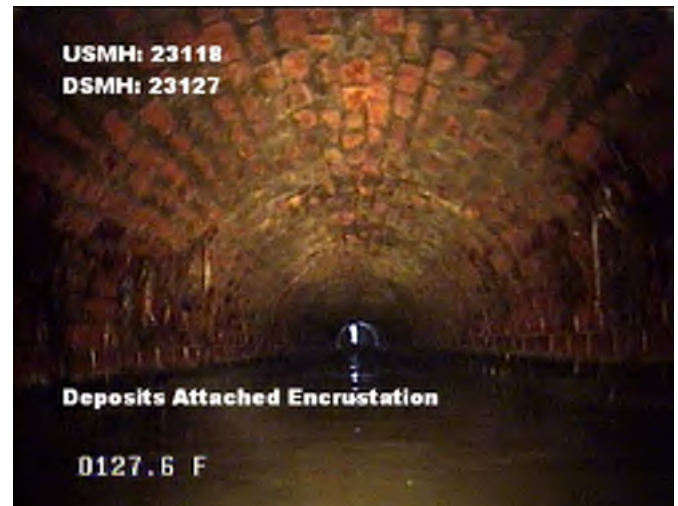
Distance: 127.6 ft. Grade: 2  
Condition: Deposits Attached Encrustation  
Remarks: N/A

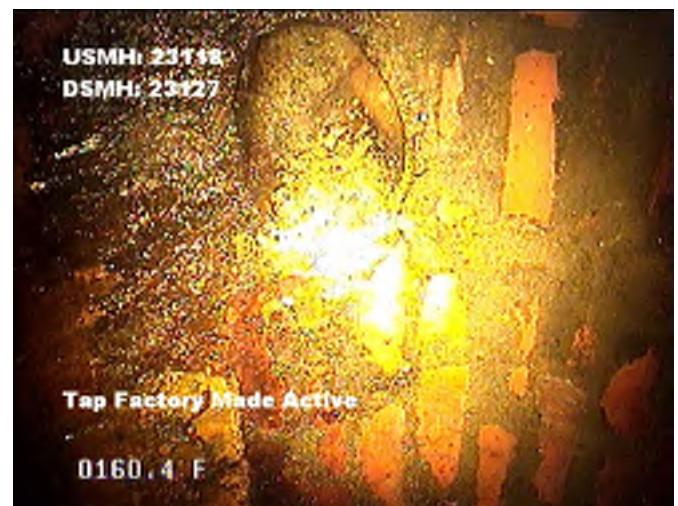
Distance: 160.4 ft. Grade: 0  
Condition: Tap Factory Made Active  
Remarks: N/A

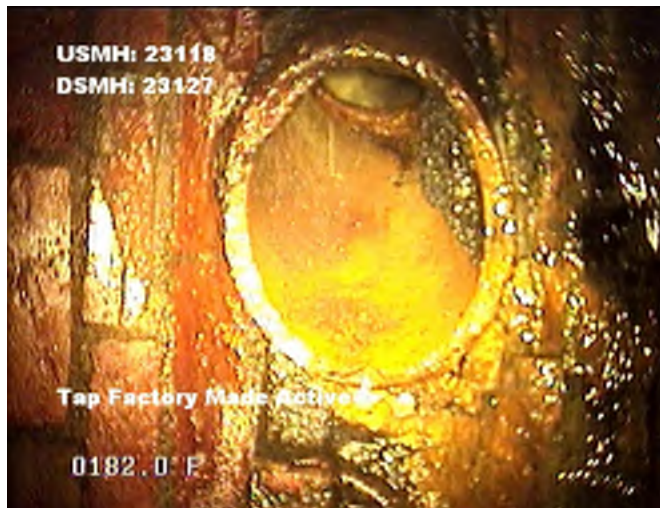
Distance: 182.0 ft. Grade: 0  
Condition: Tap Factory Made Active  
Remarks: N/A

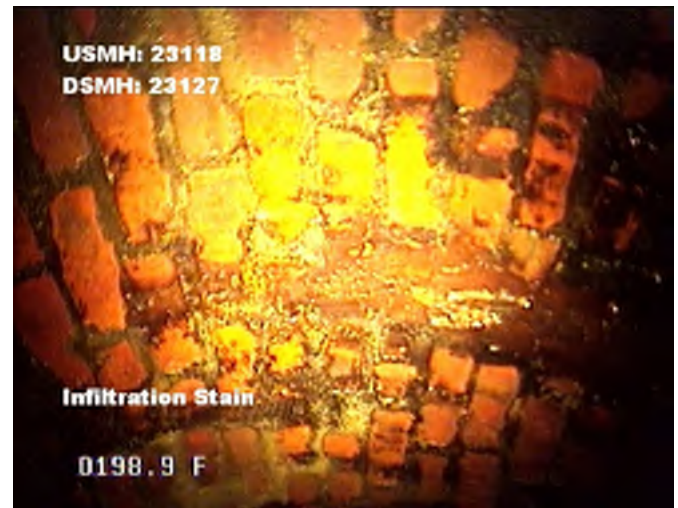
198.9 ft. Infiltration Stain

Distance: 198.9 ft. Grade: 0  
Condition: Infiltration Stain  
Remarks: N/A

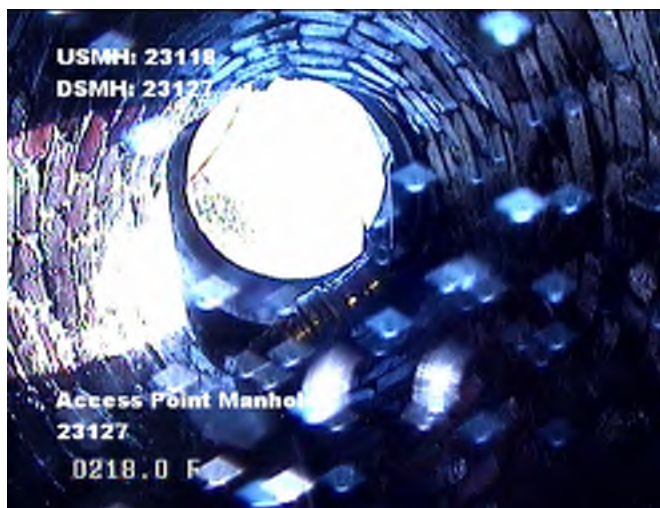
Distance: 218.0 ft. Grade: 0  
Condition: Access Point Manhole  
Remarks: 23127

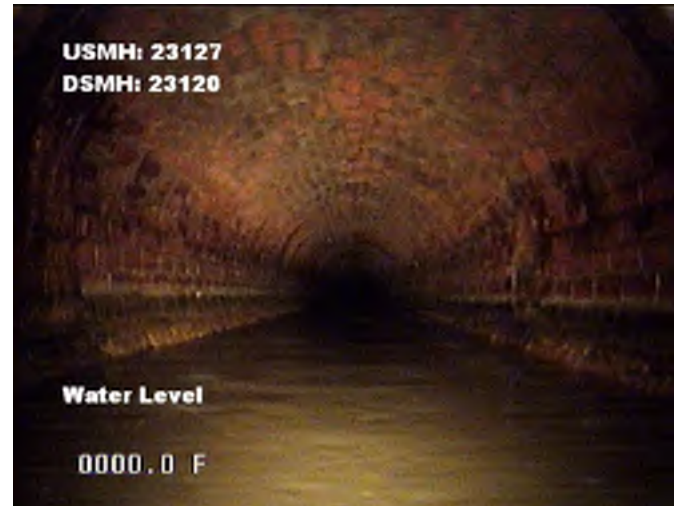
Distance: 0.0 ft. Grade: 0  
Condition: Water Level  
Remarks: N/A

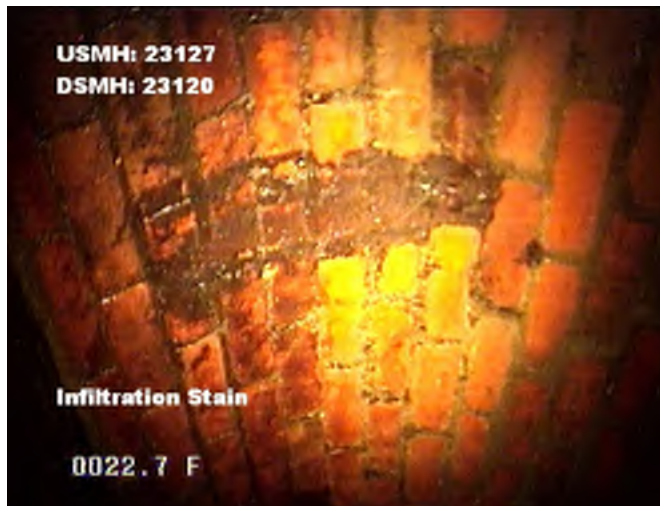
Distance: 22.7 ft. Grade: 0  
Condition: Infiltration Stain  
Remarks: N/A

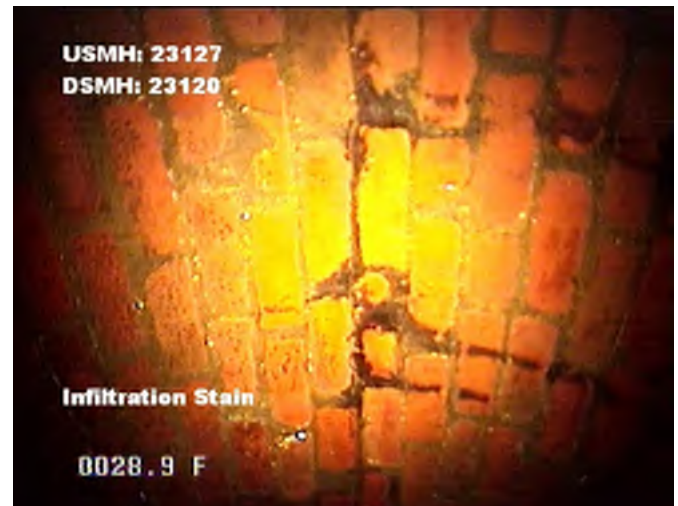
Distance: 28.9 ft. Grade: 0  
Condition: Infiltration Stain  
Remarks: N/A

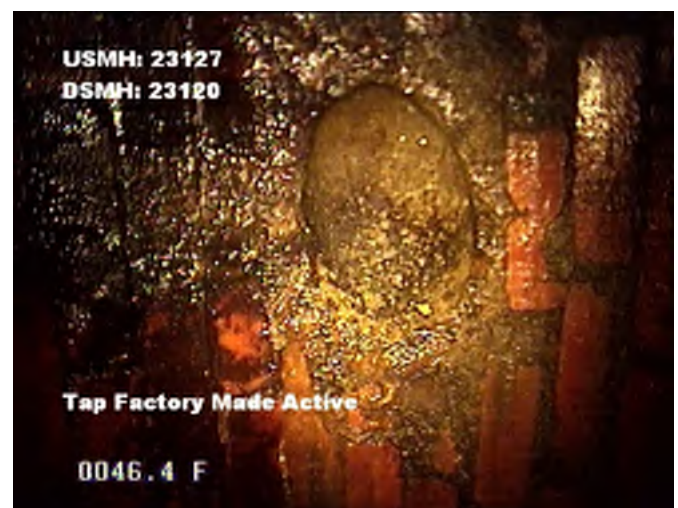
Distance: 46.4 ft. Grade: 0  
Condition: Tap Factory Made Active  
Remarks: N/A

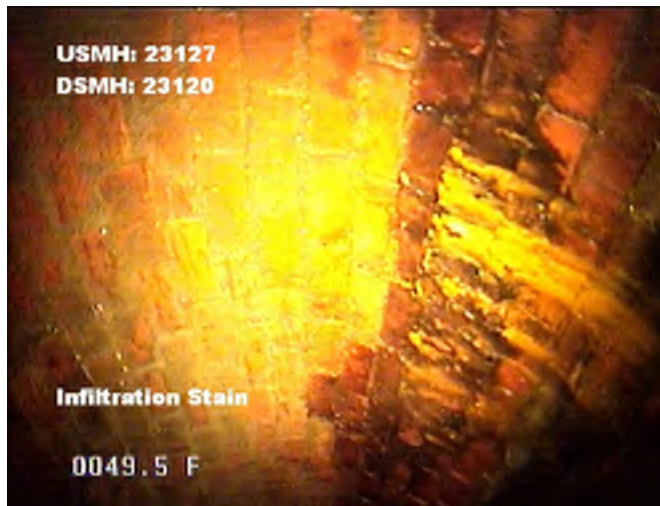
49.5 ft. Infiltration Stain

Distance: 49.5 ft. Grade: 0  
Condition: Infiltration Stain  
Remarks: N/A

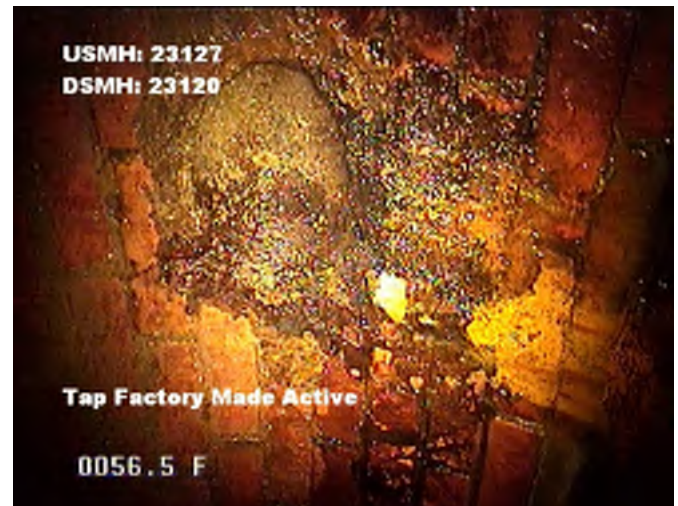
Distance: 56.5 ft. Grade: 0  
Condition: Tap Factory Made Active  
Remarks: N/A

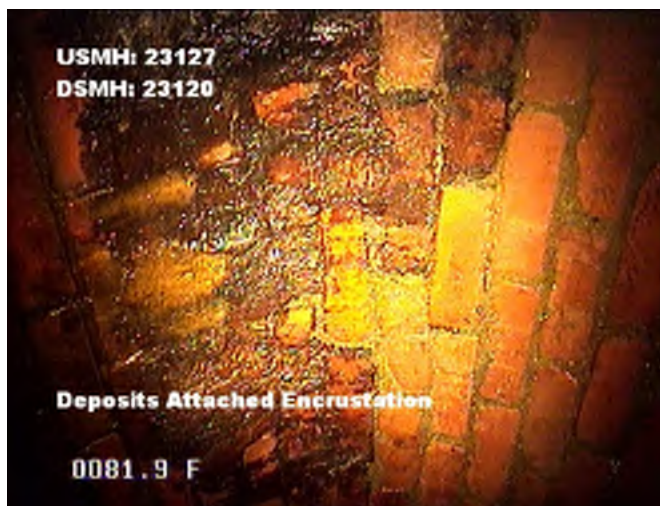
Distance: 81.9 ft. Grade: 2  
Condition: Deposits Attached Encrustation  
Remarks: N/A

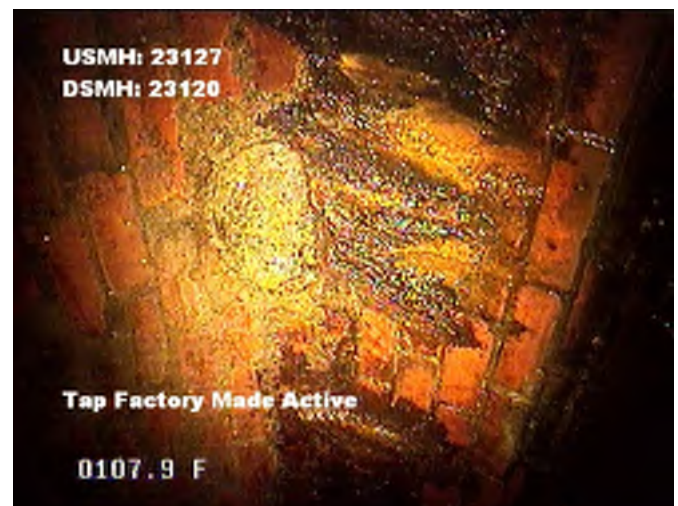
Distance: 107.9 ft. Grade: 0  
Condition: Tap Factory Made Active  
Remarks: N/A

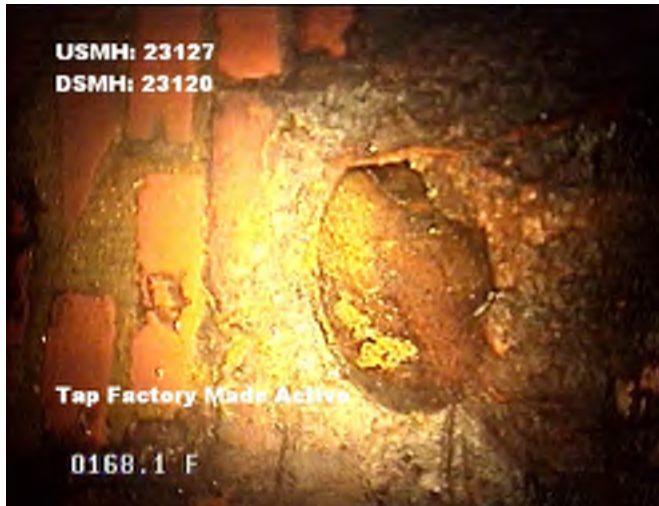
Distance: 168.1 ft. Grade: 0  
Condition: Tap Factory Made Active  
Remarks: N/A

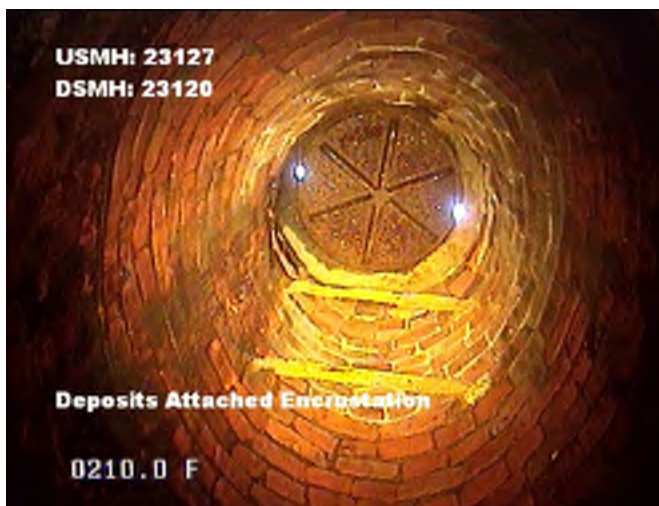
Distance: 210.0 ft. Grade: 2  
Condition: Deposits Attached Encrustation  
Remarks: N/A

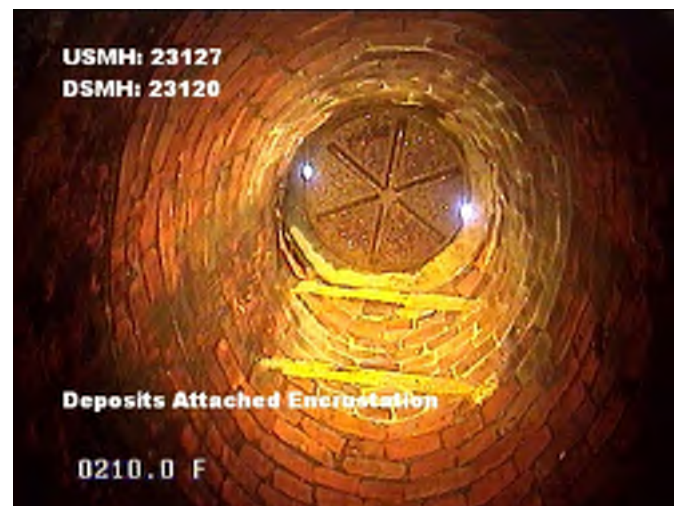
Distance: 210.0 ft. Grade: 2  
Condition: Deposits Attached Encrustation  
Remarks: N/A

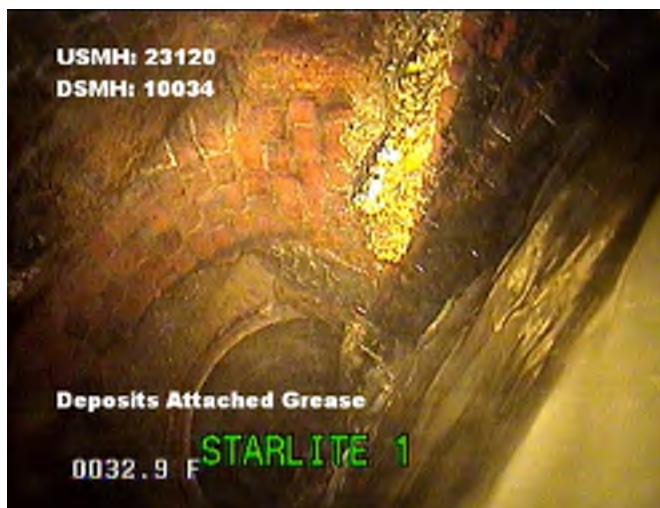
Distance: 32.9 ft. Grade: 2  
Condition: Deposits Attached Grease  
Remarks: N/A

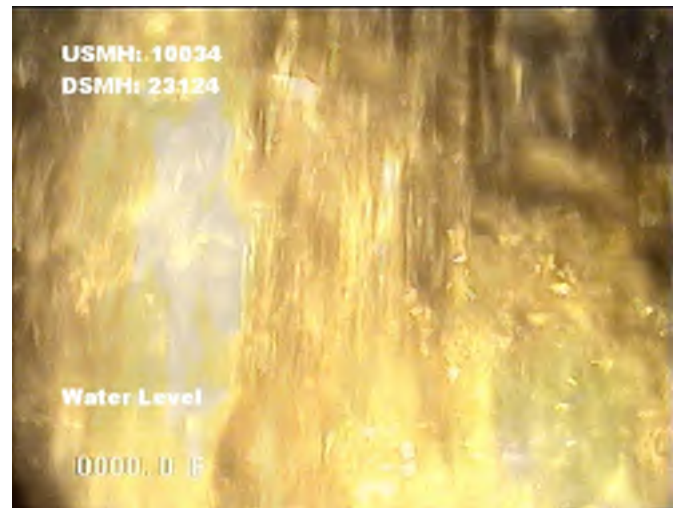
Distance: 0.0 ft. Grade: 0  
Condition: Water Level  
Remarks: N/A

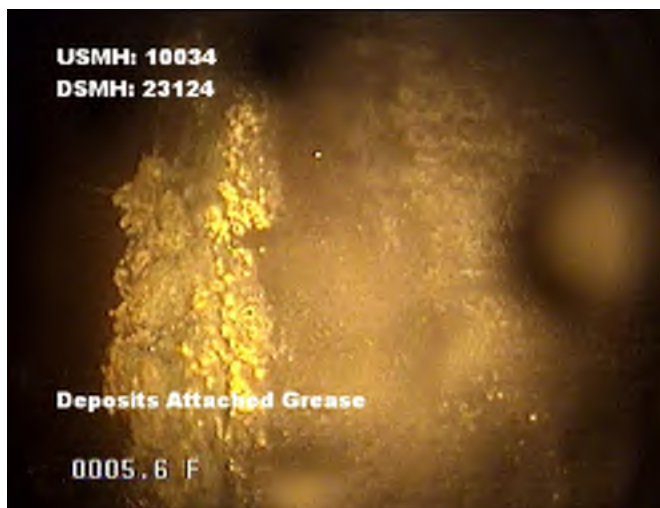
Distance: 5.6 ft. Grade: 2  
Condition: Deposits Attached Grease  
Remarks: N/A

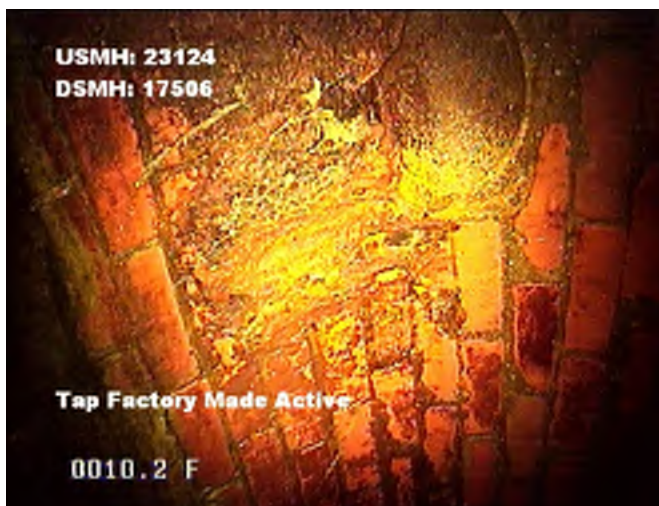
Distance: 10.2 ft. Grade: 0  
Condition: Tap Factory Made Active  
Remarks: N/A

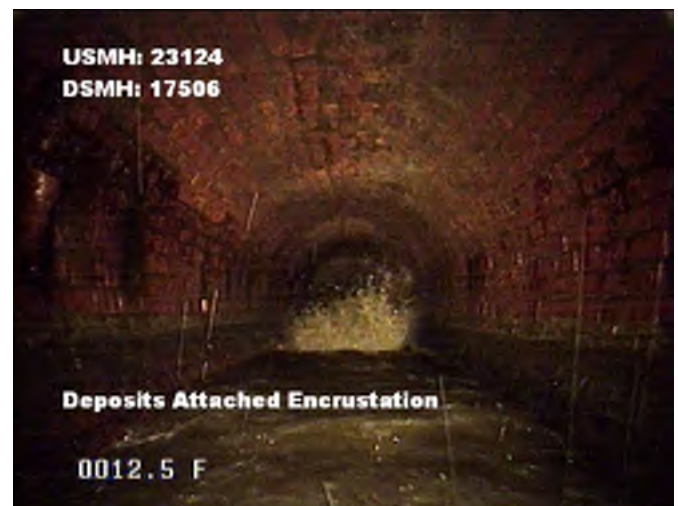
Distance: 12.5 ft. Grade: 2  
Condition: Deposits Attached Encrustation  
Remarks: N/A

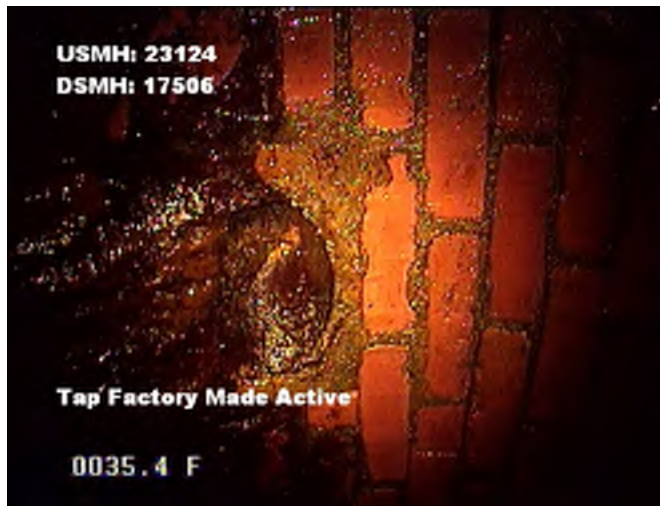
Distance: 35.4 ft. Grade: 0  
Condition: Tap Factory Made Active  
Remarks: N/A

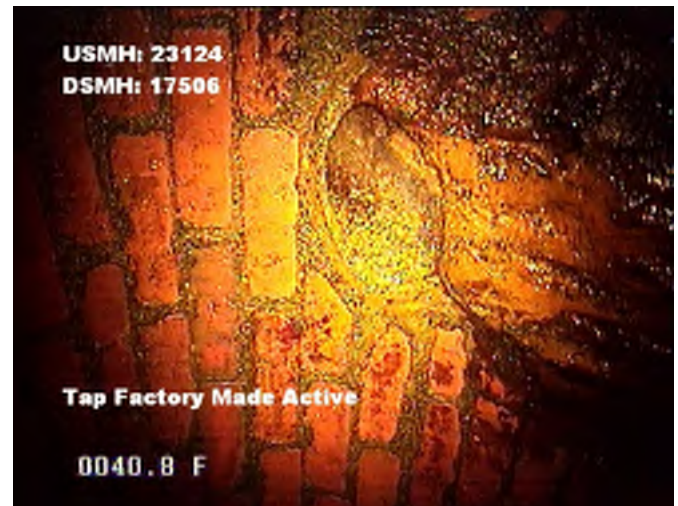
Distance: 40.8 ft. Grade: 0  
Condition: Tap Factory Made Active  
Remarks: N/A

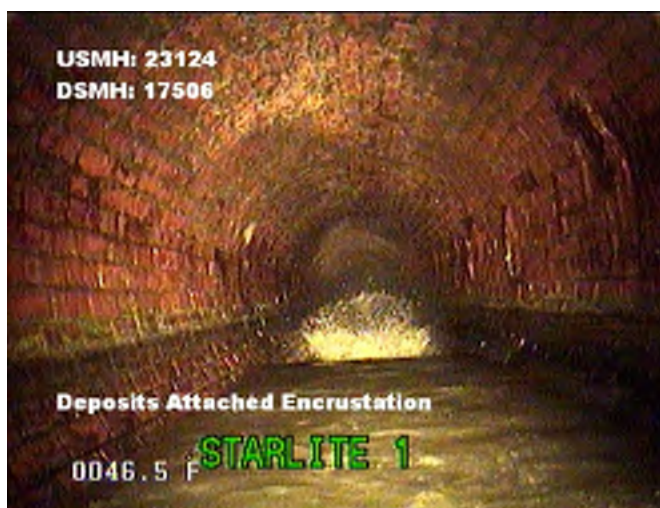
Distance: 46.5 ft. Grade: 2  
Condition: Deposits Attached Encrustation  
Remarks: N/A

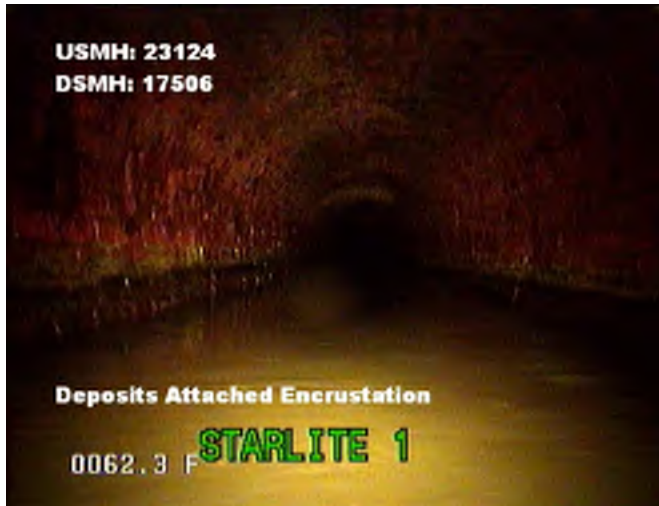
Distance: 62.3 ft. Grade: 2  
Condition: Deposits Attached Encrustation  
Remarks: N/A

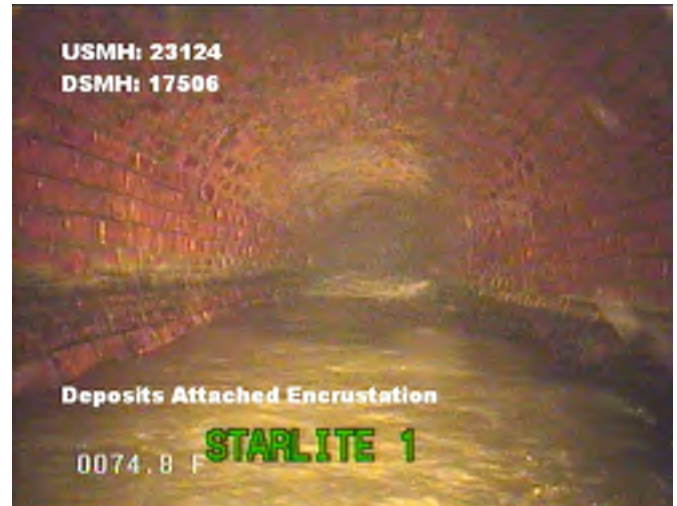
Distance: 74.6 ft. Grade: 2  
Condition: Deposits Attached Encrustation  
Remarks: N/A

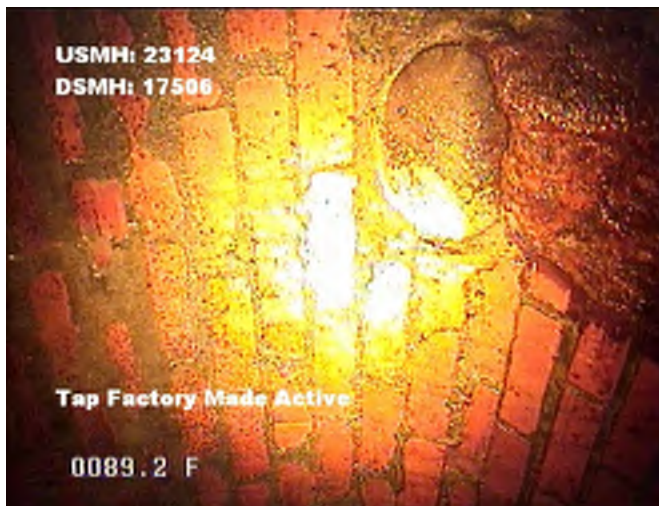
Distance: 89.2 ft. Grade: 0  
Condition: Tap Factory Made Active  
Remarks: N/A

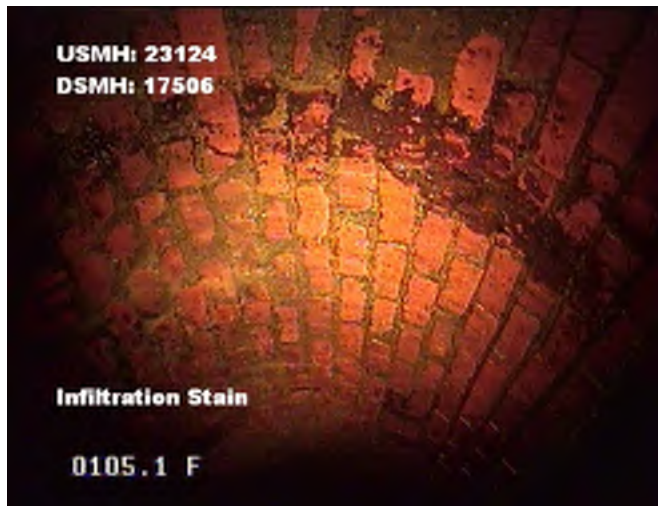
Distance: 105.1 ft. Grade: 0  
Condition: Infiltration Stain  
Remarks: N/A
