# APPENDIX A

## TELEVISION INSPECTION REPORTS AND VIDEOS

Project Name: <b>WS WORCESTER WI</b>	Project Number:	Date:
---	-----------------	-------

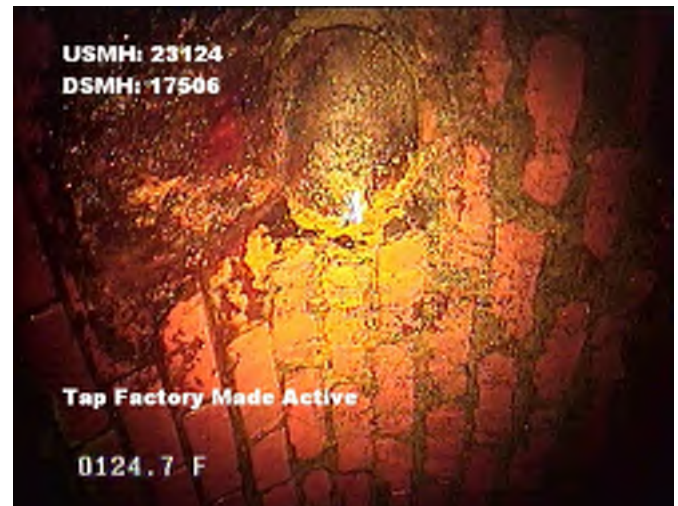
Distance: 124.7 ft. Grade: 0  
Condition: Tap Factory Made Active  
Remarks: N/A

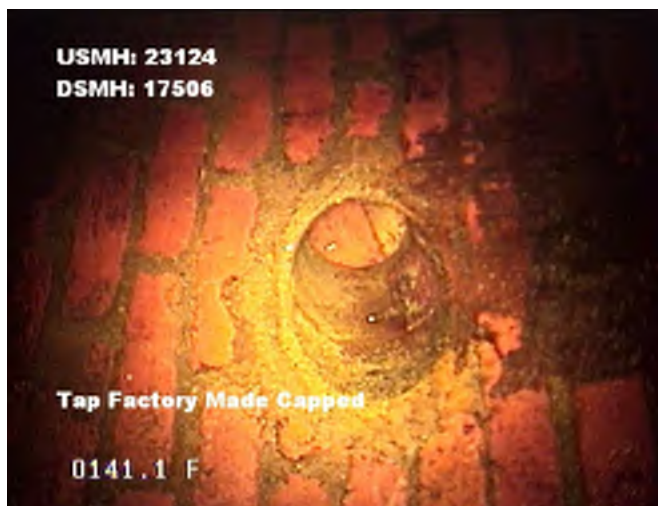
Distance: 141.1 ft. Grade: 0  
Condition: Tap Factory Made Capped  
Remarks: N/A

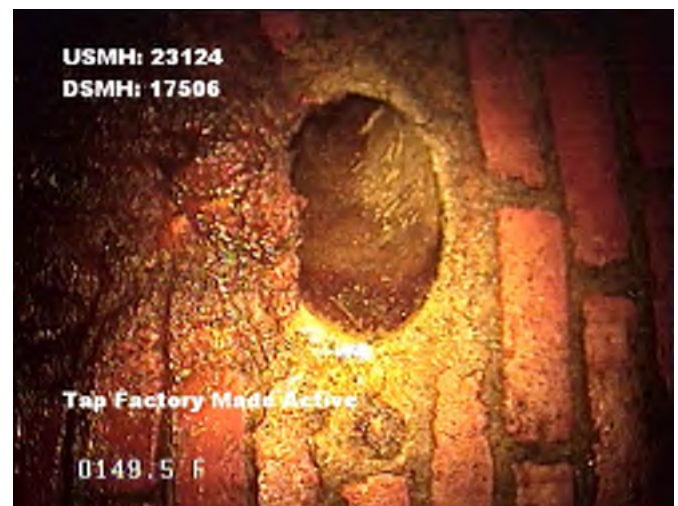
Distance: 149.5 ft. Grade: 0  
Condition: Tap Factory Made Active  
Remarks: N/A

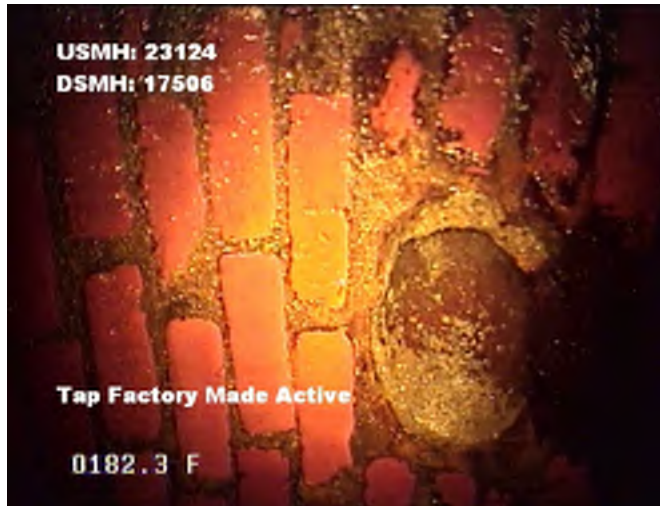
Distance: 182.3 ft. Grade: 0  
Condition: Tap Factory Made Active  
Remarks: N/A

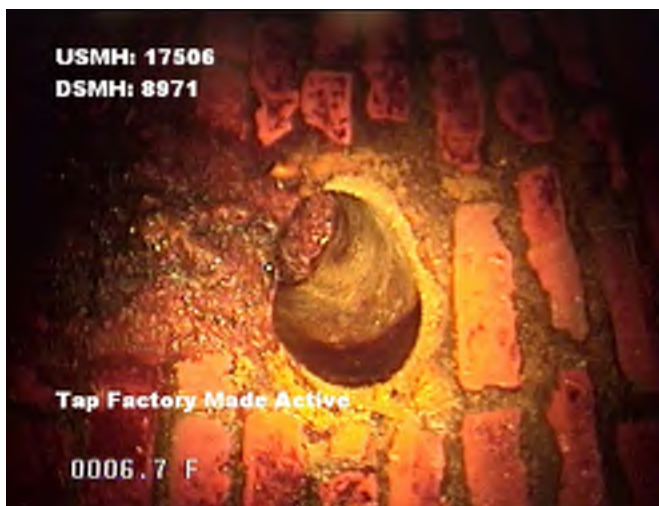
Distance: 6.7 ft. Grade: 0  
Condition: Tap Factory Made Active  
Remarks: N/A

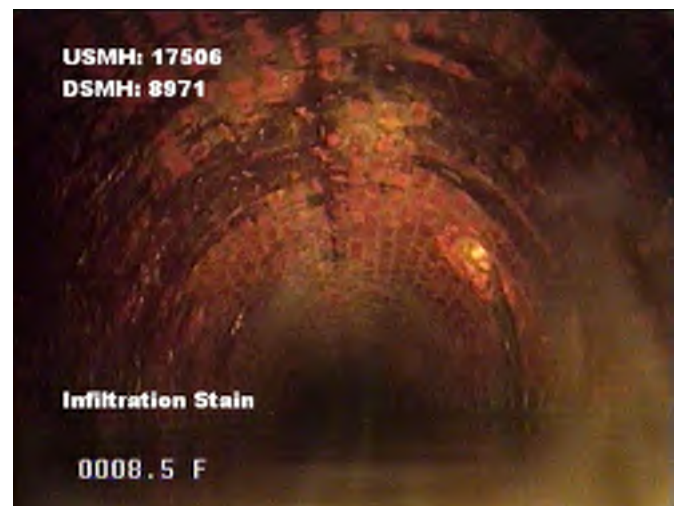
Distance: 8.5 ft. Grade: 0  
Condition: Infiltration Stain  
Remarks: N/A

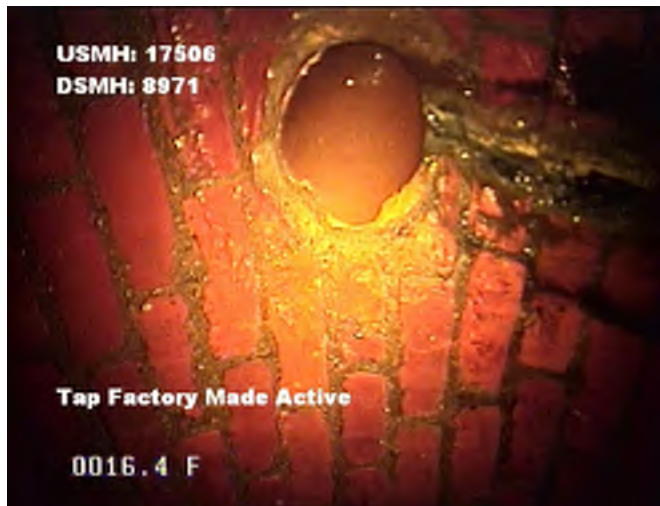
Distance: 16.4 ft. Grade: 0  
Condition: Tap Factory Made Active  
Remarks: N/A

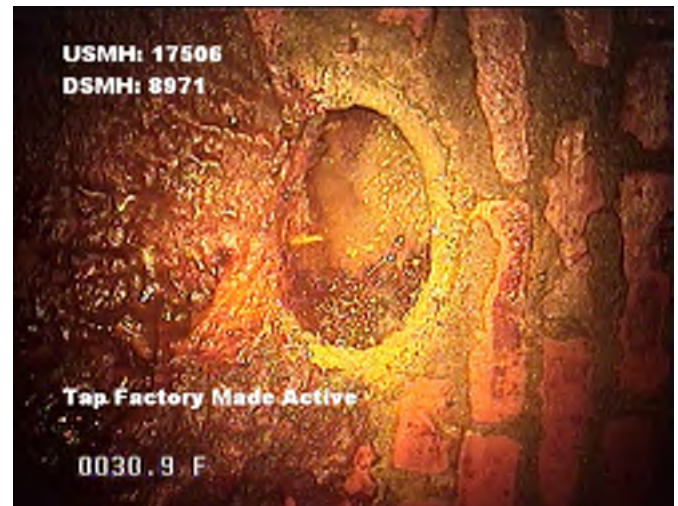
Distance: 30.9 ft. Grade: 0  
Condition: Tap Factory Made Active  
Remarks: N/A

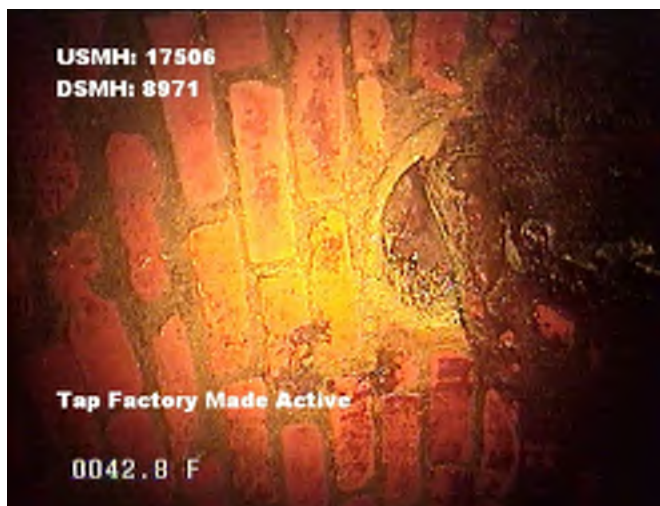
Distance: 42.8 ft. Grade: 0  
Condition: Tap Factory Made Active  
Remarks: N/A

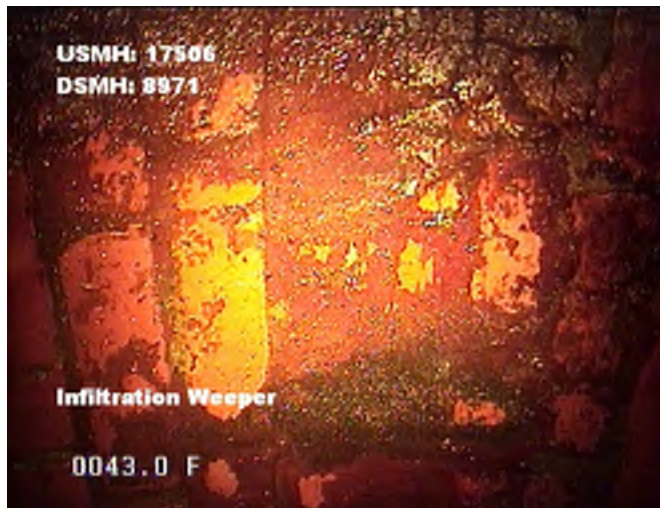
Distance: 43.0 ft. Grade: 2  
Condition: Infiltration Weeper  
Remarks: N/A

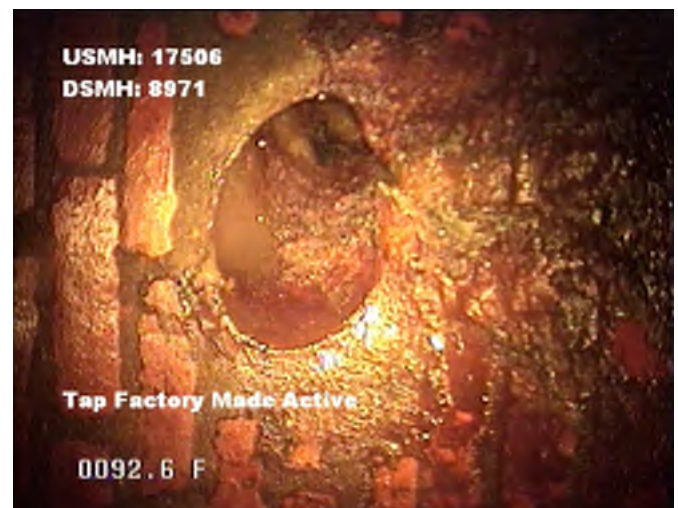
Distance: 92.6 ft. Grade: 0  
Condition: Tap Factory Made Active  
Remarks: N/A

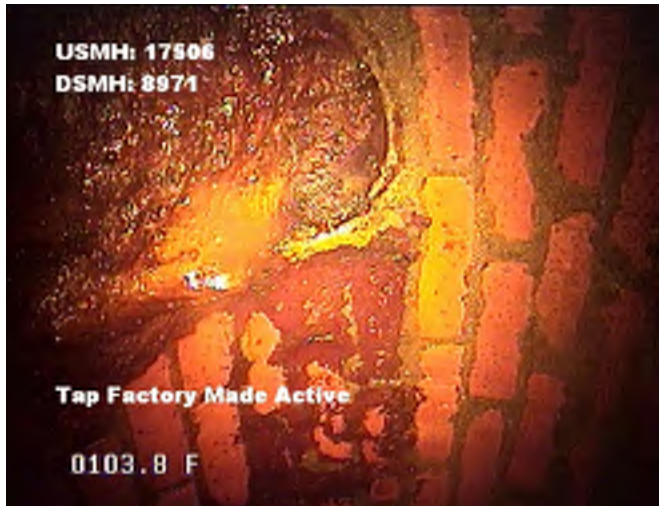
Distance: 103.8 ft. Grade: 0  
Condition: Tap Factory Made Active  
Remarks: N/A

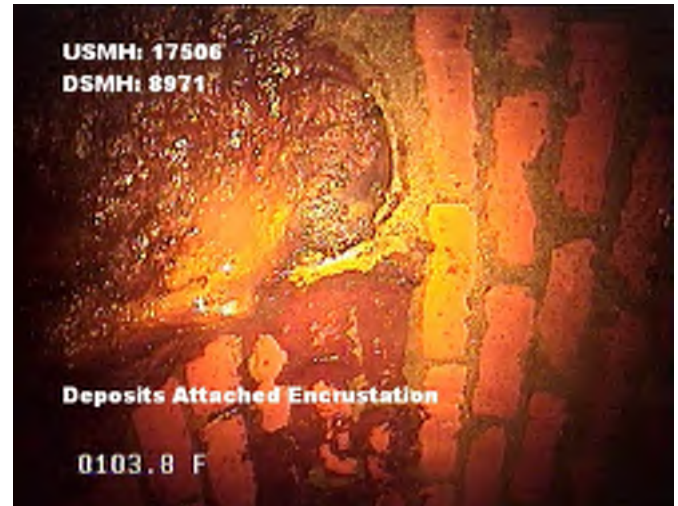
Distance: 103.8 ft. Grade: 3  
Condition: Deposits Attached Encrustation  
Remarks: N/A

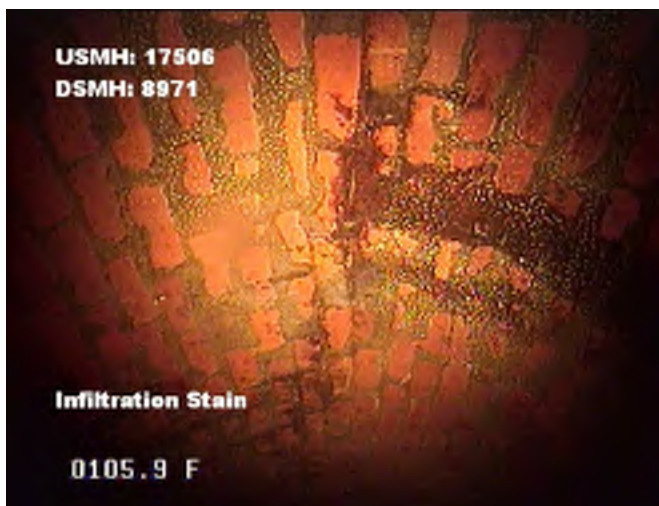
Distance: 105.9 ft. Grade: 0  
Condition: Infiltration Stain  
Remarks: N/A

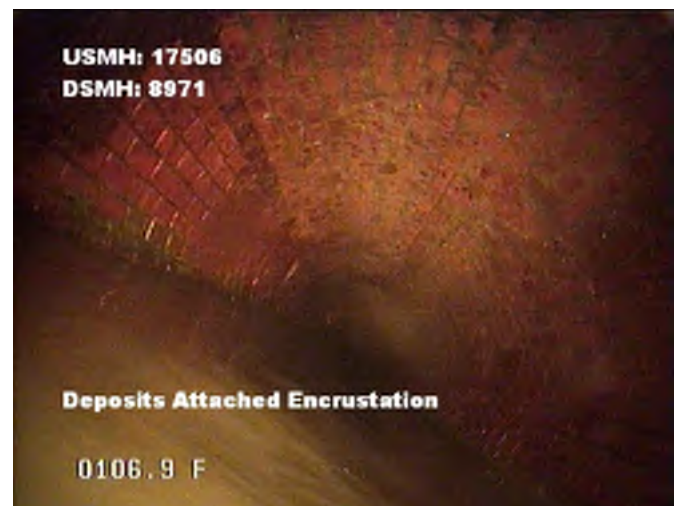
Distance: 106.8 ft. Grade: 2  
Condition: Deposits Attached Encrustation  
Remarks: N/A

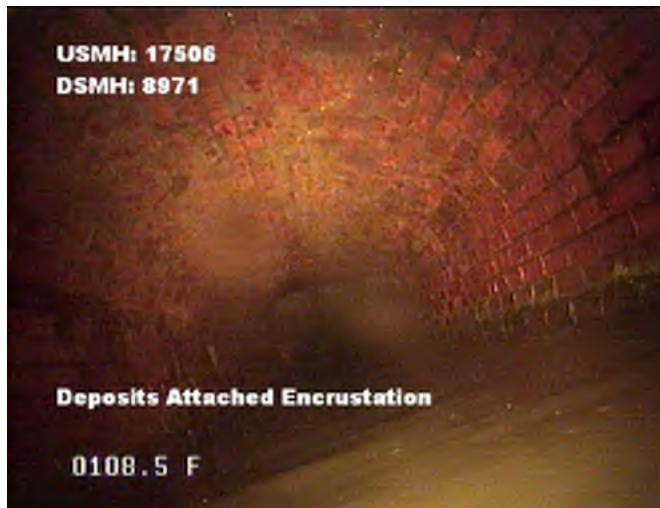
Distance: 108.4 ft. Grade: 2  
Condition: Deposits Attached Encrustation  
Remarks: N/A

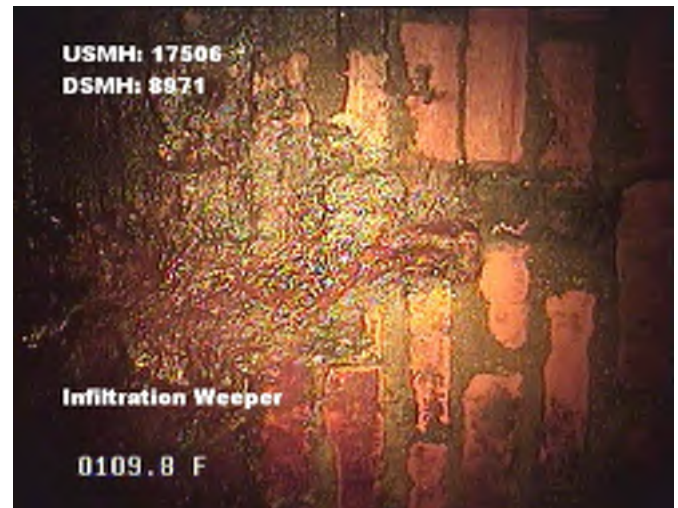
Distance: 109.8 ft. Grade: 2  
Condition: Infiltration Weeper  
Remarks: N/A

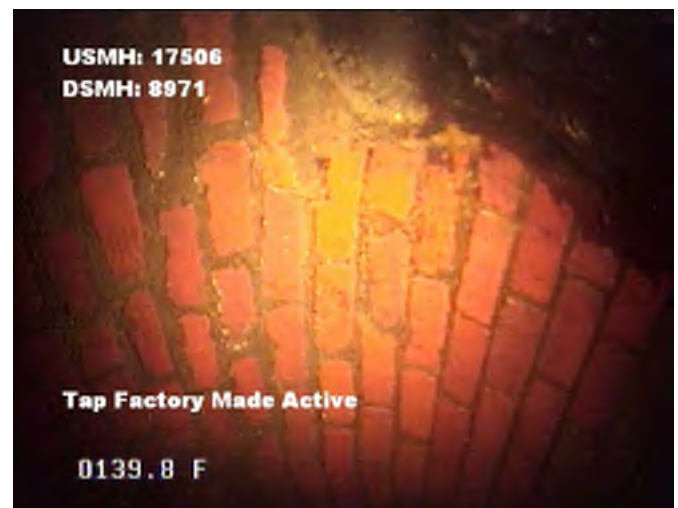
Distance: 139.8 ft. Grade: 0  
Condition: Tap Factory Made Active  
Remarks: N/A

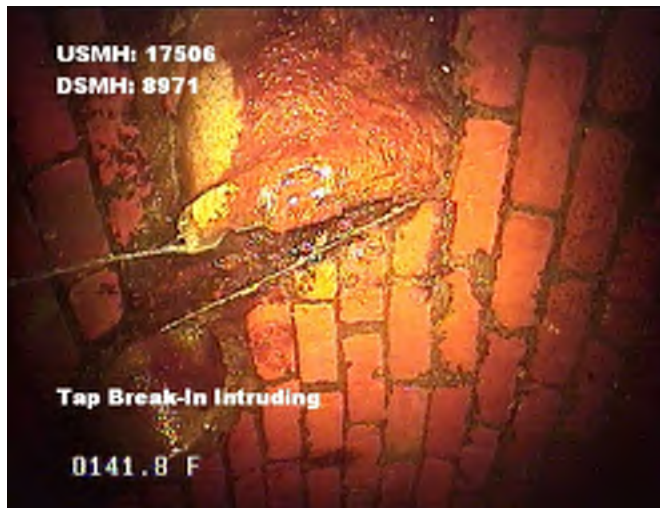
Distance: 141.8 ft. Grade: 2  
Condition: Tap Break-In Intruding  
Remarks: N/A

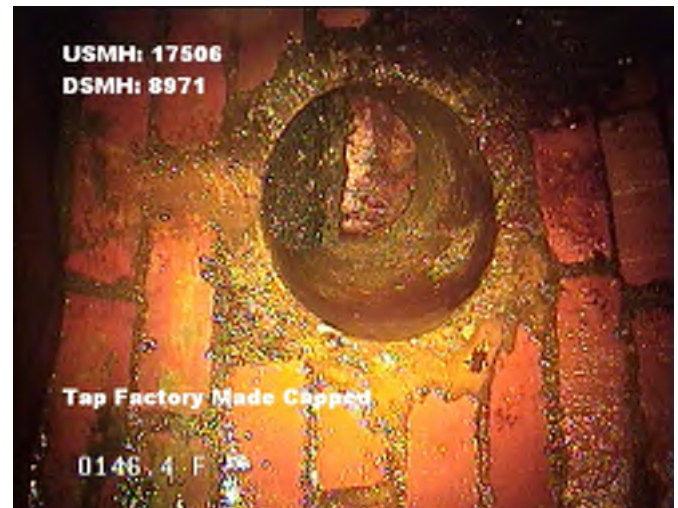
Distance: 146.4 ft. Grade: 0  
Condition: Tap Factory Made Capped  
Remarks: N/A

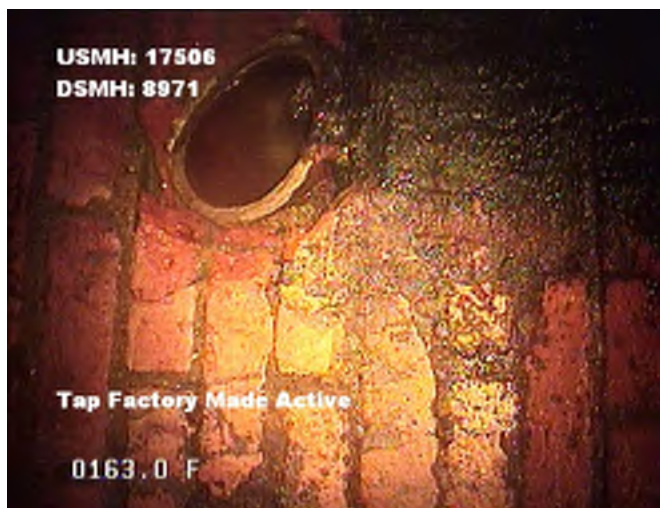
Distance: 163.0 ft. Grade: 0  
Condition: Tap Factory Made Active  
Remarks: N/A

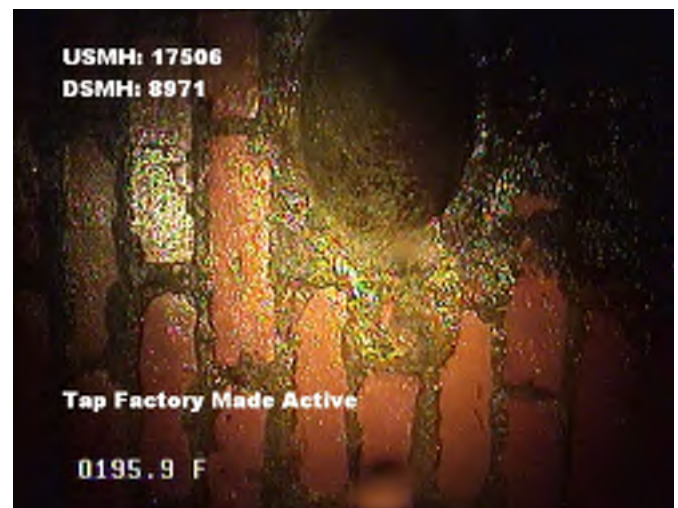
Distance: 195.9 ft. Grade: 0  
Condition: Tap Factory Made Active  
Remarks: N/A

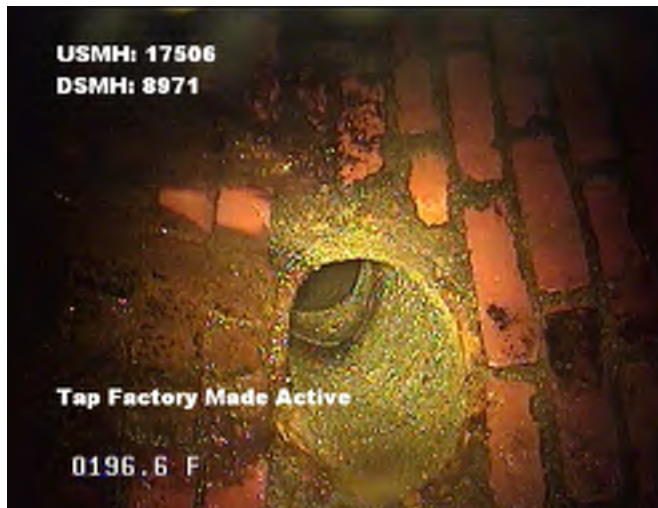
Distance: 196.6 ft. Grade: 0  
Condition: Tap Factory Made Active  
Remarks: N/A

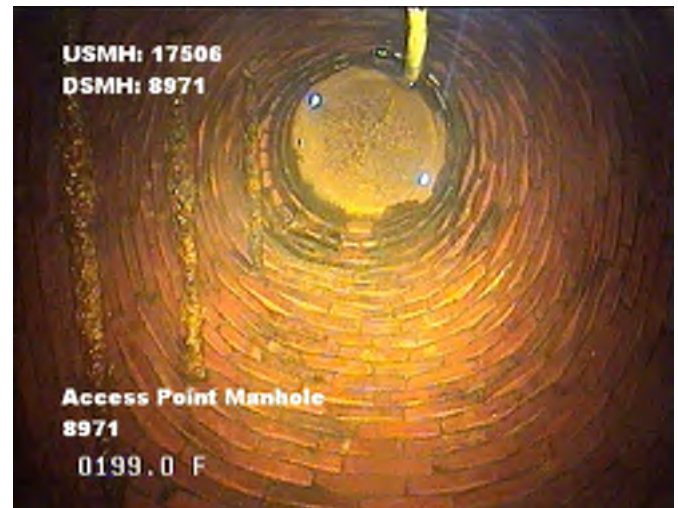
Distance: 199.0 ft. Grade: 0  
Condition: Access Point Manhole  
Remarks: 8971

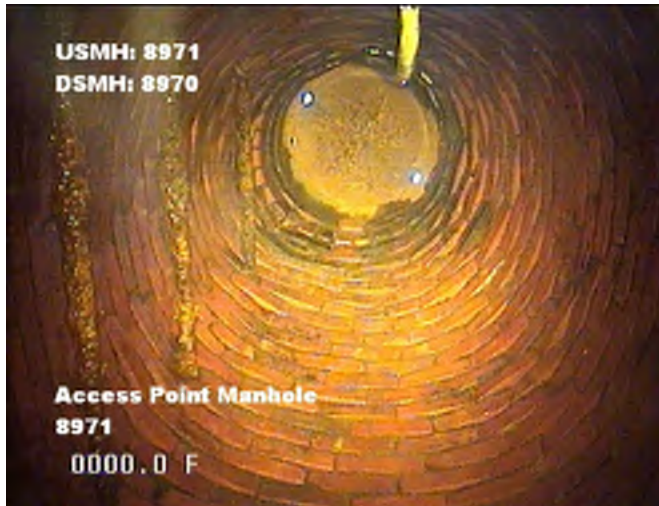
Distance: 0.0 ft. Grade: 0  
Condition: Access Point Manhole  
Remarks: 8971

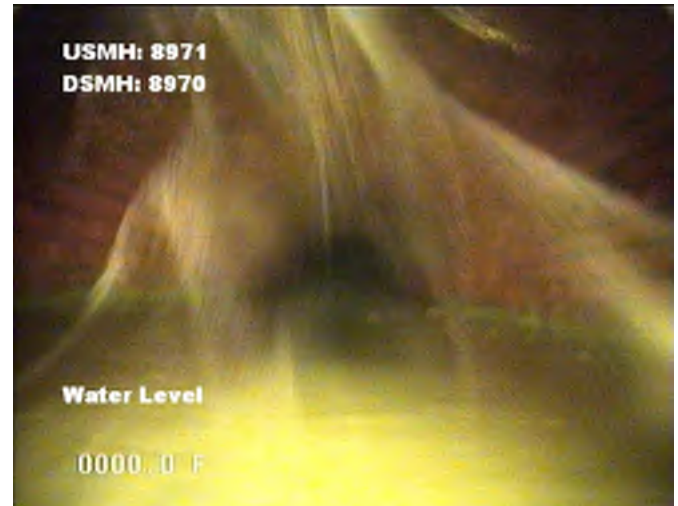
Distance: 0.0 ft. Grade: 0  
Condition: Water Level  
Remarks: N/A

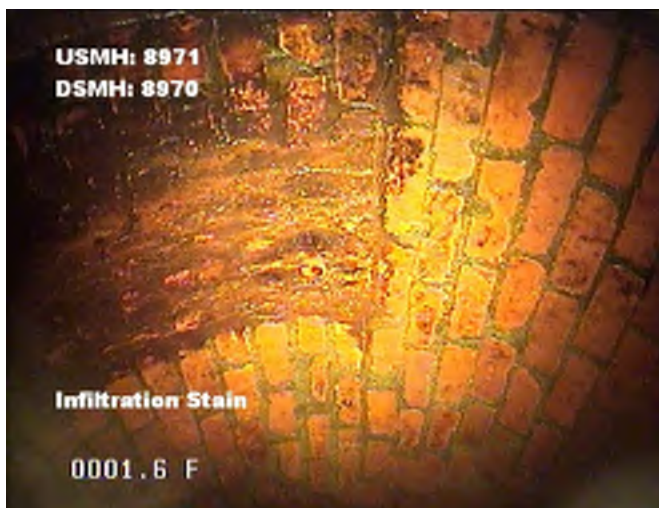
Distance: 1.6 ft. Grade: 0  
Condition: Infiltration Stain  
Remarks: N/A

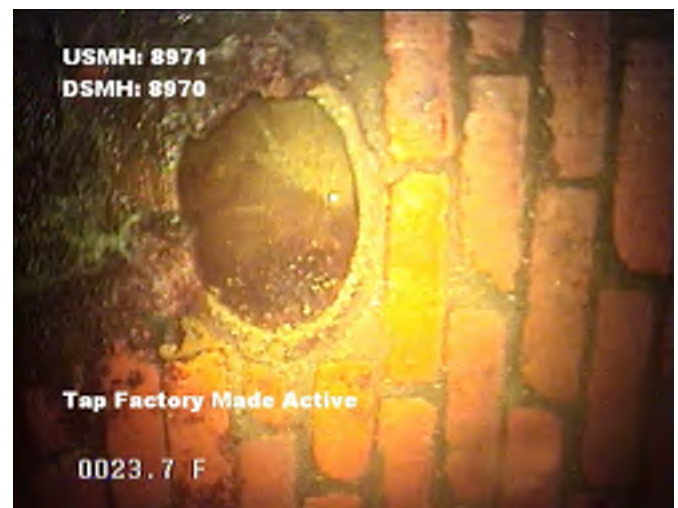
Distance: 23.7 ft. Grade: 0  
Condition: Tap Factory Made Active  
Remarks: N/A

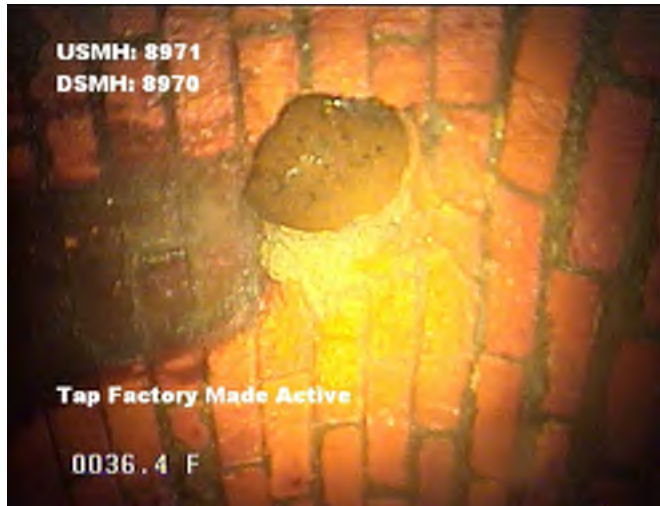
Distance: 36.4 ft. Grade: 0  
Condition: Tap Factory Made Active  
Remarks: N/A

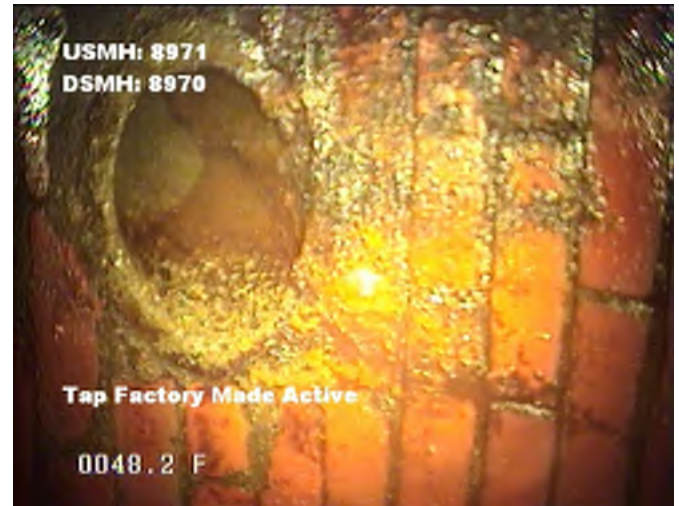
Distance: 48.2 ft. Grade: 0  
Condition: Tap Factory Made Active  
Remarks: N/A

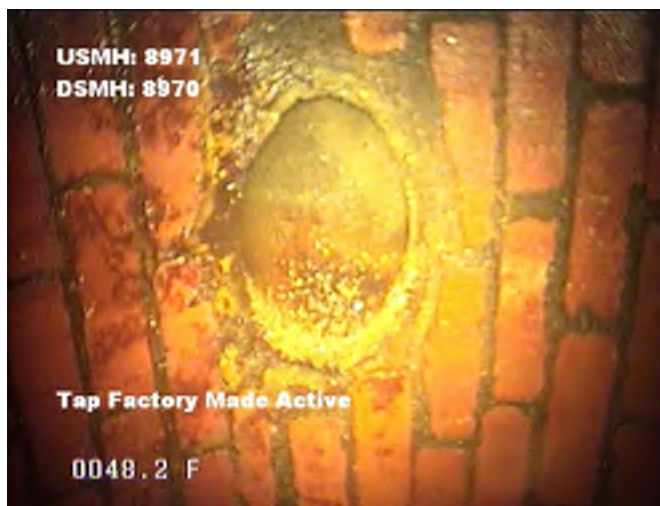
Distance: 48.2 ft. Grade: 0  
Condition: Tap Factory Made Active  
Remarks: N/A

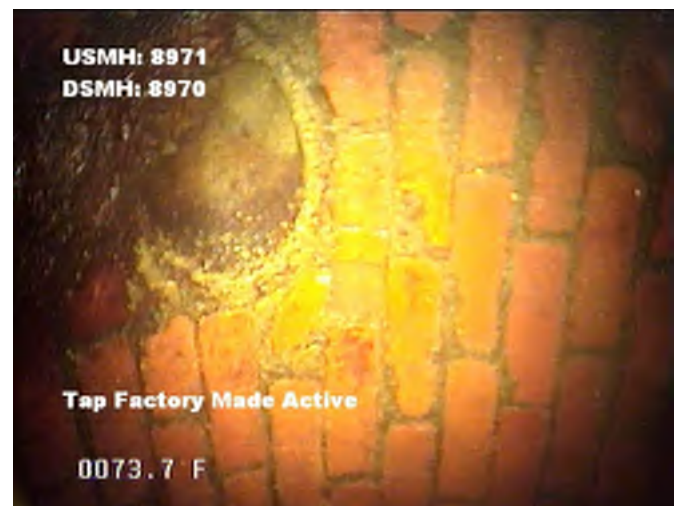
Distance: 73.7 ft. Grade: 0  
Condition: Tap Factory Made Active  
Remarks: N/A

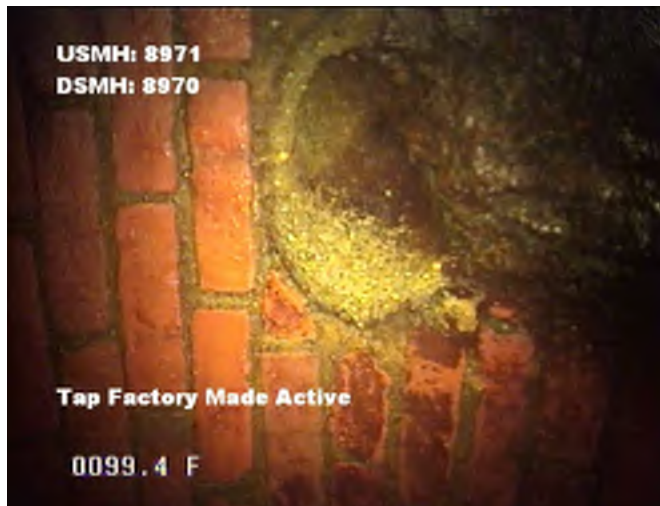
Distance: 99.4 ft. Grade: 0  
Condition: Tap Factory Made Active  
Remarks: N/A

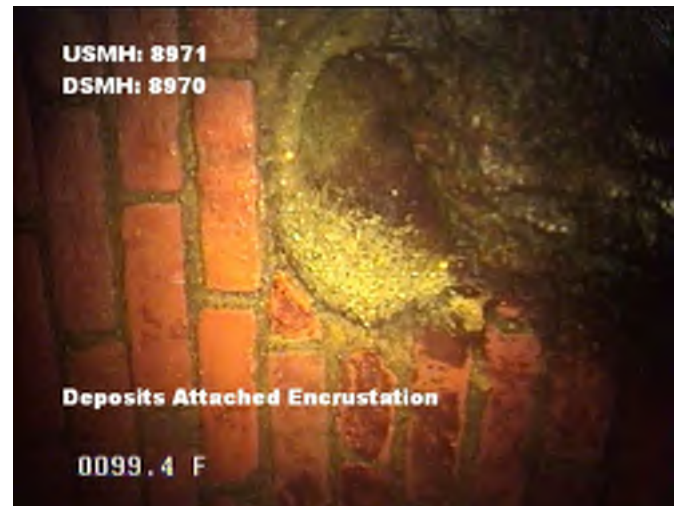
Distance: 99.4 ft. Grade: 2  
Condition: Deposits Attached Encrustation  
Remarks: N/A

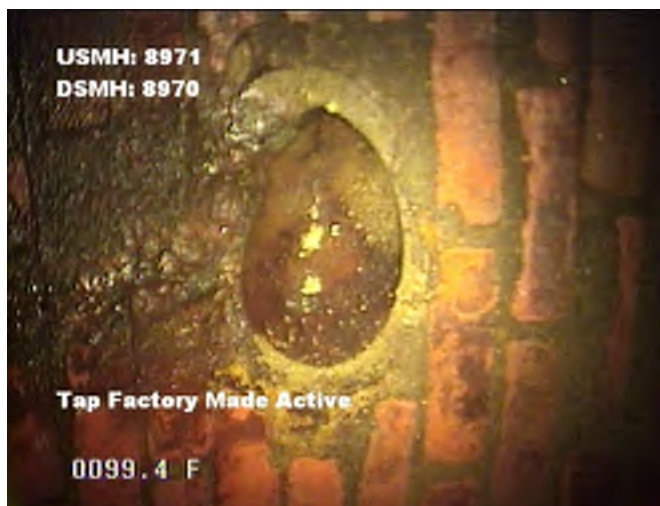
Distance: 99.4 ft. Grade: 0  
Condition: Tap Factory Made Active  
Remarks: N/A

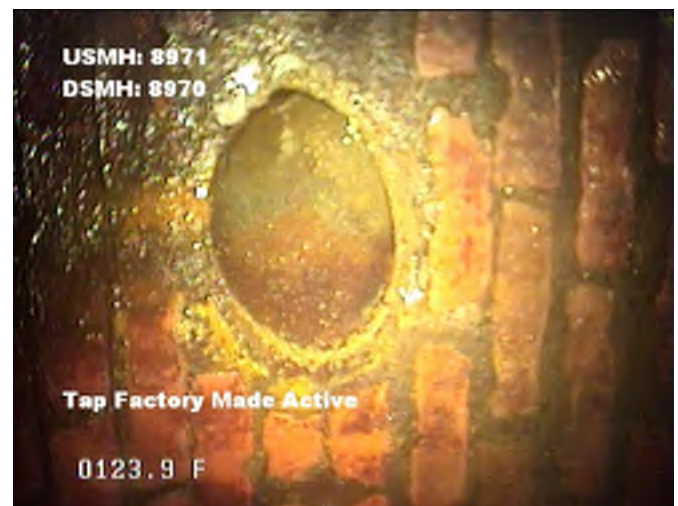
Distance: 123.9 ft. Grade: 0  
Condition: Tap Factory Made Active  
Remarks: N/A

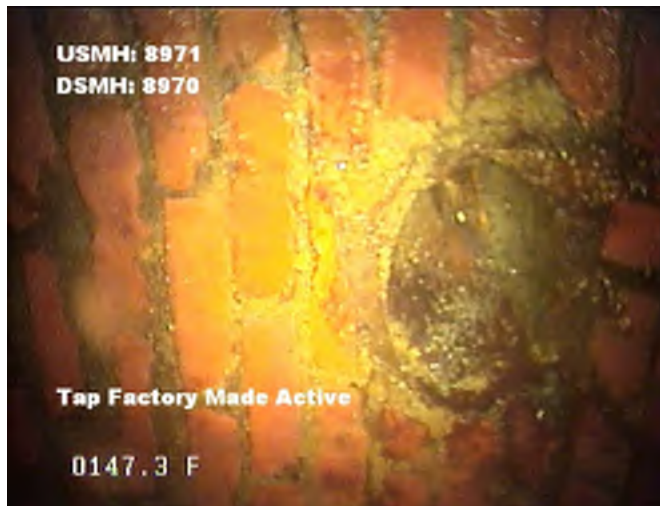
Distance: 147.3 ft. Grade: 0  
Condition: Tap Factory Made Active  
Remarks: N/A

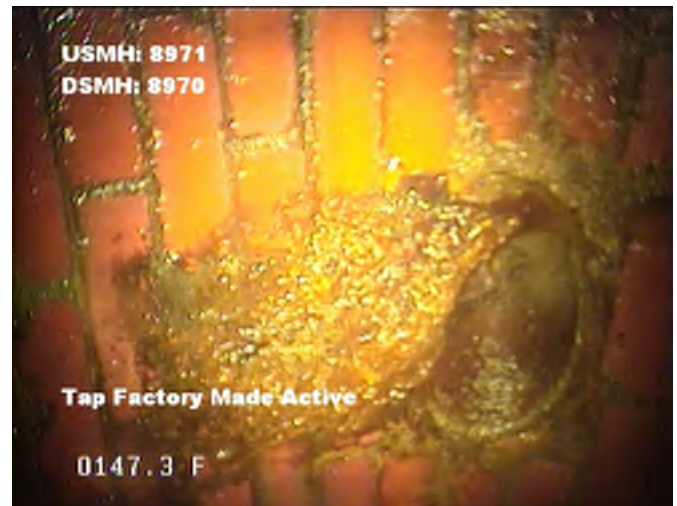
Distance: 147.3 ft. Grade: 0  
Condition: Tap Factory Made Active  
Remarks: N/A

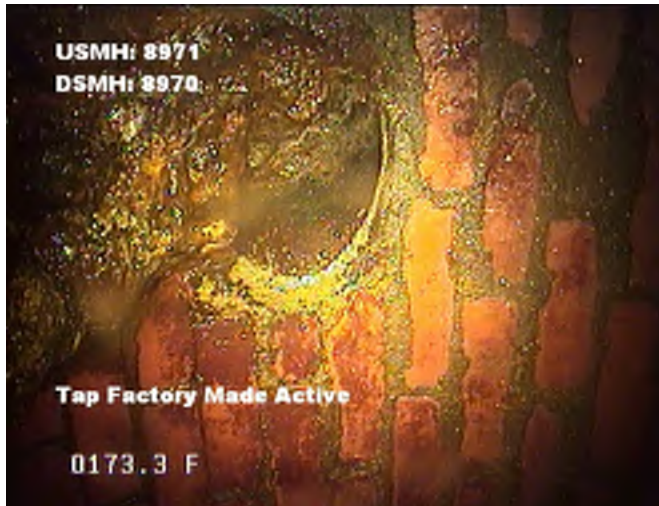
Distance: 173.3 ft. Grade: 0  
Condition: Tap Factory Made Active  
Remarks: N/A

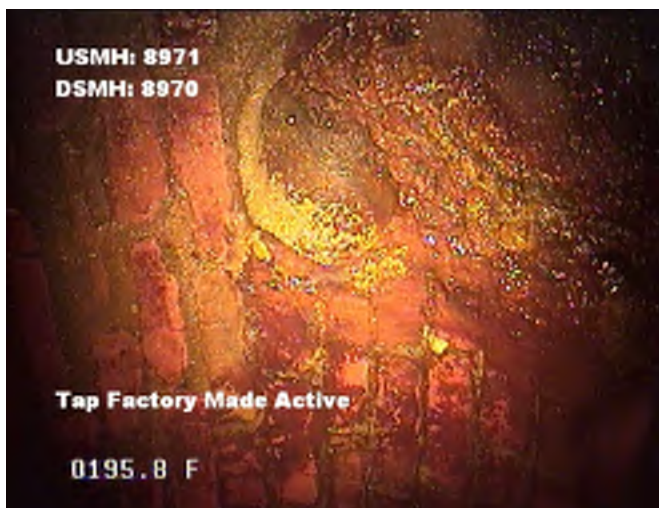
Distance: 195.8 ft. Grade: 0  
Condition: Tap Factory Made Active  
Remarks: N/A

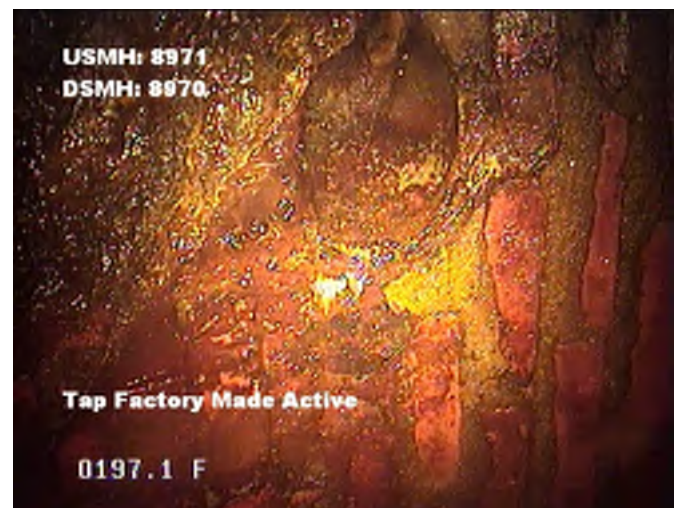
Distance: 197.1 ft. Grade: 0  
Condition: Tap Factory Made Active  
Remarks: N/A

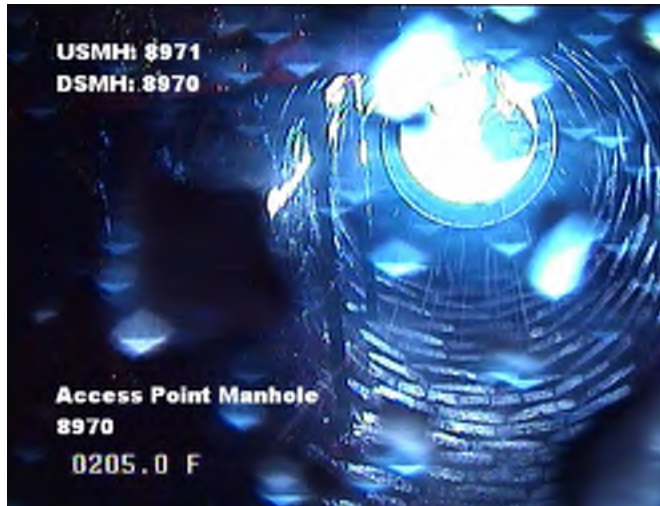
Distance: 205.0 ft.      Grade: 0  
Condition: Access Point Manhole  
Remarks: 8970

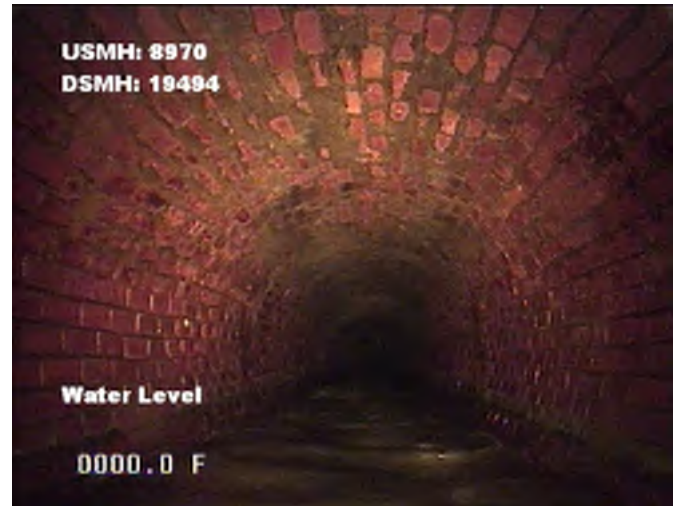
Distance: 0.0 ft. Grade: 0  
Condition: Water Level  
Remarks: N/A

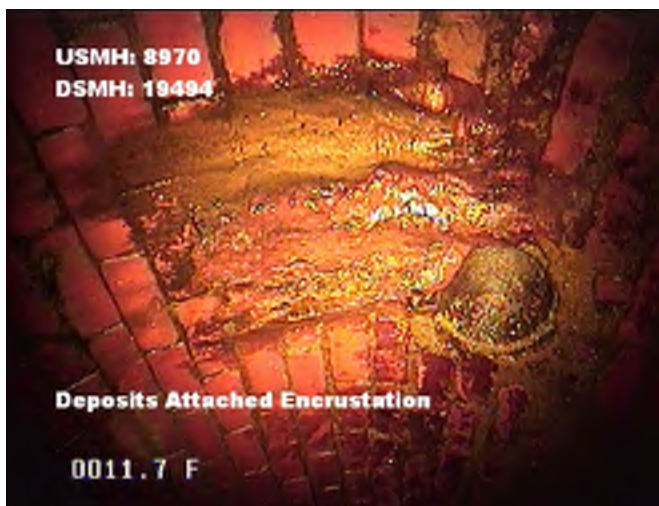
Distance: 11.7 ft. Grade: 2  
Condition: Deposits Attached Encrustation  
Remarks: N/A

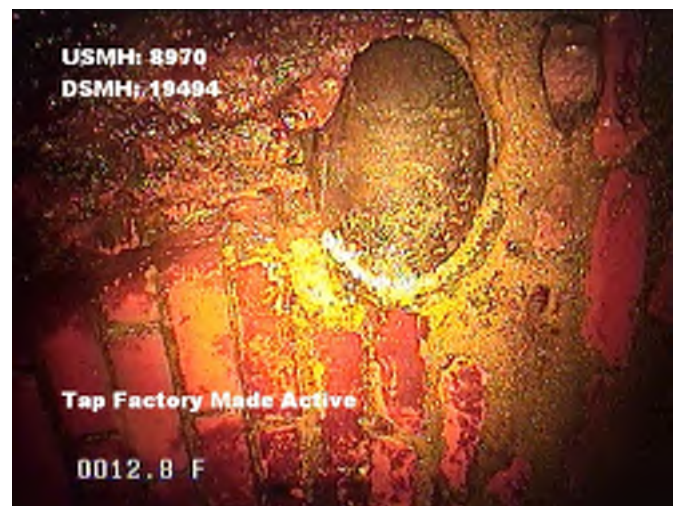
Distance: 12.8 ft. Grade: 0  
Condition: Tap Factory Made Active  
Remarks: N/A

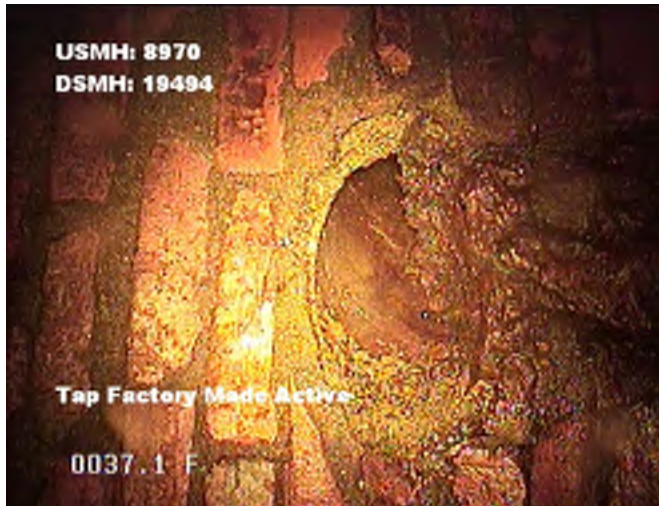
Distance: 37.1 ft. Grade: 0  
Condition: Tap Factory Made Active  
Remarks: N/A

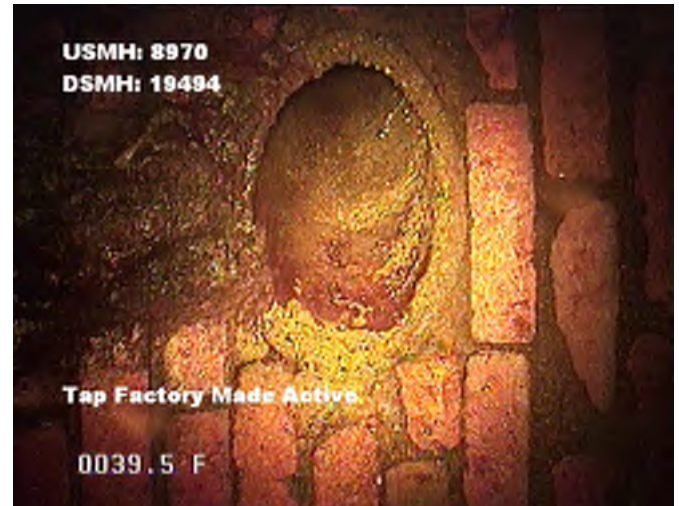
Distance: 39.5 ft. Grade: 0  
Condition: Tap Factory Made Active  
Remarks: N/A

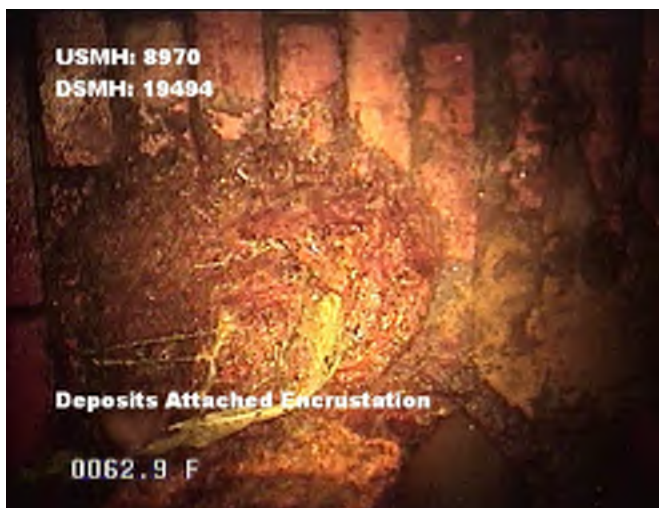
Distance: 62.9 ft. Grade: 3  
Condition: Deposits Attached Encrustation  
Remarks: N/A

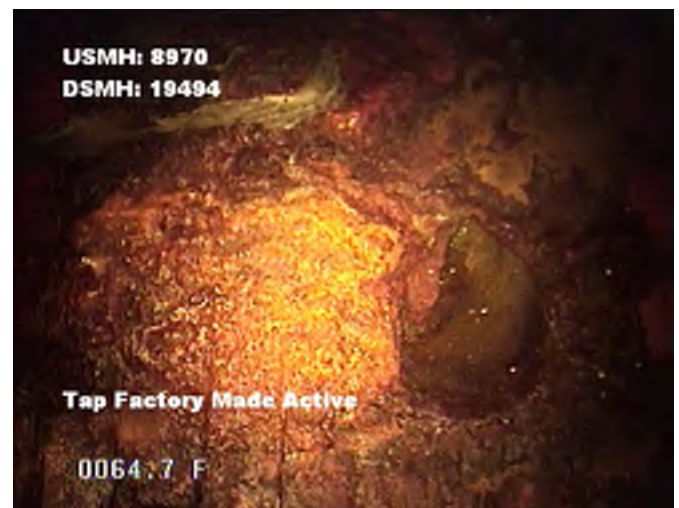
Distance: 64.7 ft. Grade: 0  
Condition: Tap Factory Made Active  
Remarks: N/A

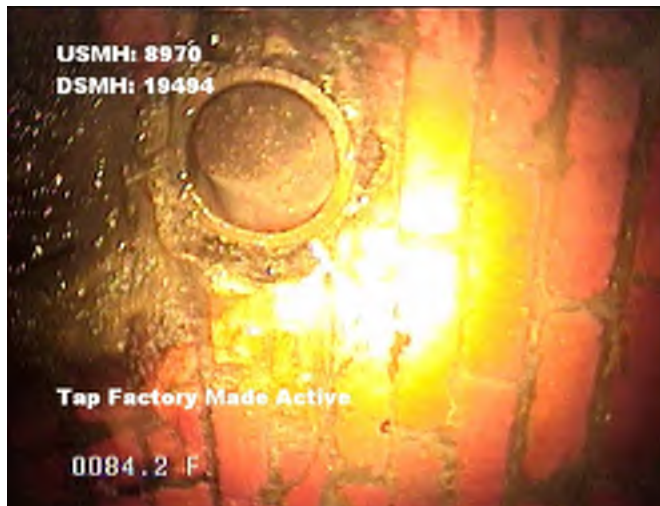
Distance: 84.2 ft. Grade: 0  
Condition: Tap Factory Made Active  
Remarks: N/A

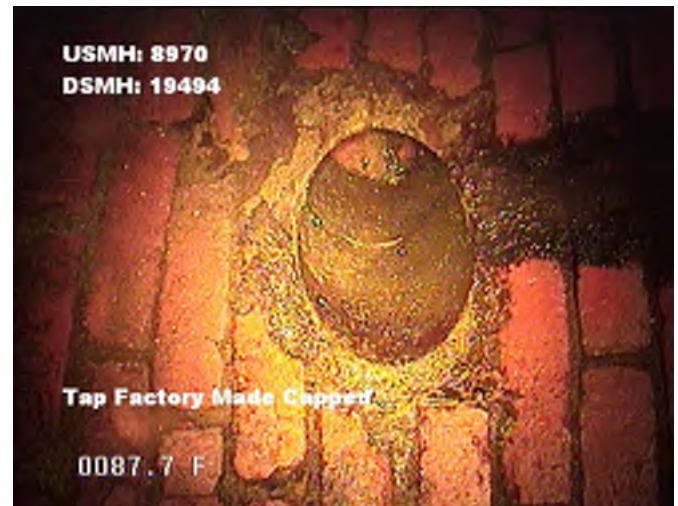
Distance: 87.7 ft. Grade: 0  
Condition: Tap Factory Made Capped  
Remarks: N/A

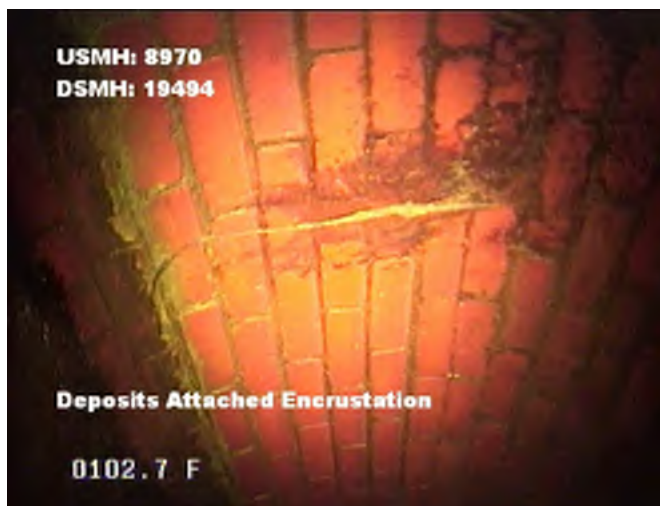
Distance: 102.7 ft. Grade: 2  
Condition: Deposits Attached Encrustation  
Remarks: N/A

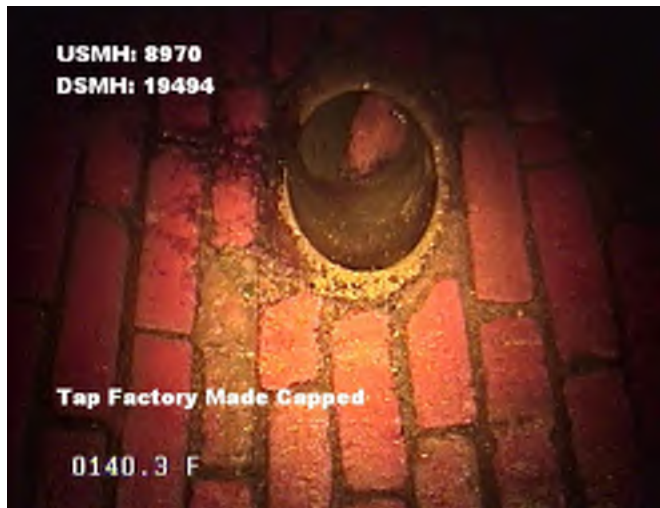
Distance: 140.3 ft. Grade: 0  
Condition: Tap Factory Made Capped  
Remarks: N/A

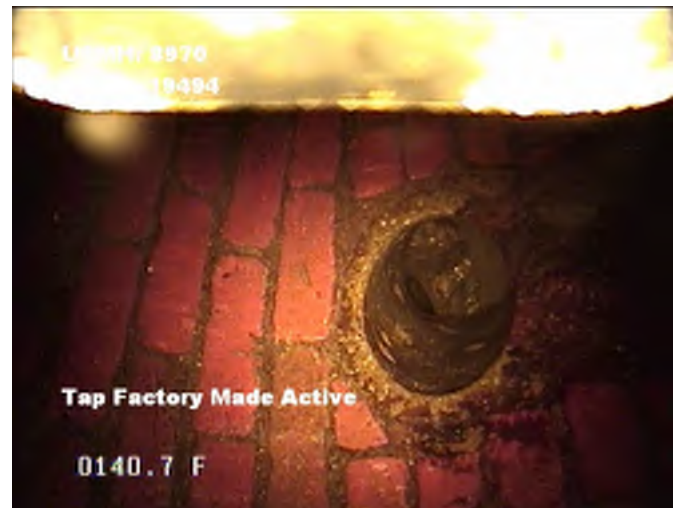
Distance: 140.7 ft. Grade: 0  
Condition: Tap Factory Made Active  
Remarks: N/A

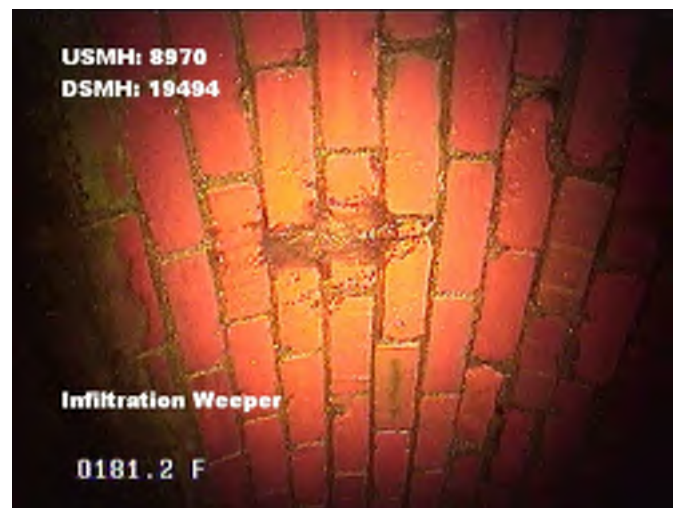
Distance: 181.2 ft. Grade: 2  
Condition: Infiltration Weeper  
Remarks: N/A

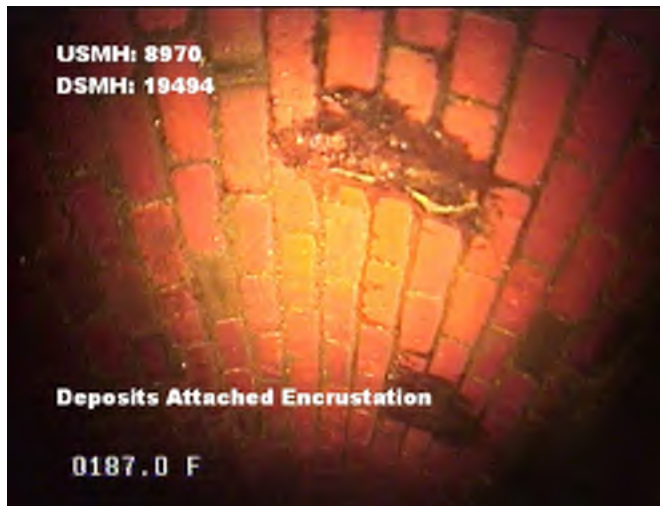
Distance: 186.9 ft. Grade: 2  
Condition: Deposits Attached Encrustation  
Remarks: N/A

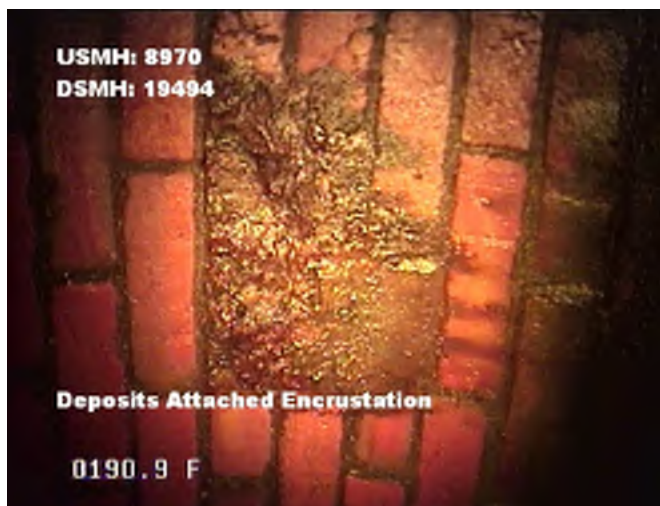
Distance: 187.6 ft. Grade: 2  
Condition: Deposits Attached Encrustation  
Remarks: N/A
